# TECHNICAL SERVICE BULLETIN

## 2.7L/3.0L EcoBoost - Oil Pan Leaking

**22-2181**  
17 October 2022

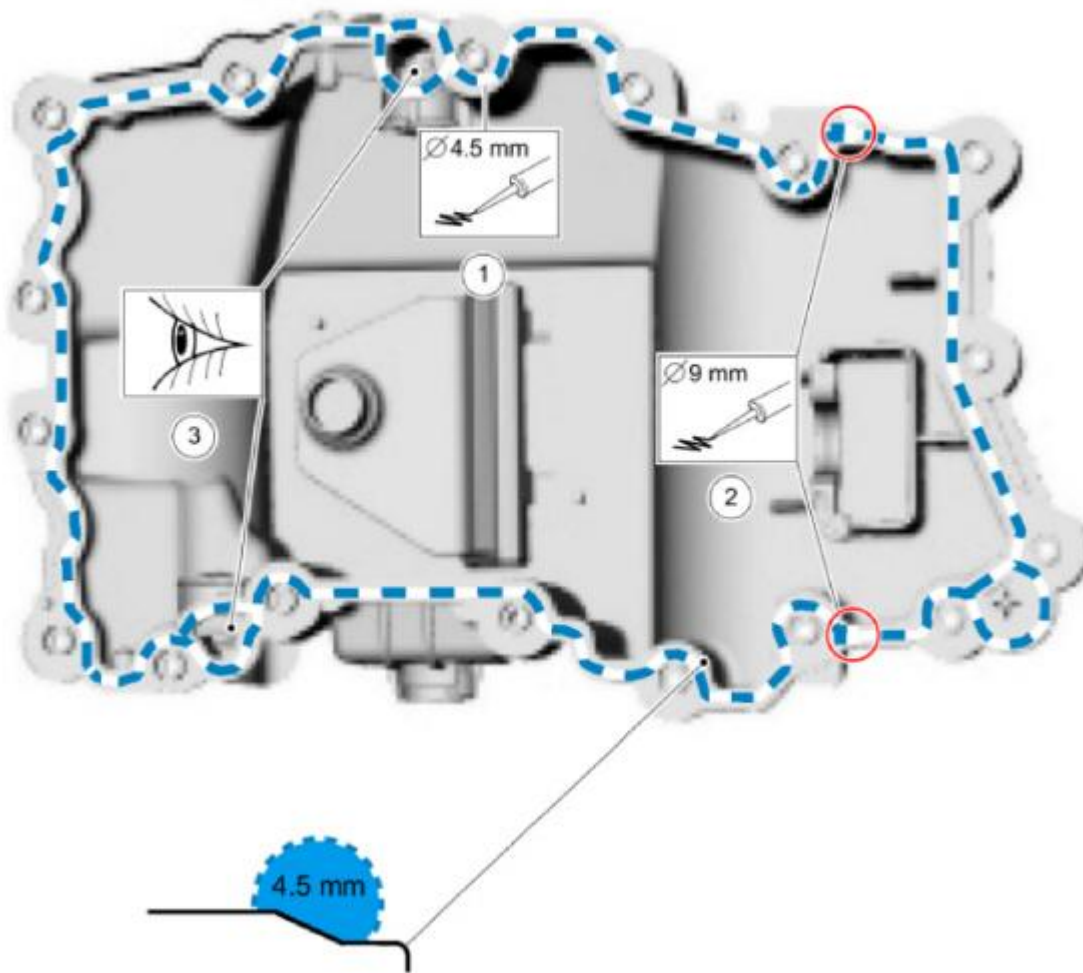
Figure 5

(1). Using too little sealant may result in oil leaks and using too much sealant may result in oil contamination and engine damage.

8. Apply a 4.5 mm (0.18 in) bead of Motorcraft® High Performance Engine RTV Silicone to the new oil pan. The RTV bead must be applied to straddle the step chamfer and sealing face. (Figures 5-6)

9. Apply a 9 mm (0.35 in) bead of Motorcraft® High Performance Engine RTV Silicone to the engine front cover-to-cylinder block joint areas on the new oil pan as shown in Figure 5.
10. Install the new oil pan. Refer to the WSM, Section 303-01.
