TECHNICAL SERVICE BULLETIN

Soft Top Wear Above B-Pillar

22-2274
17 October 2022

Ford 2021-2022 Bronco

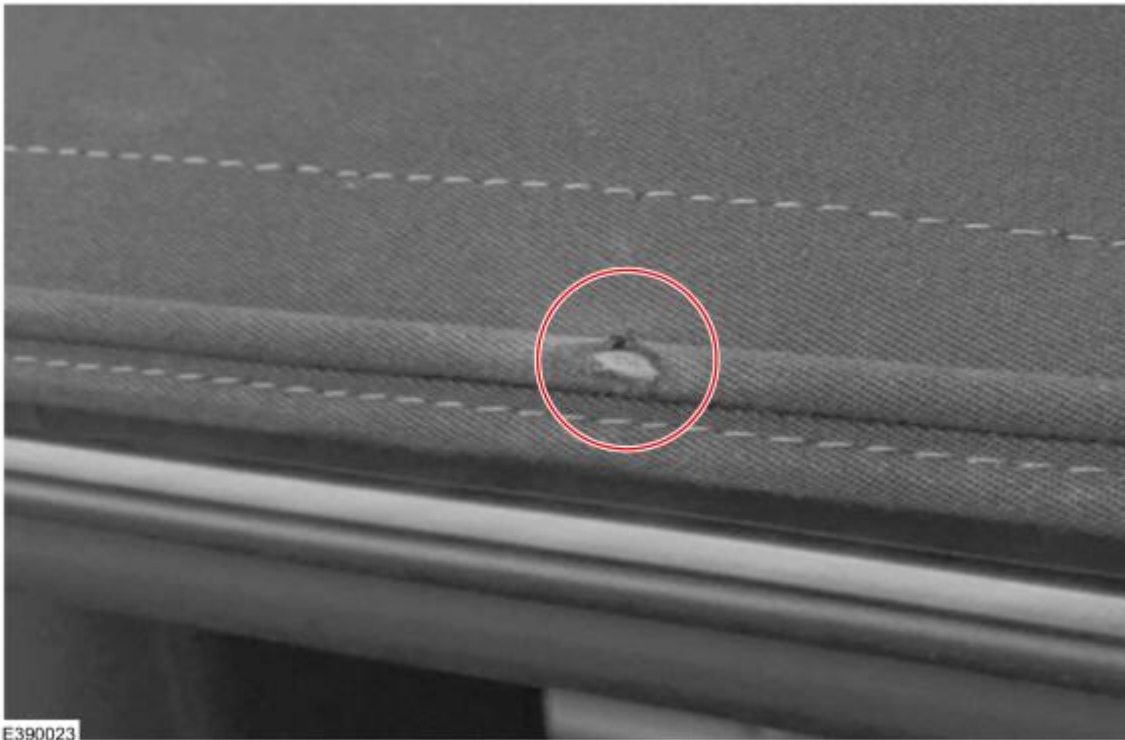
Figure 1

Issue: Some 2021-2022 Bronco vehicles equipped with a soft top may exhibit exterior wear on the sides of the top above the B-pillar. This may be due to contact and rubbing between the soft top frame and fabric. To correct the condition, follow the Service Procedure to replace both right and left deflectors attached to the soft top frame and soft top cover.

1. Does the soft top exhibit wear above the B-pillar similar to Figure 1?

(1). Yes - proceed to Step 2. Updated deflectors will be installed on both sides of the soft top frame assembly to prevent wear.
