Lippert In-Wall Slide System

KSB-220630

REPAIR OF THE INVERTED GEAR RACK IN-WALL (SCHWINTEK) SLIDE-OUT SYSTEM

TSB Number:	146-001-2022		
Product:	Inverted Gear Rack In-Wall Slide-Out System manufactured between October 2021 and January 2022		
Date:	June 24, 2022	Labor Rate:	5.0 Hours Allowed (2.5 hours per side)

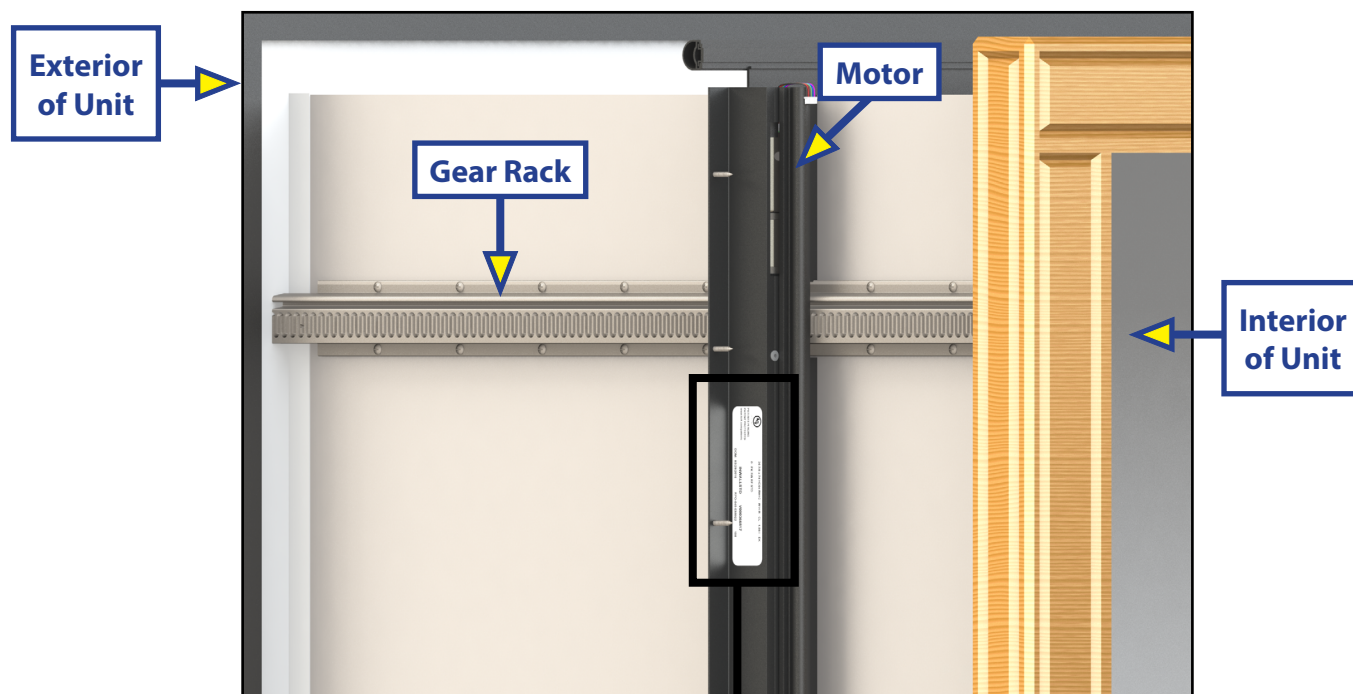
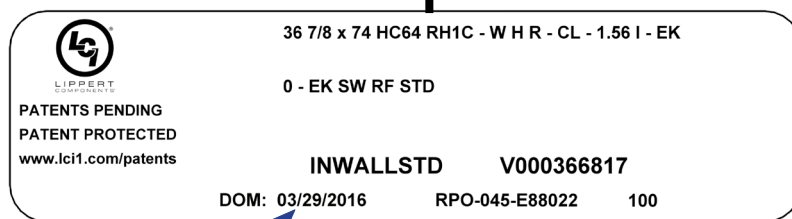
Date Of Manufacture

The specific inverted gear rack systems will have manufactured dates around Oct. 1, 2021, through Jan. 6, 2022. Dates are shown on the variant code tag located on the H-column. See location below.

NOTE: The tag featured is only a sample picture and not the actual variant code tag for the inverted gear rack slide-out.

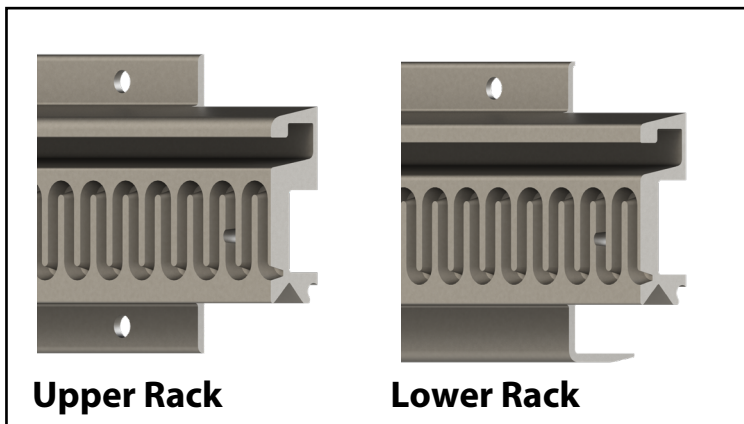
The inspection will be to validate the system as being part of the Inverted Gear Rack In-Wall Slide-Out system. The profile of the gear rack will be as shown below under the subsection "Identifying The Inverted Gear Rack In-Wall Slide-Out System."

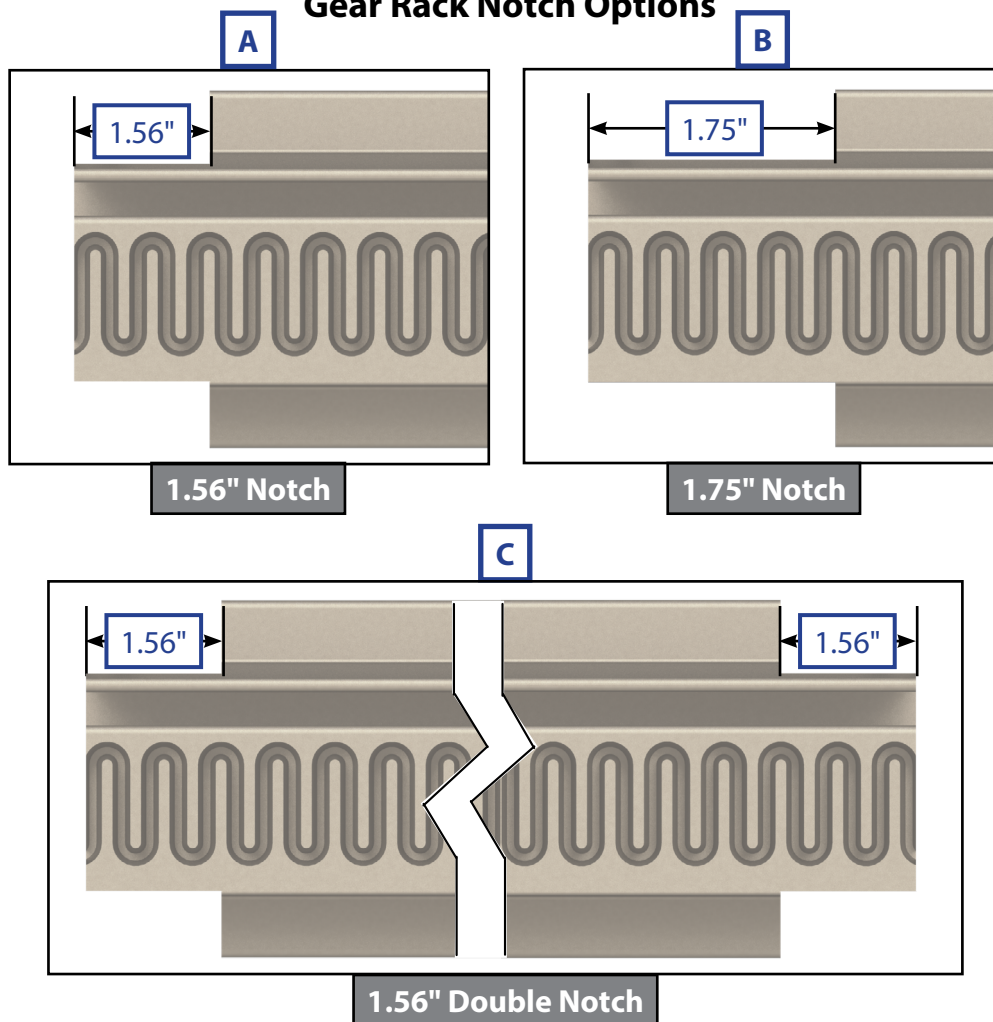
Gear Rack Notch Options

The most common gear rack notch option is 1.56" PN 2022108946. However, using the previous gear rack images to identify the notch, order the kit number listed below.

Callout	Kit #	Description
A	2022108946	1.56" Notch
B	2022108947	1.75" Notch
C	2022108948	1.56" Double Notch
