Technical product information

Topic	Driver/Passenger door/s creak on close - Bentayga
Market area	Australia E04 Bentley rest Asia and Australia (6E04),China 796 VW Import Comp. Ltd (Vico), Beijing (6796),Germany E02 Bentley rest Europe (6E02),Japan E03 Bentley Japan (6E03),Korea, (South) E08 Bentley South Korea (6E08),United Kingdom E01 Bentley UK (6E01),United States E05 Bentley USA and rest America (6E05)
Brand	Bentley
Transaction No.	2061582/6
Level	EH
Status	Approval
Release date

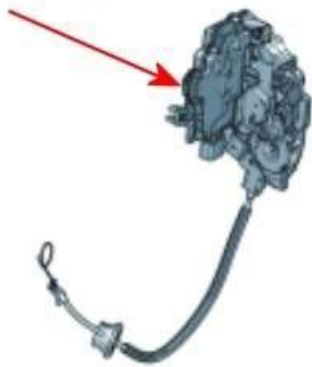
Figure 1

Refer to the vehicle repair history to check/confirm if any previous work which has been conducted regarding door latch replacement (Figure 1)

In the event the door latch date of manufacture is unknown (No notes within the vehicle repair history) the date of manufacture of each door latch must be confirmed

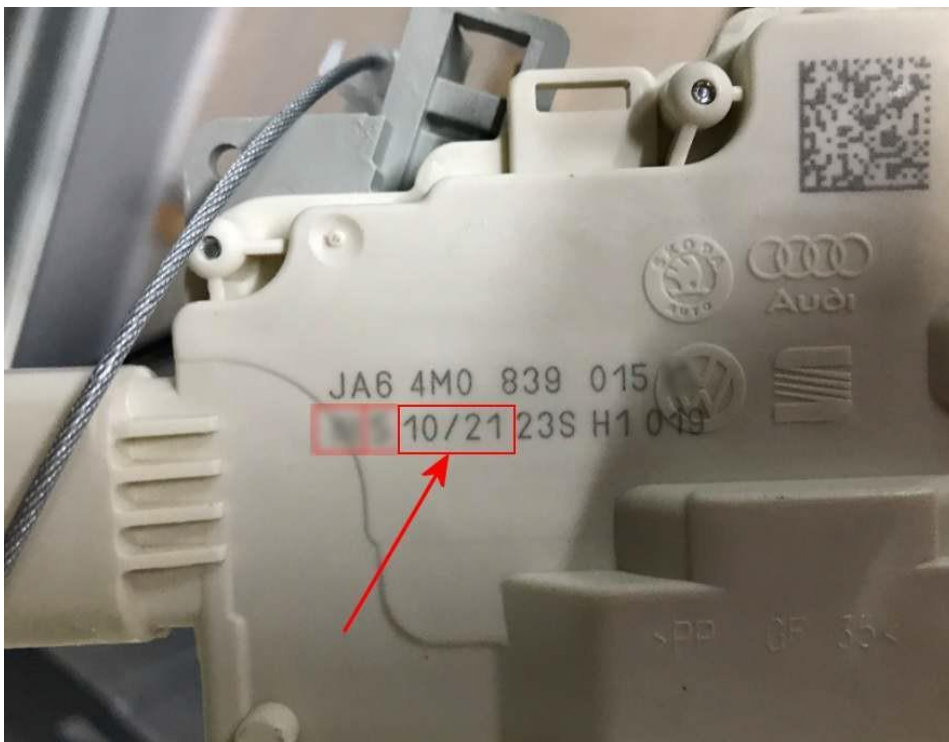
- 1) Referring to the applicable Rep.Gr - Remove the front and rear door trims
- 2) Referring to Figure 2 - Check the date of manufacture in the location shown

- Referring to the applicable Repair Group - Replace all latch motors to latest specification
- Before returning the vehicle to the customer the operative should confirm the issue is no longer evident - Open and close all doors (x10) times (Using the power close function) to confirm the issue is no longer evident NOTE: Please ensure the open/close test is replicated in the same circumstances as when the customer experiences the issue For example - Car parked in direct sunlight

- To confirm which door creaks during the "Power close" function/operation – Open and close all doors (x10) times (Using the power close function)
- Conduct the remaining instructions to the applicable door latch motors which are exhibiting creak during the "Power close" function/operation
- Referring to the applicable Repair Group - Replace the affected door latch/latches
- Before returning the vehicle to the customer the operative should confirm the issue is no longer evident - Open and close all doors (x10) times (Using the power close function) to confirm the issue is no longer evident NOTE: Please ensure the open/close test is replicated in the same circumstances as when the customer experiences the issue For example - Car parked in direct sunlight
