Technical product information

Topic	Driver/Passenger door creak on close
Market area	Russische Föderation (5RU),Australia E04 Bentley rest Asia and Australia (6E04),China 796 VW Import Comp. Ltd (Vico), Beijing (6796),Germany E02 Bentley rest Europe (6E02),Japan E03 Bentley Japan (6E03),Korea, (South) E08 Bentley South Korea (6E08),United Arab Emirates E06 Bentley Middle East and Africa (6E06),United Kingdom E01 Bentley UK (6E01),United States E05 Bentley USA and rest America (6E05)
Brand	Bentley
Transaction No.	2061605/5
Level	EH
Status	Approval
Release date

New Continental GT - New Continental GTC and New Flying Spur

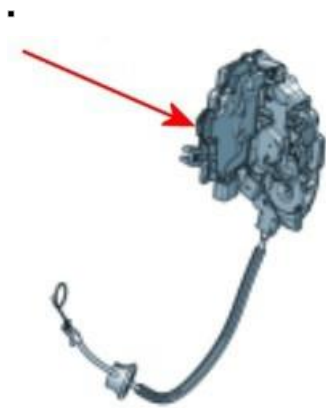
Figure 1

Refer to the vehicle repair history to check/confirm if any previous work which has been conducted regarding door latch replacement (Figure 1)

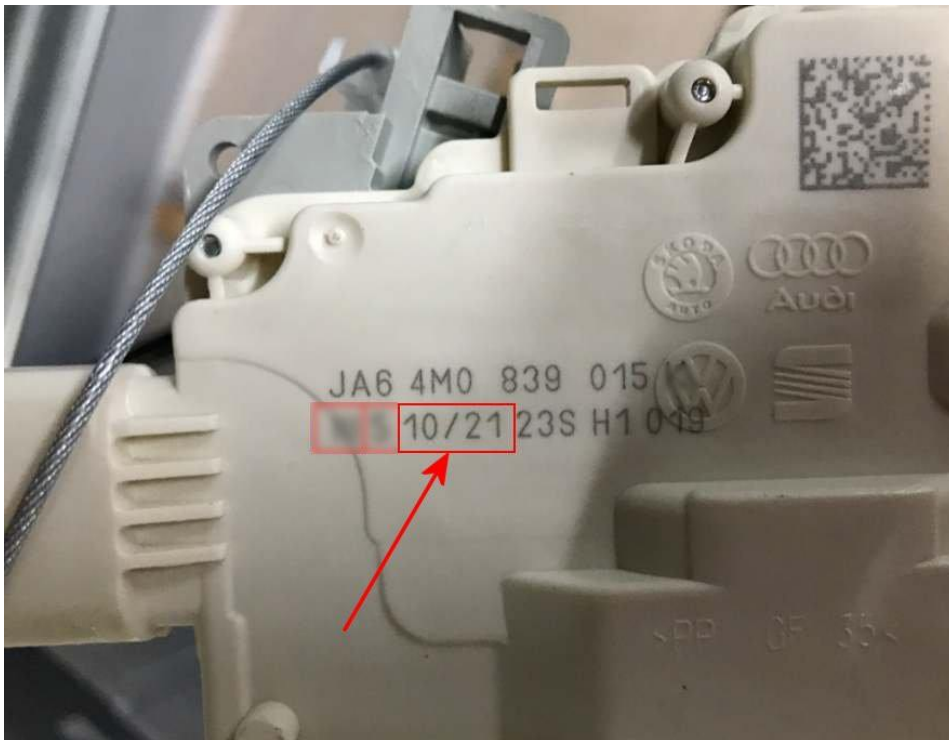
- 1) Referring to the applicable Rep.Gr - Remove the front and rear door trims
- 2) Referring to Figure 2 - Check the date of manufacture in the location shown

Latch manufacturing date code prior to 10/21

Latch manufacturing date code post 10/21

- Referring to the applicable Repair Group - Replace all latch motors to latest specification
- Before returning the vehicle to the customer the operative should confirm the issue is no longer evident - Open and close all doors (x10) times (Using the power close function) to confirm the issue is no longer evident NOTE: Please ensure the open/close test is replicated in the same circumstances as when the customer experiences the issue For example - Car parked in direct sunlight

- To confirm which door creaks during the “Power close” function/operation – Open and close all doors (x10) times (Using the power close function)
- Conduct the remaining instructions to the applicable door latch motors which are exhibiting creak during the “Power close” function/operation
- Referring to the applicable Repair Group - Replace the affected door latch/latches
- Before returning the vehicle to the customer the operative should confirm the issue is no longer evident - Open and close all doors (x10) times (Using the power close function) to confirm the issue is no longer evident NOTE: Please ensure the open/close test is replicated in the same circumstances as when the customer experiences the issue For example - Car parked in direct sunlight
