Service Bulletin

Bulletin No.: 21-NA-249

Subject: Carpet Appearance Near Center Console Area

Brand:	Model:	Model Year:		VIN:		Engine:	Transmission:
		from	to	from	to		
Chevrolet	Corvette	2020	2023	—	—	All	All

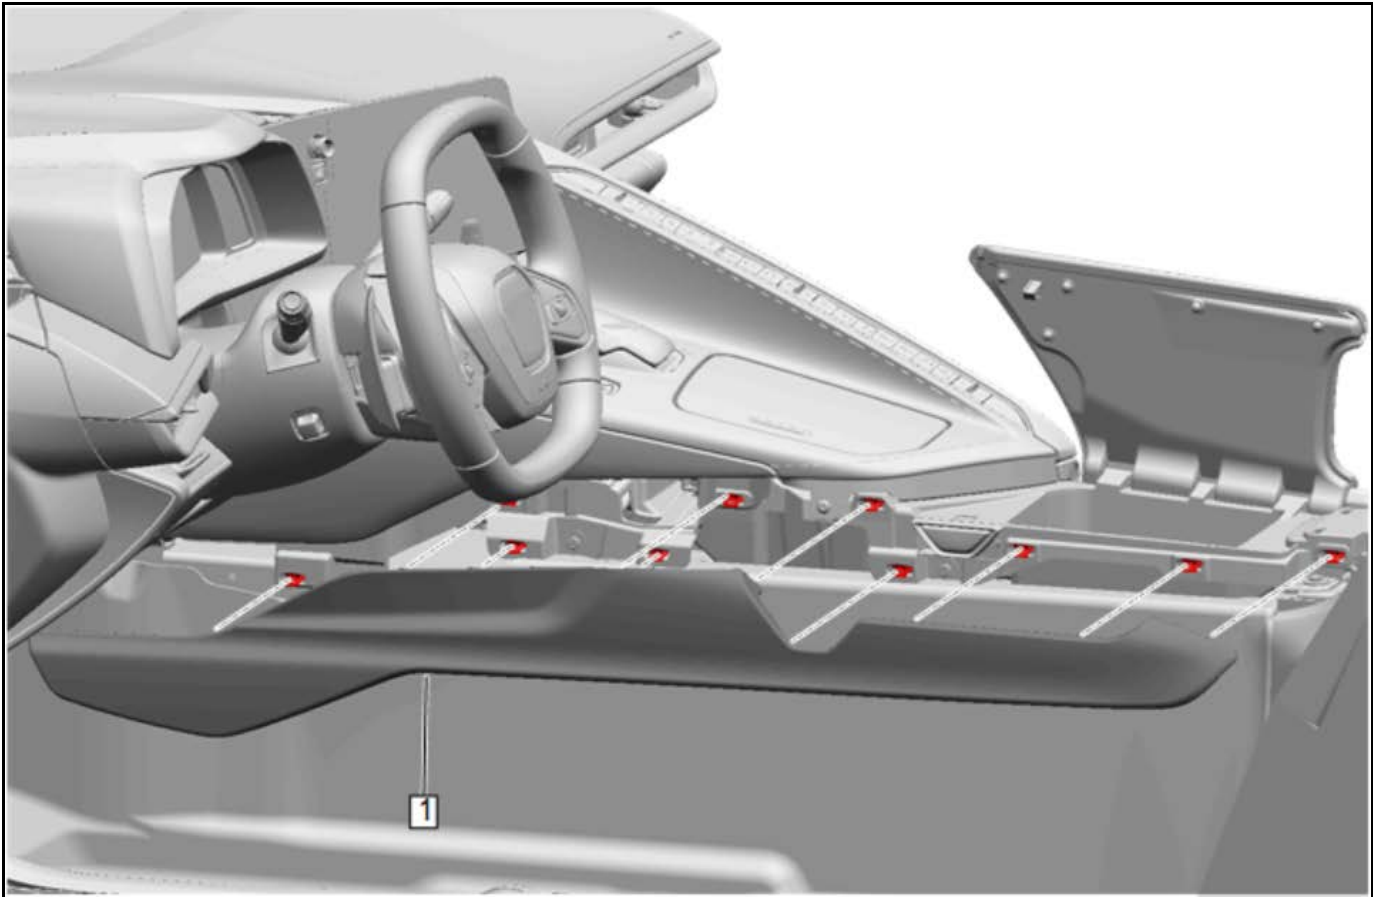
5281833

Involved Region or Country	North America, Europe, Middle East, Japan, Australia/New Zealand
Condition	Note: A visible edge of the carpeting may be noticed on either side of the center console. This will typically be noticed during PDI (Pre-Delivery Inspection) of the vehicle. Some technicians or customers may comment on the fact that there is a noticeable gap, or it appears that the carpeting has been cut too short to be completely covered by the trim on the center console.
Cause	The cause of the condition may be that the carpet running up the side of the console may need additional support.
Correction	Following the steps in the Service Procedure below, install a tie-strap to assist with holding the carpet in place.

1. Remove the front floor rear console side trim panels (1). Refer to *Front Floor Rear Console Side Trim Panel Replacement - Left Side and Right Side* in SI.
