Service Bulletin

Bulletin No.: 22-NA-081

Subject: Paint Peeling or Chipping on Front Fascia at Headlamp or Fender Seam

Brand:	Model:	Model Year:		VIN:		Engine:	Transmission:
		from	to	from	to		
Chevrolet	Corvette	2020	2023	—	—	All	All

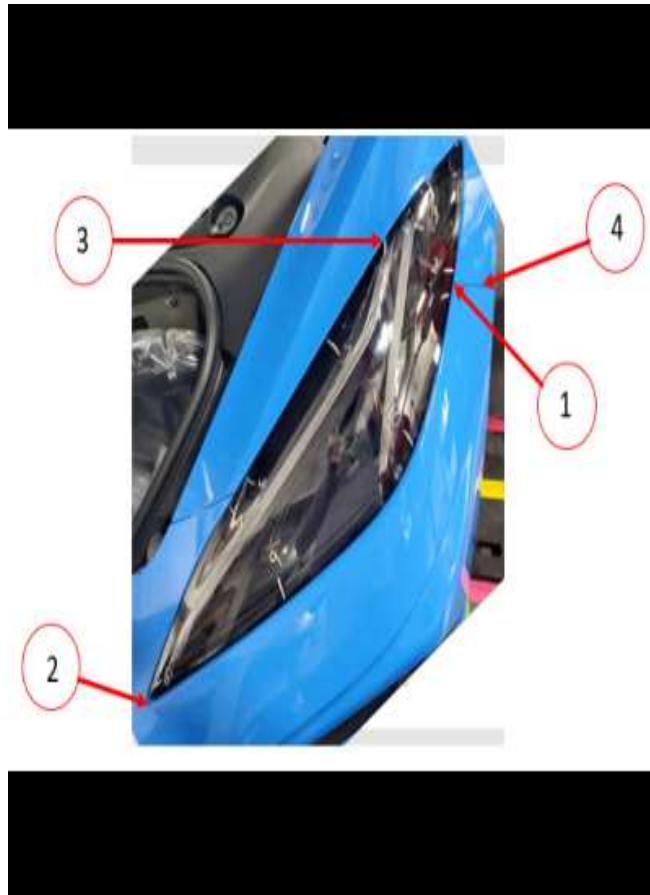
6041596

- There are four potential high contact areas where the paint may chip or peel:
1. Fender/fascia under headlamp (see Service Bulletin # 20-NA-124: Small Front Fascia Paint Chip Below Headlamp).
 2. Front corner of headlamp to the fascia.
 3. Head lamp tight to fender.
 4. Front fascia to fender.
