Service Bulletin

Bulletin No.: 20-NA-104

Subject: Malfunction Indicator Lamp (MIL) Illuminated - 5V Reference, Reduced Power, Extended Crank, Stabilitrak Message on, Body Harness to Fuel Tank Damage

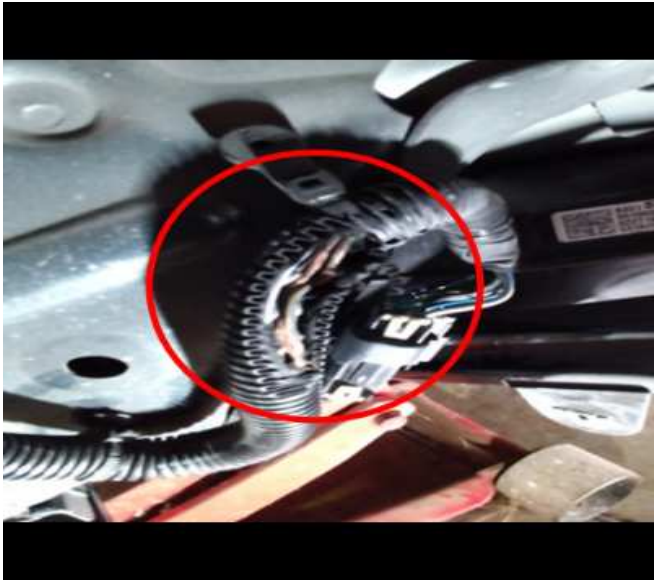
5599085

This concern may be caused by a damaged body to fuel pump harness and/or the use of oversized tires that may damage the Chassis module to fuel pump connector X350. The harness damage may also cause an intermittent short during heavy acceleration if vehicle is not exhibiting the other concerns. Upon inspection, the F35RA fuse in the rear fuse block may also be blown.

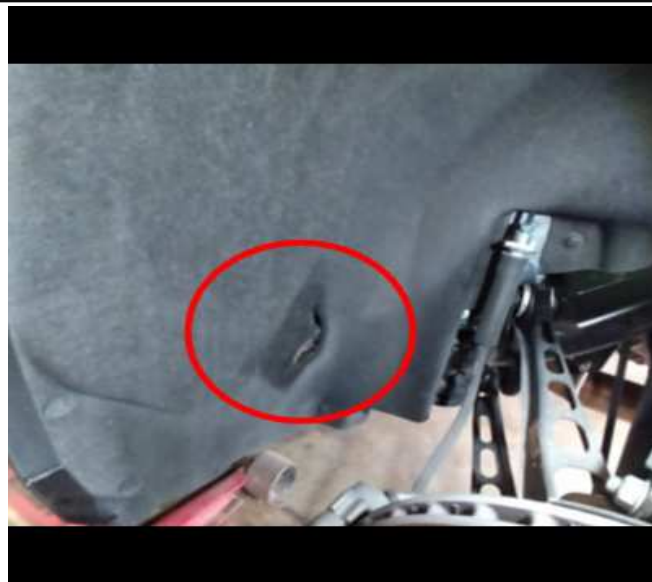
5599088

Inspect the left rear wheelhouse liner for a rub through condition due to incorrect tire size.

If you encounter a vehicle with the above concern, inspect the left rear wheelhouse liner for a rub through condition.

- If the concern is caused by a rub through condition and the vehicle is not equipped with original equipment (OE) tires, then advise the customer of the importance to use the same tire size and manufacturer as the vehicle was originally equipped with. The repair is not covered as a warranty claim.

- If the concern is caused by a rub through condition and the vehicle is equipped with the OE tires, please submit a field product report and include pictures and tire information.
