91-20-09TT - Car Net® 2.0 - Emergency Call Module and Communication Unit  
-J949- Green Light Does Not Illuminate

Release date: 10/13/2022

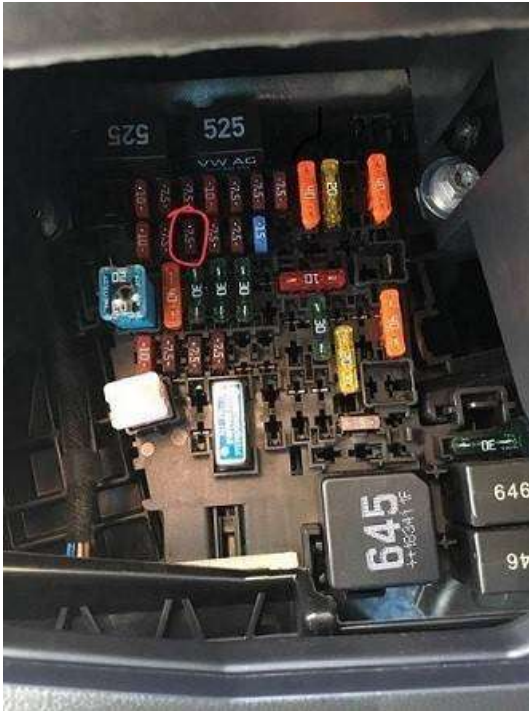
Figure 3. SC17

2.3. Remove the 7.5 amp fuse in position SC17 (for all MQB platform vehicles). The instrument cluster losing power is an indication that the proper fuse was pulled. (Figure 3.)

2.4. Wait 5 minutes with the fuse out to allow the Control Module for Emergency Call Module and Communication Unit -**J949**- internal backup battery to completely discharge.

2.5. Re-insert the fuse into the slot and reinstall the pull out door.
