01-22-05 - Update Programming Engine/Motor Control Module - J623- for Various Concerns

Release date: 10/10/2022

Technical Background

Customer states MIL-ON with various fault codes found in the ECM.

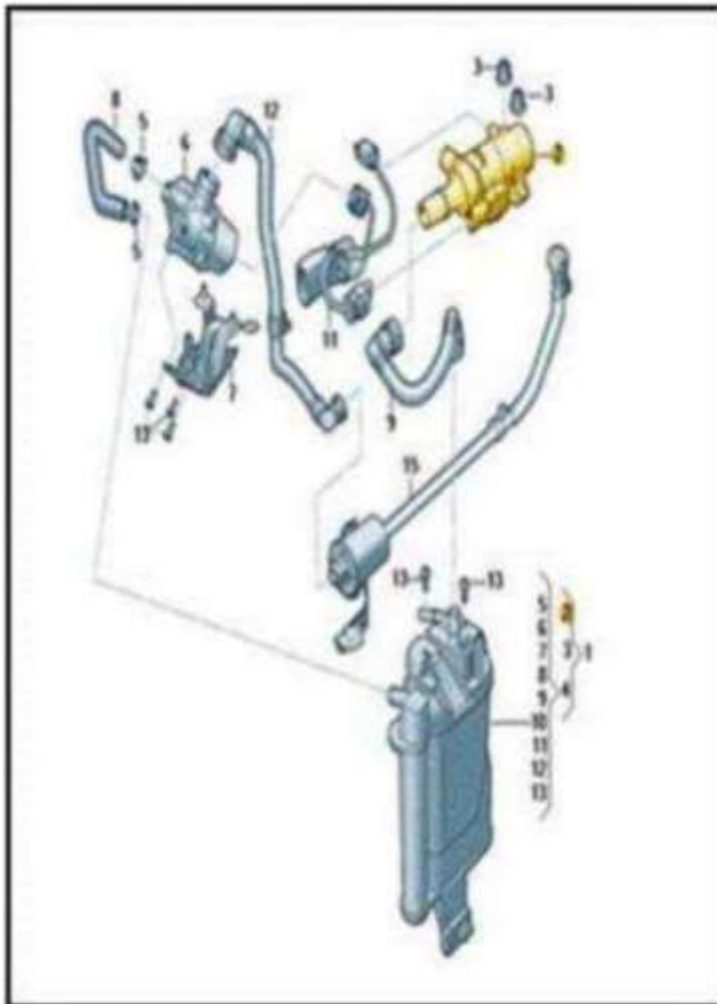
Figure 1.

In addition to the software improvement, there is also an improvement to the FTIV (fuel tank isolation valve/tank switch-off valve -**N288**-) (Figure 1.), which is necessary in preventing erroneous occurrences of the P2421 fault code.

The FTIV / Tank switch-off valve -**N288**- currently installed on the vehicle must be inspected, to verify whether an improved part has already been installed. The FTIV / Tank switch-off valve -N288- is mounted to the EVAP canister assembly, as shown below.

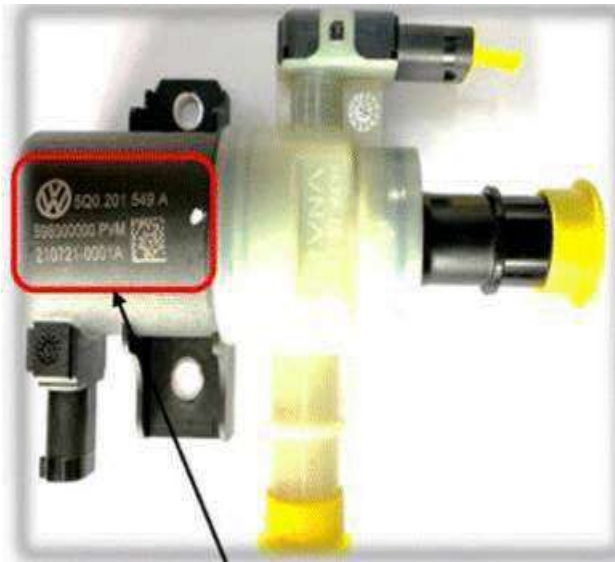
Figure 2.

Remove the EVAP canister assembly and inspect the face of the FTIV / Tank switch-off valve -**N288**-. If the part is already updated, it will have a white paint marking or "02S" printed after the part number, as shown in Figure 2 and Figure 3.

- If the part has a white paint mark or “02S”, the FTIV / Tank switch-off valve -N288- is already the updated component. In this case DO NOT replace it, and instead reinstall the EVAP canister assembly. Only the software update will be required.
- If there is no white paint mark or “02S” visible on the FTIV / Tank switch-off valve -**N288**-, the component must be replaced in addition to the software update. Always refer to ETKA for the most up to date part number information.
