Service Bulletin

Bulletin No.: 21-NA-149

Subject: Engine Wire Harness Chafing / IPC Gauges Sweep / IPC Warning Message / SES/Check Engine/MIL / No Start / No Crank / Runs Rough / Stalls / Reduced Engine Power / Various DTCs

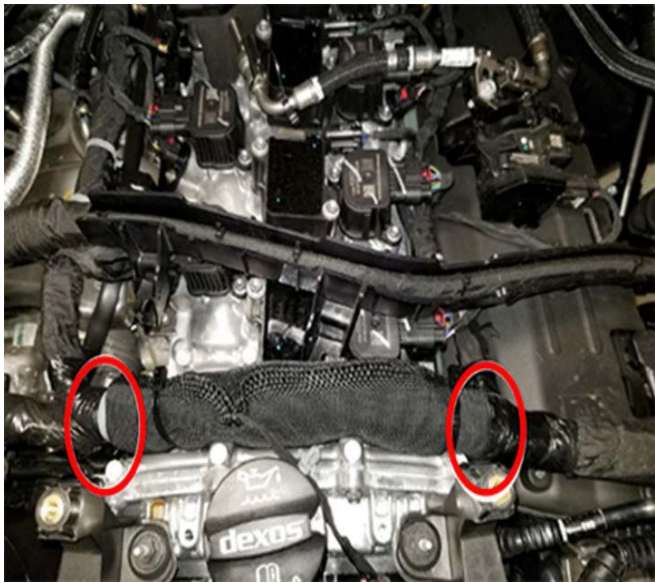
5394681

<p>Cause 1</p>	<p>This Cause pertains to vehicles equipped with engine 2.7L, L3B only.</p> <p>These concerns may be caused by engine harness contact with under hood components.</p> <p>Caution: This Document Only Applies To VINs NOT Covered by Customer Satisfaction Program N192219370 Please Verify In VIS Before Proceeding</p> <p>Shown below are areas that should be inspected for this concern.</p> <p>Inspect the engine harness as it crosses over top of the Camshaft Carrier Cover.</p> <p>Harness damage can occur at any point across the Camshaft Carrier Cover.</p> <p>Typical inspection locations shown below.</p>

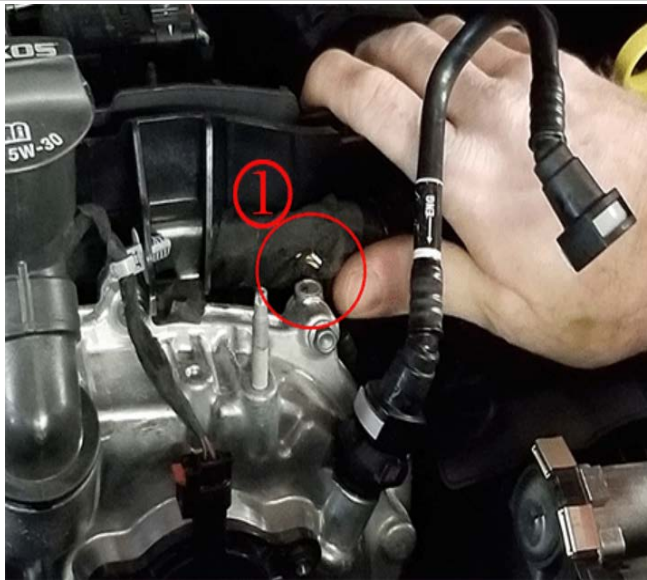
5324748

<p>Example of engine wiring harness damage at Camshaft Carrier Cover shown below.</p>

If engine wiring harness contact is isolated during inspection, use a seam ripper type tool to carefully inspect for internal wiring damage.

If found, repair the damaged wiring following the SI wire to wire repair procedures.

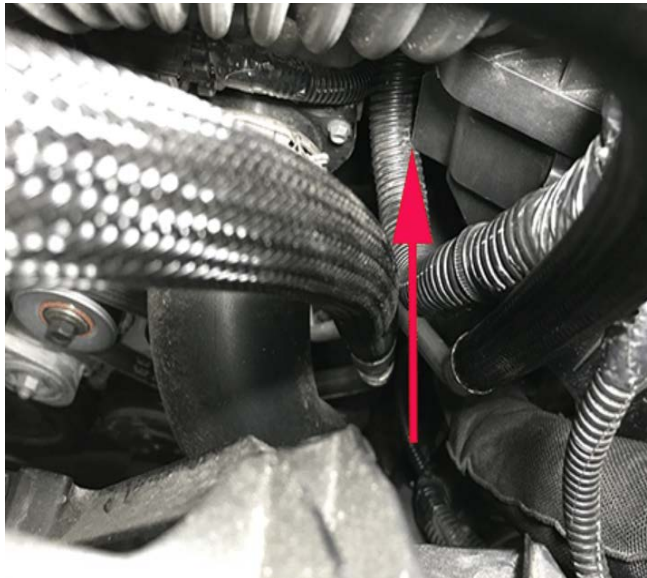
5394683

Inspect the engine harness at the Lower Air Cleaner Housing as shown below.

Example of engine harness damage, Lower Air Cleaner Housing removed shown below.

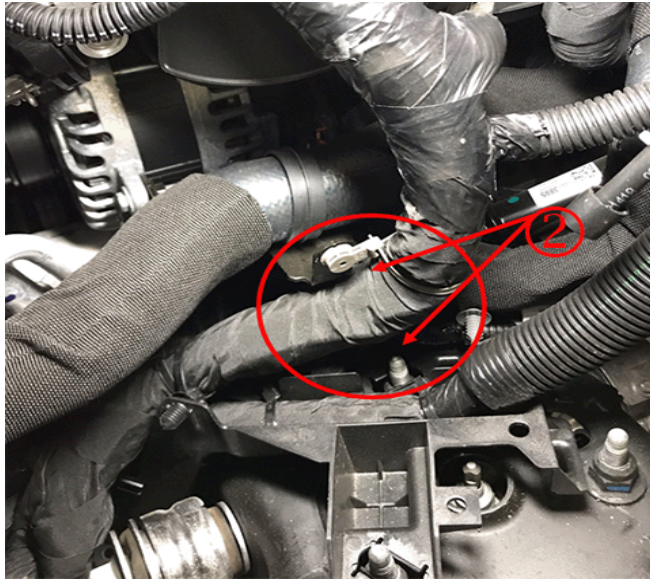
5324752

Inspect the engine harness at the Generator Bracket and Left Front Coil Spring stud as shown below.

Note: Under normal driving conditions, the engine will rock back and forth in its mounts.

This may result in harness contact with this bracket that may not be present during engine off inspections.

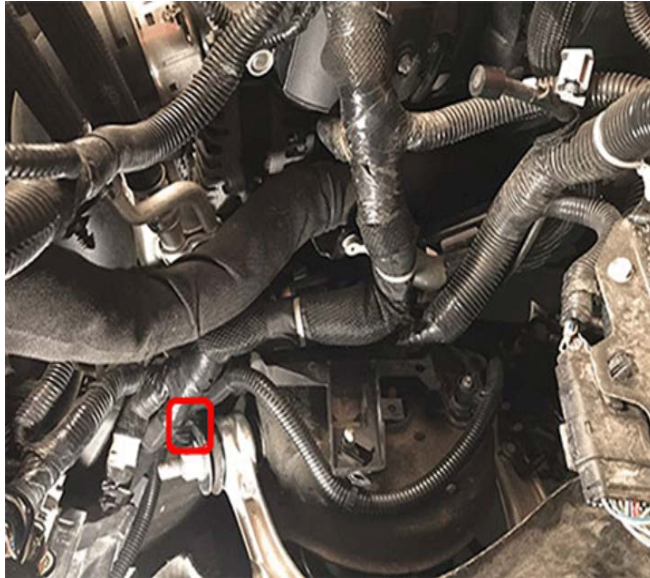
5394677

Inspect the engine harness at the Left Front Upper Control Arm Bushing as shown below.

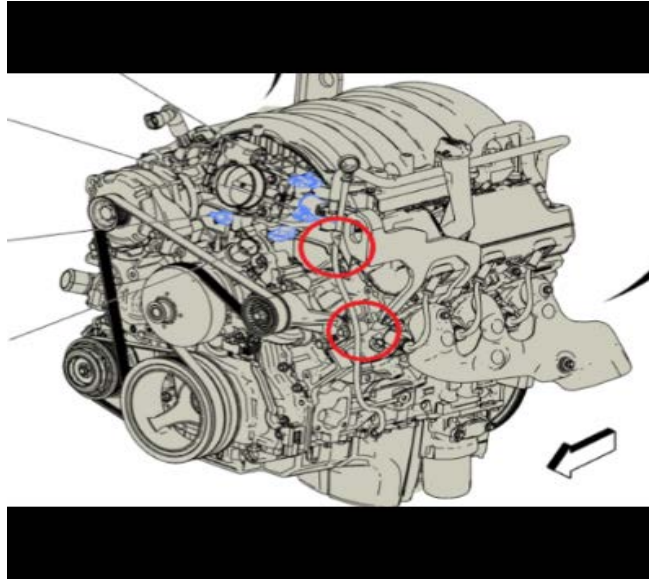
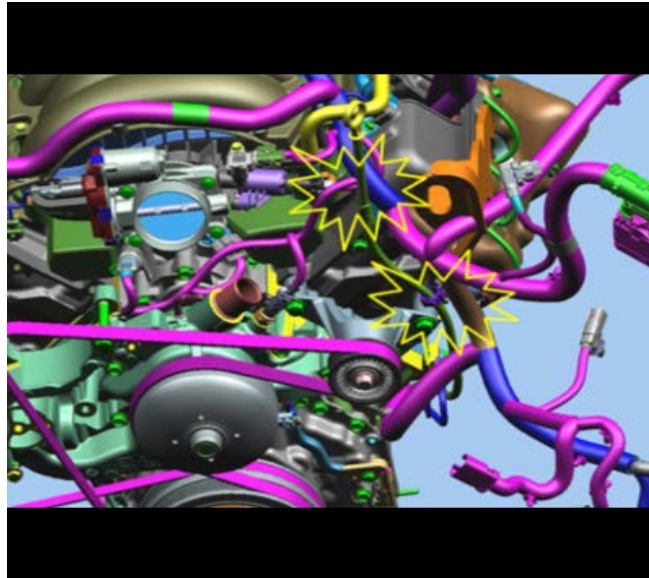
These concerns could be caused by engine wiring harness chafe on underhood components at various locations such as: Front corner of the left hand cylinder head, drive belt idler pulley bracket, or oil dipstick bracket; noted by the circled and starred areas in the graphics above.

This harness chaffing could cause shorting of any number of circuits to ground. Due to the number of circuits in the harness, there is a wide variety of different symptoms that could occur depending on which circuit(s) are damaged.

To correct this concern, repair the damaged wiring following the SI wire-to-wire repair procedures. Once repaired, protect and reposition the engine wiring harness to prevent future harness damage.

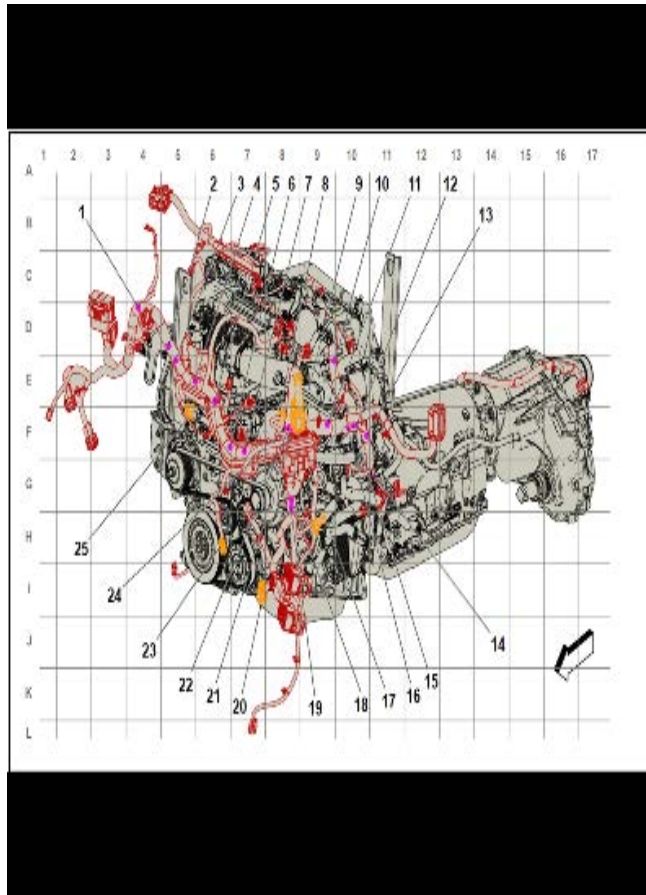
6163833

1. The engine harness pinched/shorted/chaffed at grid coordinates G-8, as shown above. This location is approximately 18 inches from the ECM connectors (1) and on top of the generator (2), as shown below. Due to the number of circuits in the harness, there is a wide variety of different symptoms that could occur, depending on which circuit(s) are damaged.

2. The engine harness shorted/chaffed at grid coordinates C-9, as shown above. The engine harness could be shorted out on the PVC hose clamp at the crankcase pressure regulator, as shown below (6). This is located approximately 4 inches from the crankcase sensor connector pigtail harness breakout.

Inspect areas designated by the graphics and call-outs in Cause # 3.

In many cases, the ECM has been unnecessarily replaced for these concerns. Please thoroughly inspect the areas shown above and follow published SI diagnostics before any parts are replaced. If any concerns are found, then follow SI Wiring and Connector repair instructions to correct the concern.

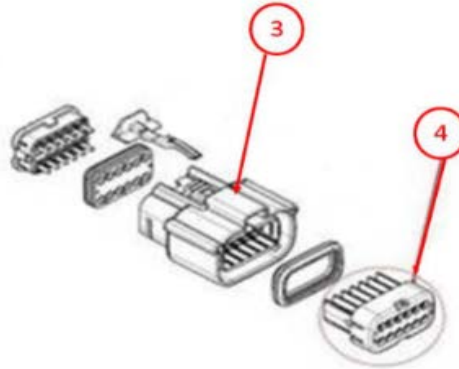
5643650

1. Inspect for poor terminal tension at connector X160, shown in the grid above, as callout 25. While inspecting X160 make sure the terminal locking feature (4), shown below, is not missing.

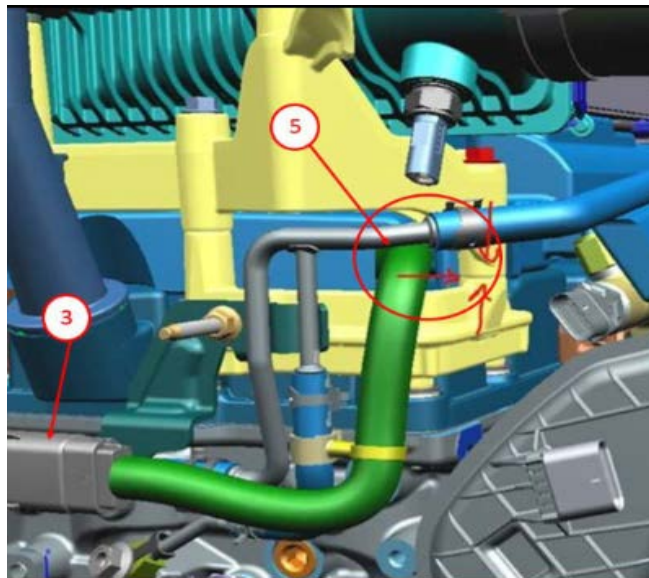
5643651

2. Inspect the fuel injector connectors to make sure they are fully connected/seated.
3. Inspect the fuel injector wiring harness near the X160 connector (3) for being pinched/shorted/chaffed, as shown below (5).

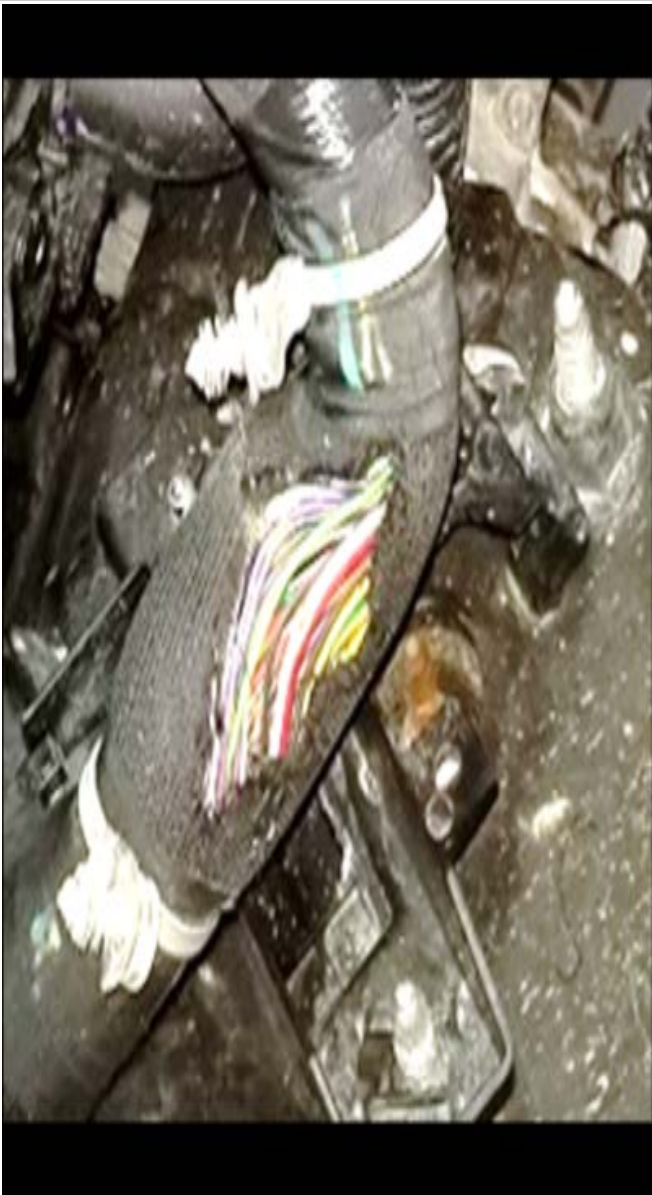
5868347

Examples of extreme wire chaffing.

The cause of the condition may be an engine wire harness clip was removed during production due to ergonomic issues (hand clearance and branch stiffness). This led to an uncontrolled branch that came into contact with a sharp edge (1) & (2) on the ECM/TCM bracket, driver side upper control arm, and/or shock tower and caused chaffing during engine vibration and roll.

Utilizing Engine Harness sleeves, anti-abrasion tape, and zip-ties to secure the harness away from one or more of the chaffing points. Follow the Service Procedure steps below.

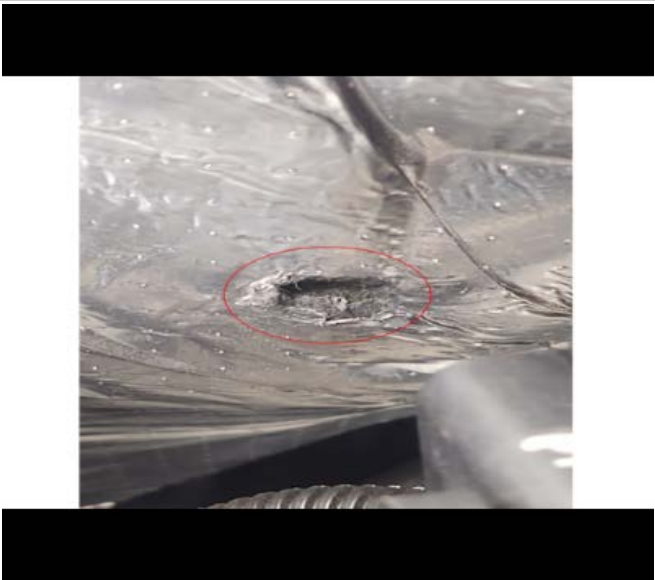
5949751

An example of firewall insulator chaffing

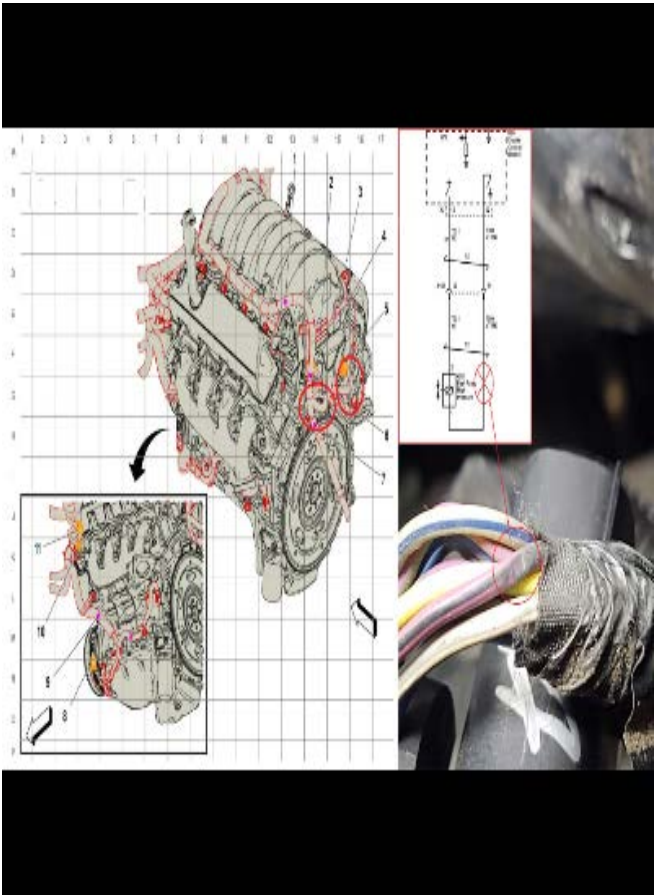
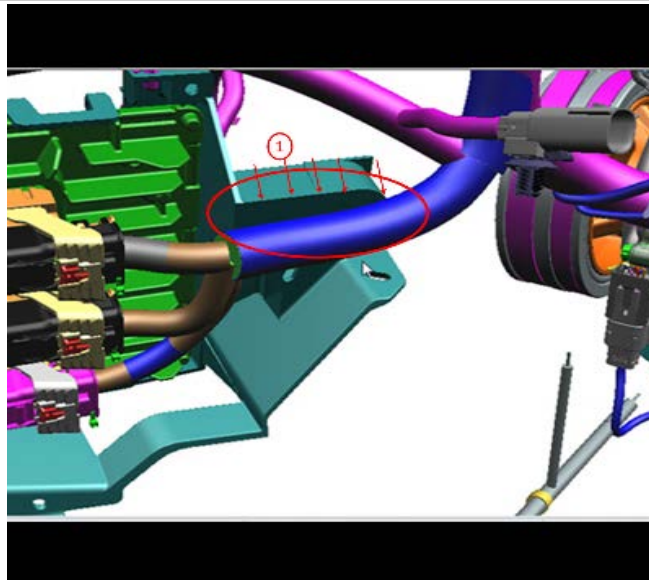
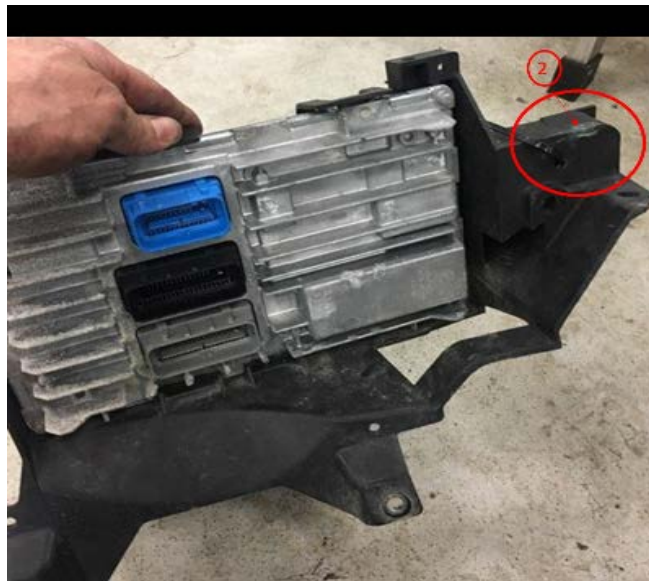
Other areas of concern.

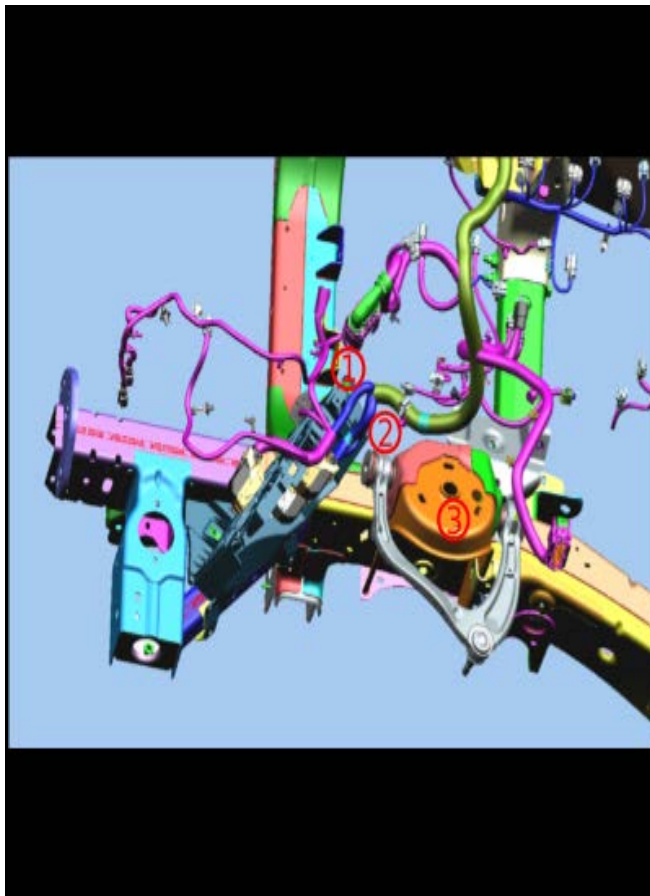
5868341

3. Locate the three contact points where the wire harness is chaffing, the ECM/TCM black bracket (1), the upper control arm (2), and the shock tower bolt (3).

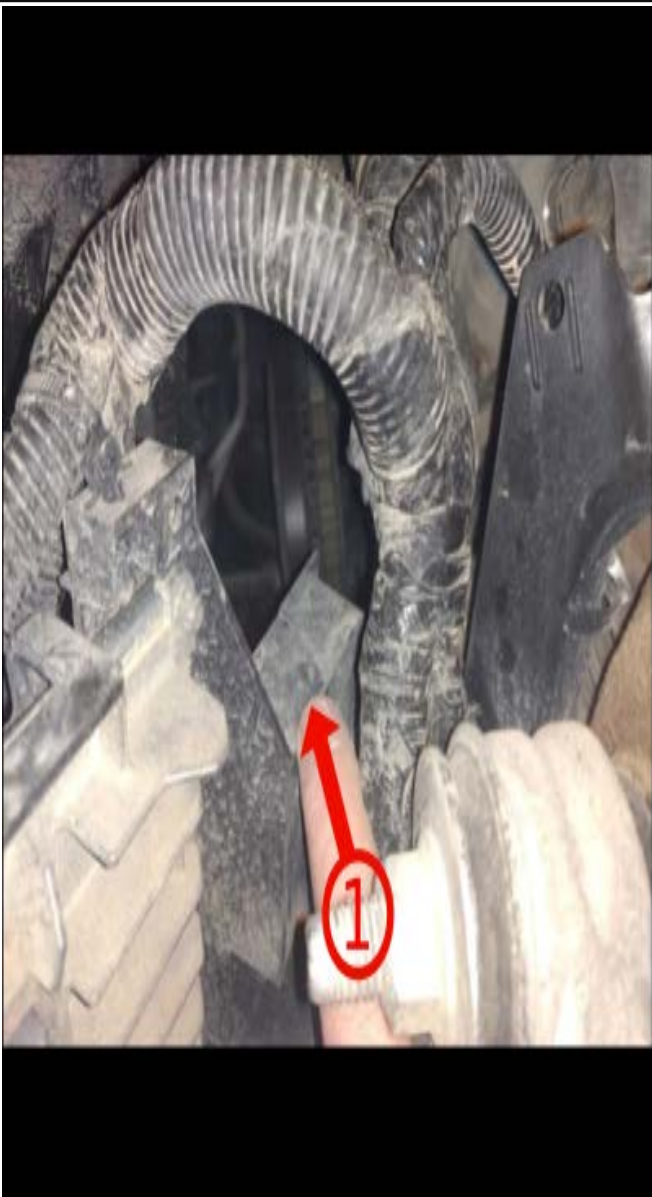
5868349

4. At the ECM/TCM bracket, locate the wire harness laying against the ledge (1).

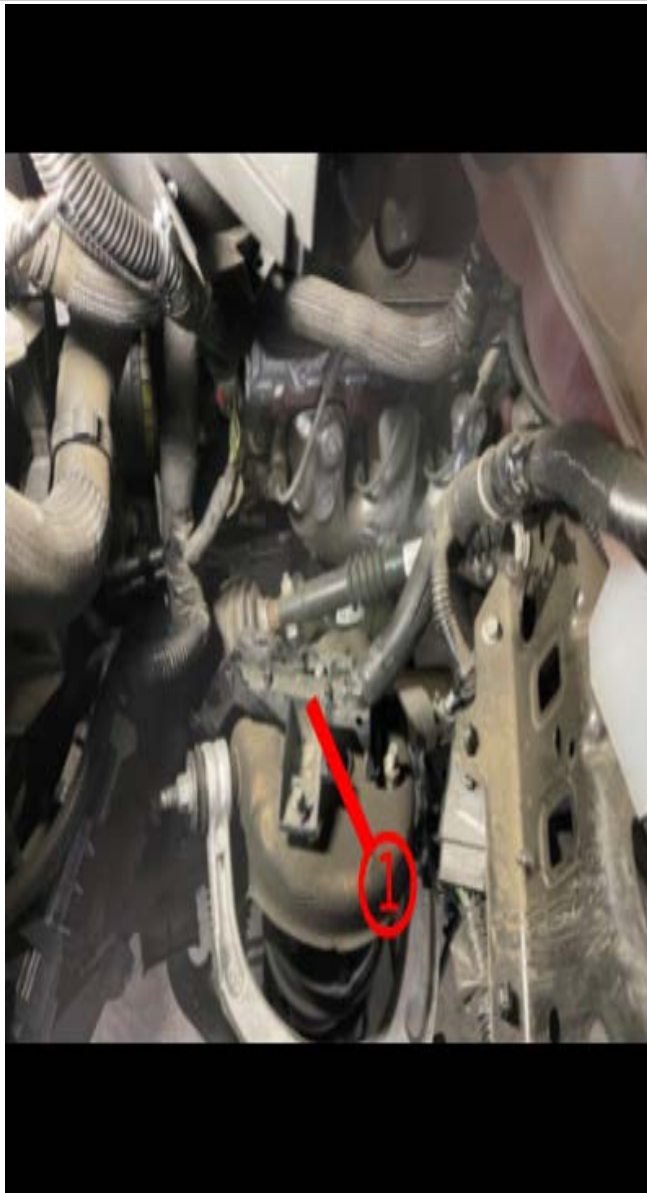
5868359

9. At the shock tower point there is a wire harness canal (1).
