# Technical Journal

**Cannot lock/unlock vehicle with remote control key**REF NO:  
**TJ 36195.11.0**ISSUING DEPARTMENT:  
**Technical Service**CAR MARKET:  
**United States and Canada**PARTNER:  
**3 US 7510 Volvo Car USA**ISSUE DATE:  
**2022-09-16**STATUS DATE:  
**2022-09-19**FUNC GROUP:  
**3666**FUNC DESC:  
**Access (central looking &  
remote)****Page 1 of 7**

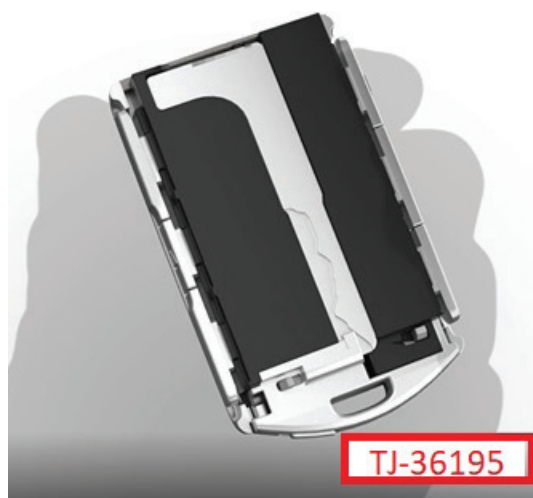
1. Cannot Lock/unlock vehicle with the “RCK”, but vehicle can be unlocked with the mechanical key blade located inside the “RCK” (see attachment “**Mechanical location**”).
2. If symptom #1 has been confirmed and starting the vehicle with the “RCK” in the backup position and DIM message stating, “Key not found”. (See picture for backup position location)
3. The vehicle can only be started with the “RCK” in the backup position located in the tunnel console (See attachment “**Backup Position**” for backup location)
4. No communication when attempting to connect/readout vehicle with VIDA.
