SIB 36 03 22

SERVICE ACTION: REPLACING THE WHEEL ELECTRONICS OF THE  
TIRE PRESSURE MONITOR (TP

E-Series	Model Description	Production Date
G07	X7 Sports Activity Vehicle	August 15-16, 2022

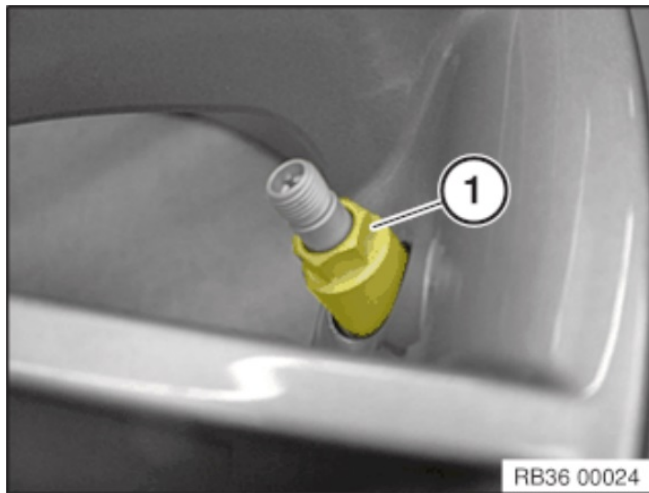
The tire valves were installed without a union nut. A slow leak can develop.

Union nut (1) shown.

Replace the wheel electronics modules together with the tire valves of the TPM on all 4 wheels.

Replace all wheel electronics modules (4) with valves of the TPM as per repair instructions REP36 11 535.
