SIB 52 04 19

2022-09-23

SECOND ROW 60/40 DRIVERS SIDE SEAT INTERMITTENTLY WON'T LATCH

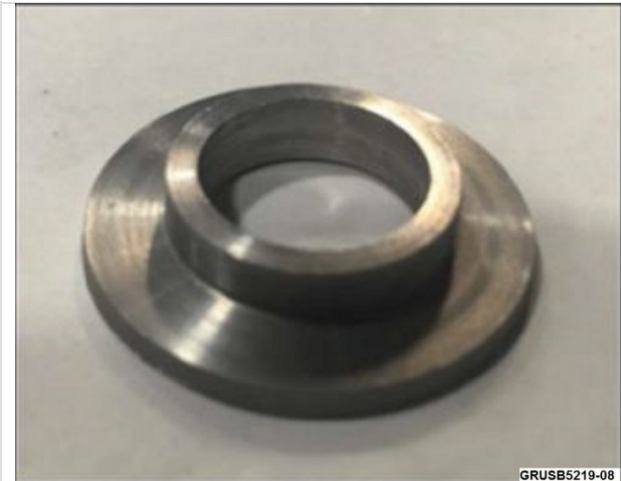
The driver's side (left rear) of the 60/40 split 2nd row seat may intermittently not fully latch into position on one side (inner rail).

Manufacturing tolerances of the seat assembly.

<p>As of March 2019 production, two machined washers (shown) were added to the bottom of the inner seat rail on the driver's side (left rear) of the 60/40 split 2nd row seat.</p>
--	---

For vehicles with this specific complaint that were produced prior to March 2019, a comparable correction is to add two 2mm thick flat washers in this location.

- 2 mm thickness
- 15 mm inner diameter hole for the bolt fitment
- Outside diameter must be at least 30 mm
