SIB 52 06 22

2ND ROW PASSENGERS SEAT INTERMITTENTLY WON'T LATCH

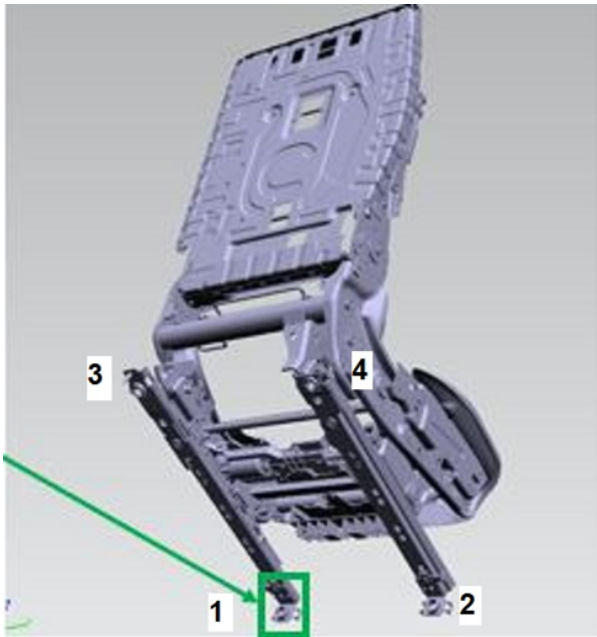
- Only the one bolt on the inner rail at the front left must be removed. All other mounting bolts can be loosened but left in place.

5. Install a single flat 2 mm thick washer under front of inner rail of the 40% structure.

Washer is installed between the floor of vehicle and the inner seat rail.
