SIB 54 04 21

GAP IN FRONT SUNROOF SEAL

This Service Information Bulletin (Revision 1) replaces SI B51 04 21 **dated November 2021**.

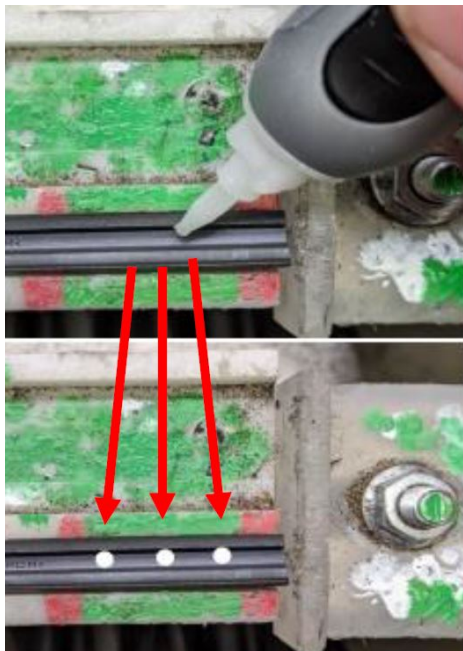
The front sunroof glass seal has shrunk, creating a gap which can cause wind noise or excess water entry.

1. Remove the front sunroof glass seal (mounted to the glass panel) following repair instructions **REP 54 13 052 "Replace seal on front glass slide/tilt sunroof panel"**.
