#### SIB 61 10 22

## SERVICE ACTION: REWORKING THE REAR POWER DISTRIBUTION BOX

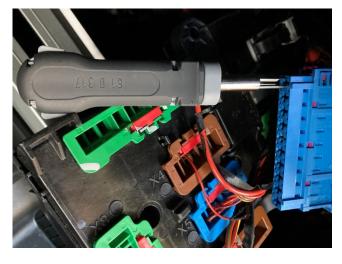
Due to an incorrect terminal assignment, the compressor circuit is protected with a 30 Amp fuse (slot F227). A 40 A fuse (slot F229) is required for suitable circuit protection.

Incorrect pinning at the rear power distribution box for the single-axle ride level control compressor.

- 4. Insert special tool (61 0 317) into pin location
- 7, remove RT/WS female terminal wire.

5. Relocate RT/WS female terminal wire to pin location **9**.
