SIB 64 04 22

2022-09-20

## INTERFERENCE NOISE IN THE HEATING AND AC UNIT

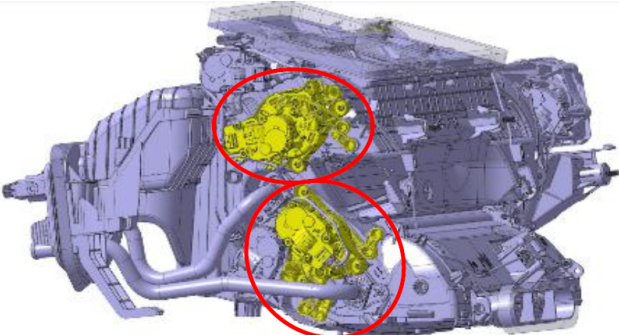
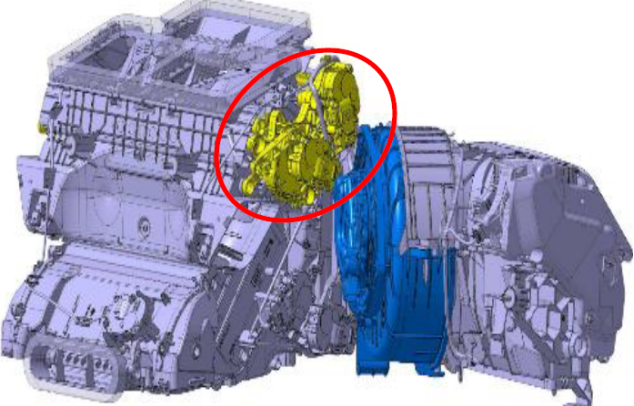
The heating and air-conditioning unit in **F97 / F98 / G01 / G02 / G20 / G22 / G23 / G26 / G42 / G80 / G82** left-hand drive (LHD) vehicles contains 3 servomotors total. **Driver Side** view

1. Remove the instrument panel support.  
Follow repair instructions "**51 45 075** Removing and installing the instrument panel support".
2. Remove all ventilation flap/stratification flap/recirculated air flap servomotors once the instrument panel support has been removed.

Depending on the vehicle model, the number of servomotors (and the associated kinematics unit) varies. On some variants assembly bolts are covered by the piping for the air conditioning system which requires evacuating the refrigerant from the system prior to removing the servomotor.

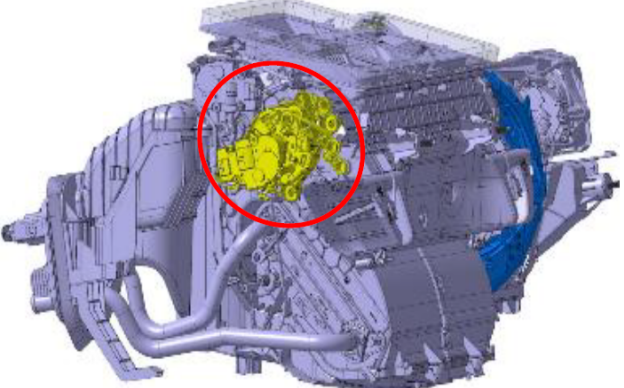
<p>The heating and air-conditioning unit in <b>F97 / F98 / G01 / G02 / G20 / G22 / G23 / G26 / G42 / G80 / G82</b> left-hand drive (LHD) vehicles. <b>Passenger Side</b> view</p>

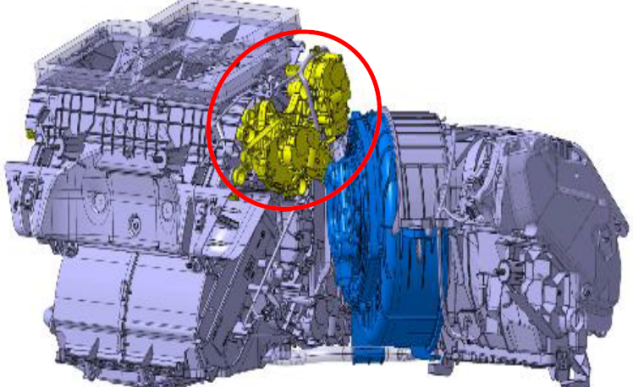
<p>The heating and air-conditioning unit in the <b>G29</b>, left-hand drive (LHD) vehicles contain 2 servomotors total. <b>Driver Side</b> view</p>

<p>The heating and air-conditioning unit in the <b>G29</b>, left-hand drive (LHD). <b>Passenger Side</b> view</p>

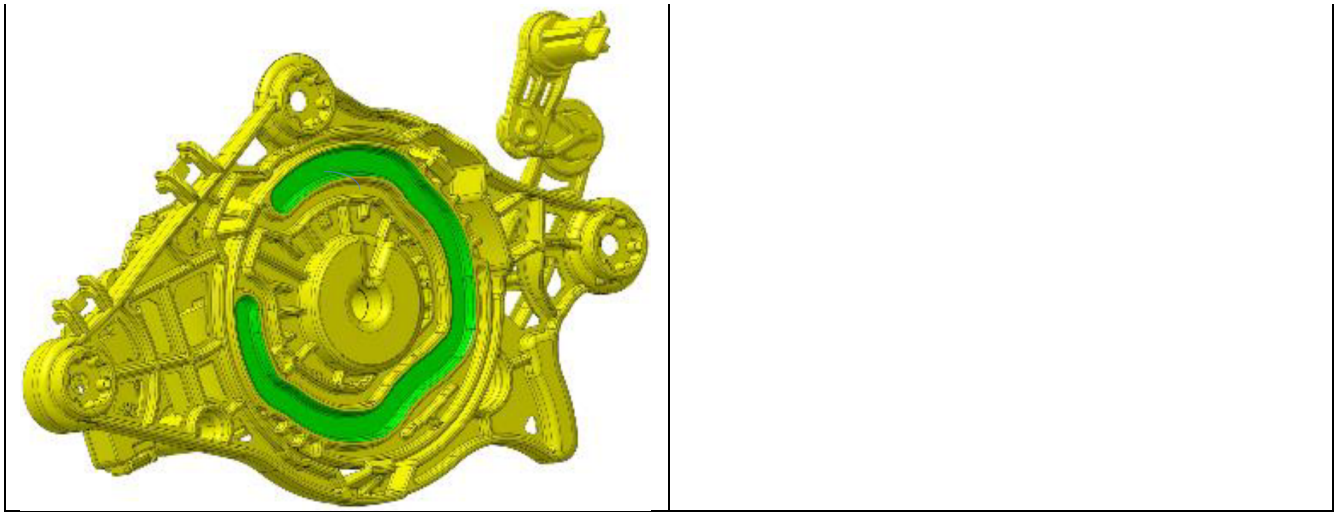
- Contamination may cause a decrease in lubrication of the kinematics unit (behind the servomotor) on the ventilation flap, air stratification flap, and the recirculated air flap.
- Incorrect tolerances on the kinematics unit

<p>4. Remove the old grease on the gate disc of the kinematics (green area) with a clean cloth and use Unisilkon TK M1011 to regrease.</p>
--	--
