SIB 33 03 22

RE-LUBRICATE THE DRIVESHAFT TAPER SPLINE

2022-09-07

SERVICE ACTION – RE-LUBRICATE THE DRIVESHAFT TAPER SPLINE

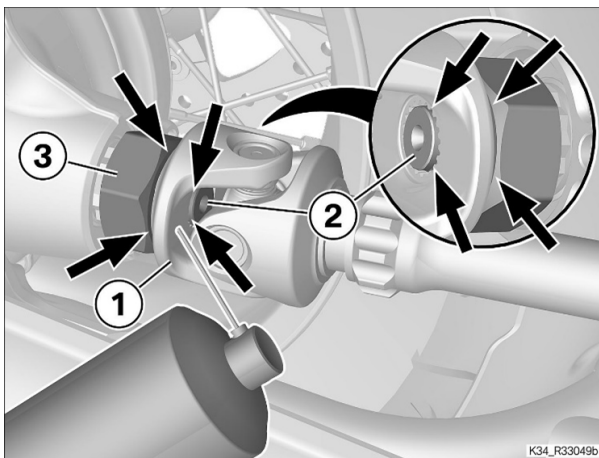
The taper spline between the driveshaft and the rear drive assembly were assembled dry on certain vehicles. This could result in rust to form.

Cover the rear wheel in the working area with cardboard or similar.

Clean lubricating points (arrows).

Spray lubricating material **into gap** between universal joint (1) and drive shaft (2) and/or nut (3) (arrows).

- Spray at four points each, offset by 90°.
- Spray for approx. 1 second each time.

Allow lubricating material to **evaporate**.

- Evaporation time approx. 15 minutes.

If necessary, remove excess spray wax with a soft cloth or similar.

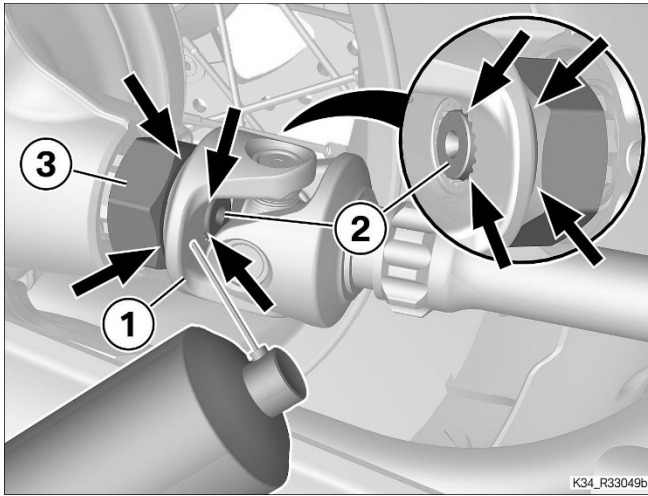
The taper spline between the driveshaft and the rear drive assembly were assembled dry on certain vehicles. This could result in rust to form.

- Cover the rear wheel in the working area with cardboard or similar.
- Clean lubricating points (arrows).
- Spray lubricating material **into gap** between universal joint (1) and drive shaft (2) and/or nut (3) (arrows).
 - Spray at four points each, offset by 90°.
 - Spray for approx. 1 second each time.
- Allow lubricating material to **evaporate**.
 - evaporation time approx. 15 minutes.
- If necessary, remove excess spray wax with a soft cloth or similar.
