## Aftersales Bulletin

### 00 51 49 05 00 – Service Action Comfort Entry Access Reactivation, Check and Rework

This Service Action affects Rolls-Royce Phantom (RR11/12), Ghost (RR21/22) and Cullinan (RR31) models produced from January 28<sup>th</sup>, 2022, to April 12, 2022, which are fitted with Comfort Entry Access feature (option code 322).

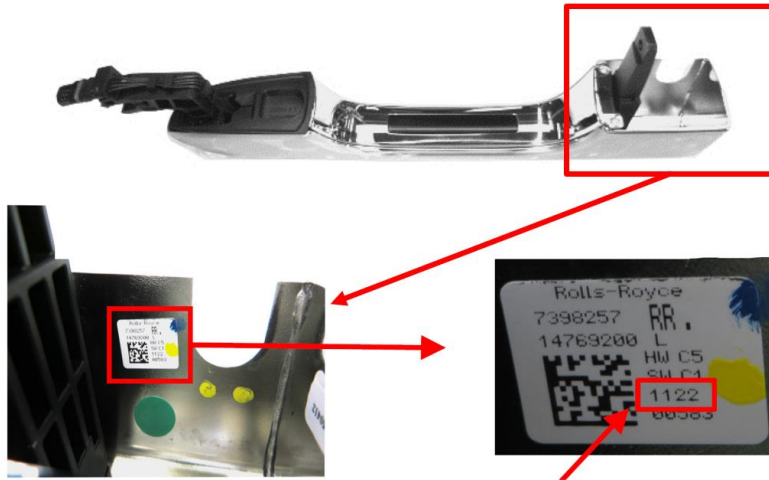
- Locate the door handle supplier build day code (DDDY format) number on the inner side of the outer metal shell.

- Check the supplier build day code on the white label to see if it is between range 0192 and 0982 (from 19th to 98th day of 2022).

Batch Identification Number	Status
xxxx 0190 0191	↑ If number is lower than 0192, Part is OK – Do not replace insert
0192 xxxx xxxx xxxx 0982	} If number is in this range part is <b>Not OK</b> and will require insert replacement work to be performed
0983 0984 xxxx	↓ If number is higher than 0983 Part is OK – Do not replace insert

- If the number on label is outside (lower than 0192 or higher than 0982) of this range (OK part), go to Step 29 of this instruction.
  - If the number on label is within the day range above (**not OK** part), the insert will need to be replaced. Continue with repair from steps 7 onwards.
- Place the door handle to be repaired on a clean padded surface.

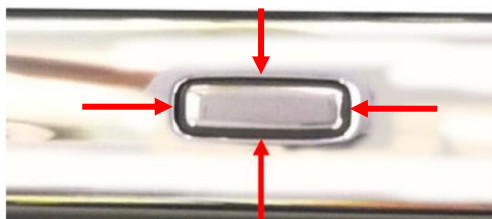
21. Double check again the alignment of the button sensor within the outer metal shell to ensure that it is centralized. Correct alignment gap should be 1.2 mm with  $\pm 0.2$  mm tolerance all the way around (min 1.0 mm / max 1.4 mm gap).

Button sensor alignment centered.  
Gap around button sensor:  $1.2 \pm 0.2$  mm

- If the button sensor alignment gap is within the required range ( $1.2 \pm 0.2$  mm) – adjustment is not needed. Please go to Step 28 of this repair instruction.
  - If the button sensor alignment gap is outside the required range ( $1.2 \pm 0.2$  mm) – further adjustment is needed. Follow Steps 22 – 27 for the additional work.
22. Steps 22 – 27 are **only required if button sensor alignment it not OK.**  
Remove the 2 x countersunk screws and loosen round head screw (do not fully remove).

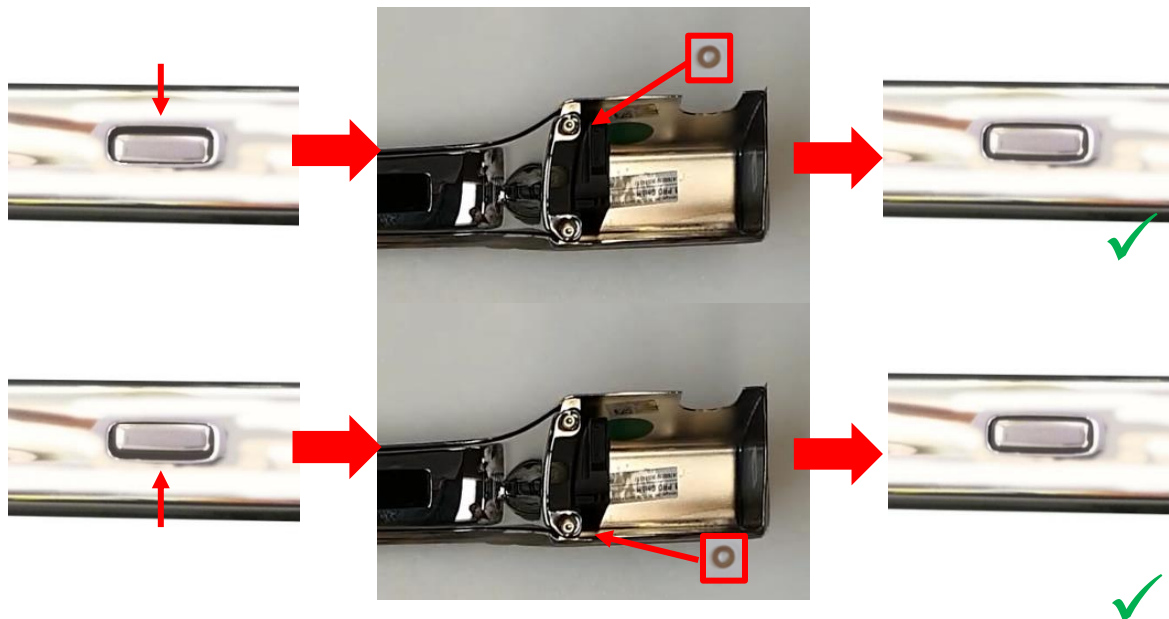
A spacer washer reduces the gap between the button sensor and the outer shell on the same side where it is inserted.

23. Remove or place a single spacer washer between the outer metal shell and door plastic handlebar electronics to adjust the gaping.
