## STAR ONLINE PUBLICATION

**Case Number:** S2223000060

**Symptom/Vehicle Issue:** Hood Is Under Flush To The Fender

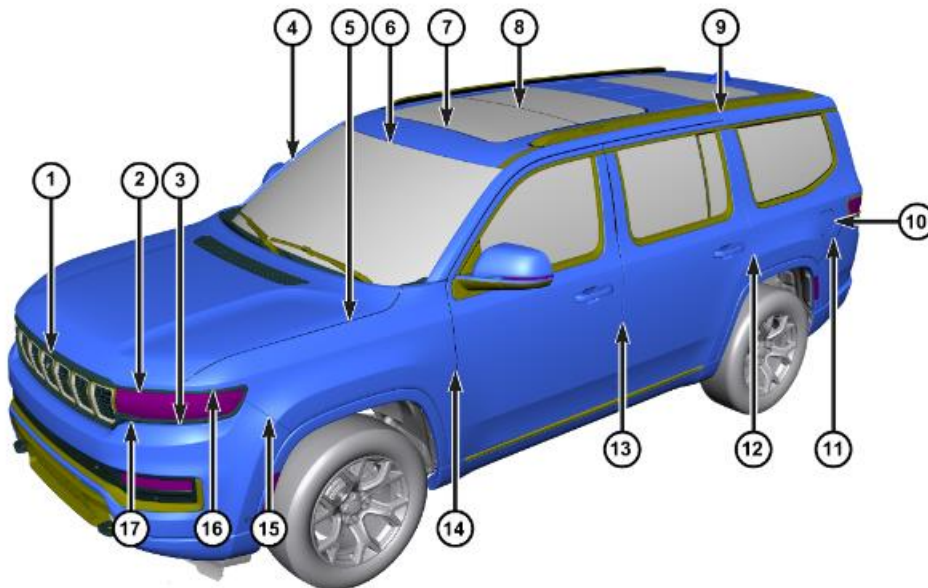
**Customer Complaint/Technician Observation:** Customer or technician may notice the hood on a vehicle appears under flush. Customer may request adjustment.

**Discussion:** For awareness, the specifications for hood to fender flush are as follows:

Nominal: Hood U/F 2.0 +/- 1.5  
Transition to 2.2 at front +/- 1.5  
Transition to 0.0 at rear +/- 1.5  
Consistent within 1.5 (frt to back)  
Side to side within 1.9

If the vehicle meets these specifications do not adjust the hood or body panels. For additional information on gap and flush refer to Service Library 23 - Body / Body Structure / Gap and Flush / Specifications GAP AND FLUSH DIMENSIONS
