Revision (2) August 2022

Dealer Service Instructions for:

## Emissions Recall U90 Catalyst Efficiency

About **232,707** of the above vehicles may exceed tailpipe emission standards due to a loss of catalyst CO/NOx conversion efficiency resulting from the catalyst operating at high temperatures.

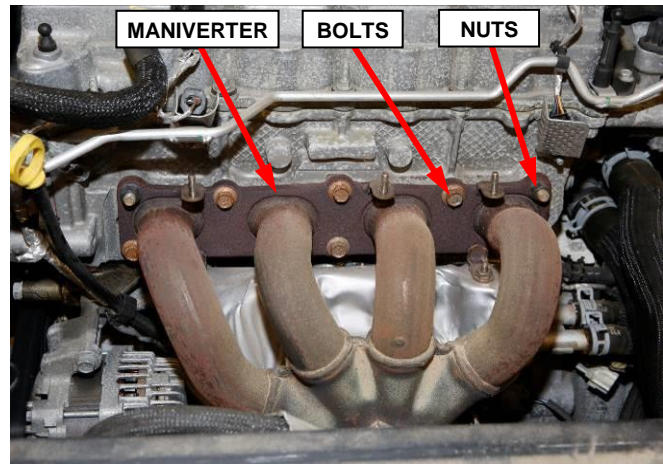
Figure 12 – Maniverter to Engine

**CAUTION:** Use care when removing the bolts that secure the maniverter to the engine cylinder head. Aluminum cylinder head fastener threads are susceptible to damage if the bolts are not removed with care. Use hand tools **ONLY**.

19. Remove the fasteners, six bolts and two nuts, securing the maniverter to the engine cylinder head (Figure 12).

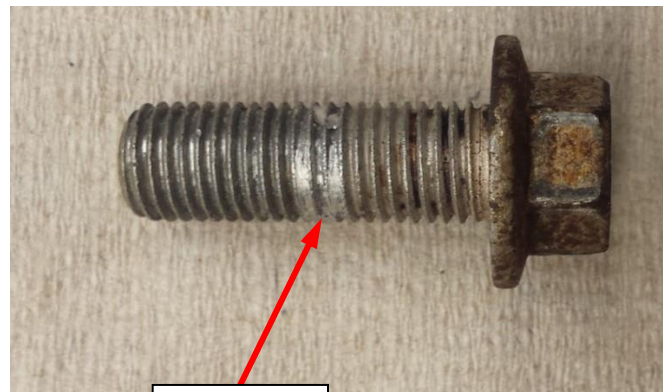
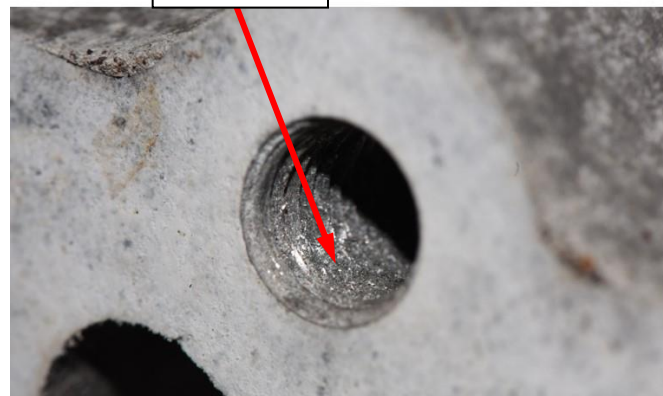
Figure 13 – Inspect for Thread Loss

**NOTE:** Pay attention to the bolts for signs of thread loss or bolt breakage as they are removed and note which hole they came from (Figure 13).

20. Inspect the bolts and bolt holes for any signs of thread loss then **DISCARD** the bolts (Figure 11).

- If bolt holes do not show signs of thread loss, proceed to **Step 23**.
- If bolt holes show signs of thread loss, continue with **Step 21**.
- If a bolt is broken off in the hole, proceed to **Step 22**.

21. If thread loss is suspected, use compressed air to remove any debris from the suspect bolt hole. With the old maniverter and gasket still in place on the engine head, install a **NEW** exhaust manifold bolt in the suspect hole and tighten the bolt to 34 N·m (25 ft. lbs.) to determine if proper torque can be achieved.

- If the bolt is able to be tightened to 34 N·m (25 ft. lbs.), no further action is required. Remove the bolt and proceed to **Step 23**.
  - If the bolt hole threads are stripped allowing the bolt to rotate, unable to achieve proper torque, remove the bolt and continue with **Step 22**.

22. For stripped hole(s) or broken bolt(s), submit a collateral damage claim to obtain authorization for installing a helicoil in the damaged hole(s). Remove the maniverter and gasket following **Steps 23 - 25**. Then use the special tool **2073500090 - Kit, Cylinder Head Thread Repair - 2.4L MAIR** to perform the helicoil thread repair operation by following the service instructions published in **DealerCONNECT / Service Library / Engine, 2.4L Multiair / Standard Procedure / Exhaust Manifold Fastener Hole Repair**. After the damaged bolt hole(s) have been repaired with helicoil(s), proceed with **Step 26**.
