NUMBER: 23-033-22

Windshield Washer Nozzle Spray Not Uniform

2022 (LA) Dodge Challenger

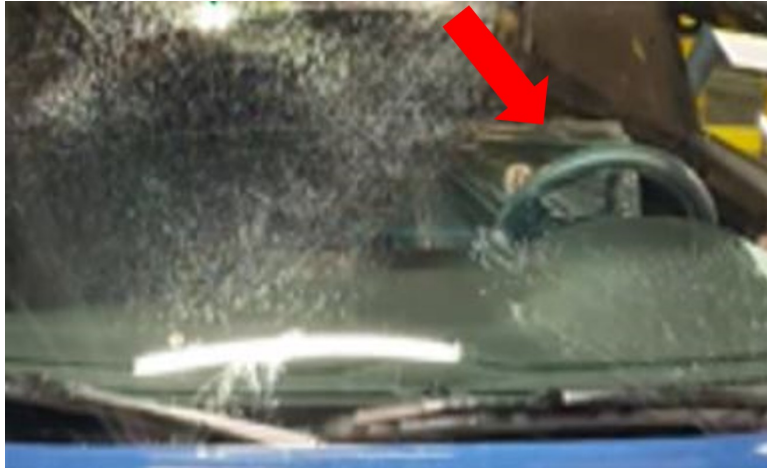
2. Was an uneven spray pattern noticed from one or both washer nozzles (Fig. 1) ?
- YES>>> Proceed to [Step 1](#) of the Repair Procedure.
 - NO>>> This bulletin has been completed, use inspect LOP (23-43-20-97) to close the active RSU.

Fig. 1
Uneven Washer Nozzle Pattern on Driver Side

1. Replace one or both windshield washer nozzles. Refer to the detailed service procedures available in DealerCONNECT/Service Library under: Service Info>08 - Electrical / 8R - Wipers/Washers / Nozzle, Washer / Removal / Installation.
2. Operate the washer system and verify spray pattern coverage.
