**NUMBER:** 18-101-22 REV. A

Flash: Powertrain Control Module (PCM) Updates

This bulletin involves reprogramming the Engine Control Module (ECM) / Powertrain Control Module (PCM) with the latest available software.

2019	(DJ)	RAM 2500 Pickup
2019	(D2)	RAM 3500 Pickup

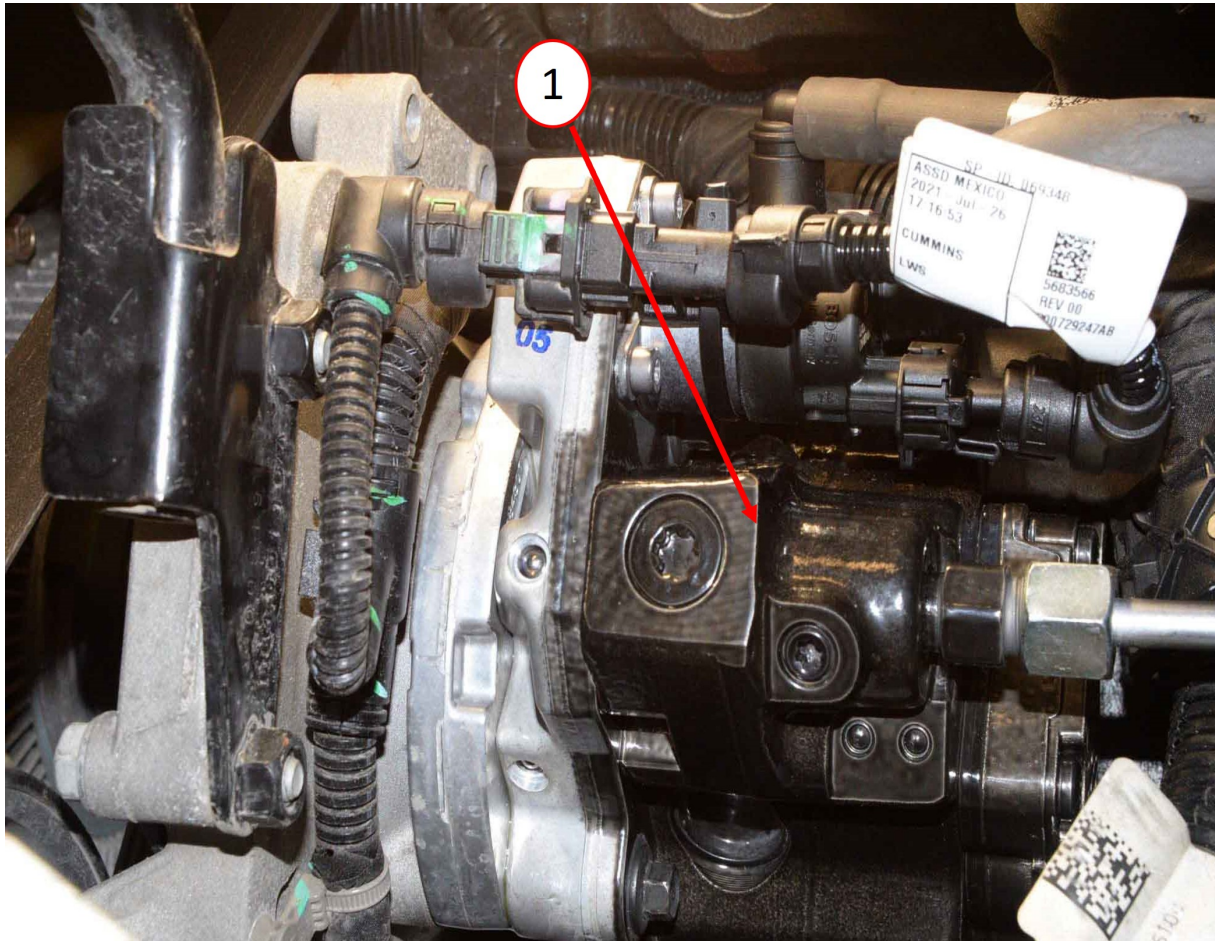
**Fig. 1**  
**CP3.3 Design Pump**

**NOTE:** The only calibration available will be for the updated CP3.3 design High-Pressure Fuel Injection Pump (**Fig. 1**) . Please ensure that recall Y78 has been completed first before proceeding with this update.

1. Inspect the High-Pressure Fuel Injection Pump to see which pump is currently installed on the vehicle (**Fig. 1**) . Also review the vehicle VIP report to see if campaign Y78 has been performed.

1 - CP3.3 Design Pump From Top View.

2. Does the VIP report indicate that Y78 has been performed, and is the vehicle equipped with the new design fuel injection pump released under the campaign?
  - YES>>> Proceed to [Step 1](#).
  - NO>>> Perform the Y78 campaign first. Once the campaign is performed, new pump installed and PCM updated, the PCM will have all of the updates listed in this document. This Bulletin does not apply.
