NUMBER: 18-102-22 REV. A

Flash: Powertrain Control Module (PCM) Updates

This bulletin involves reprogramming the Engine Control Module/Powertrain Control Module (ECM/PCM) with the latest available software.

2020	(DJ)	RAM 2500 Pickup
2020	(D2)	RAM 3500 Pickup

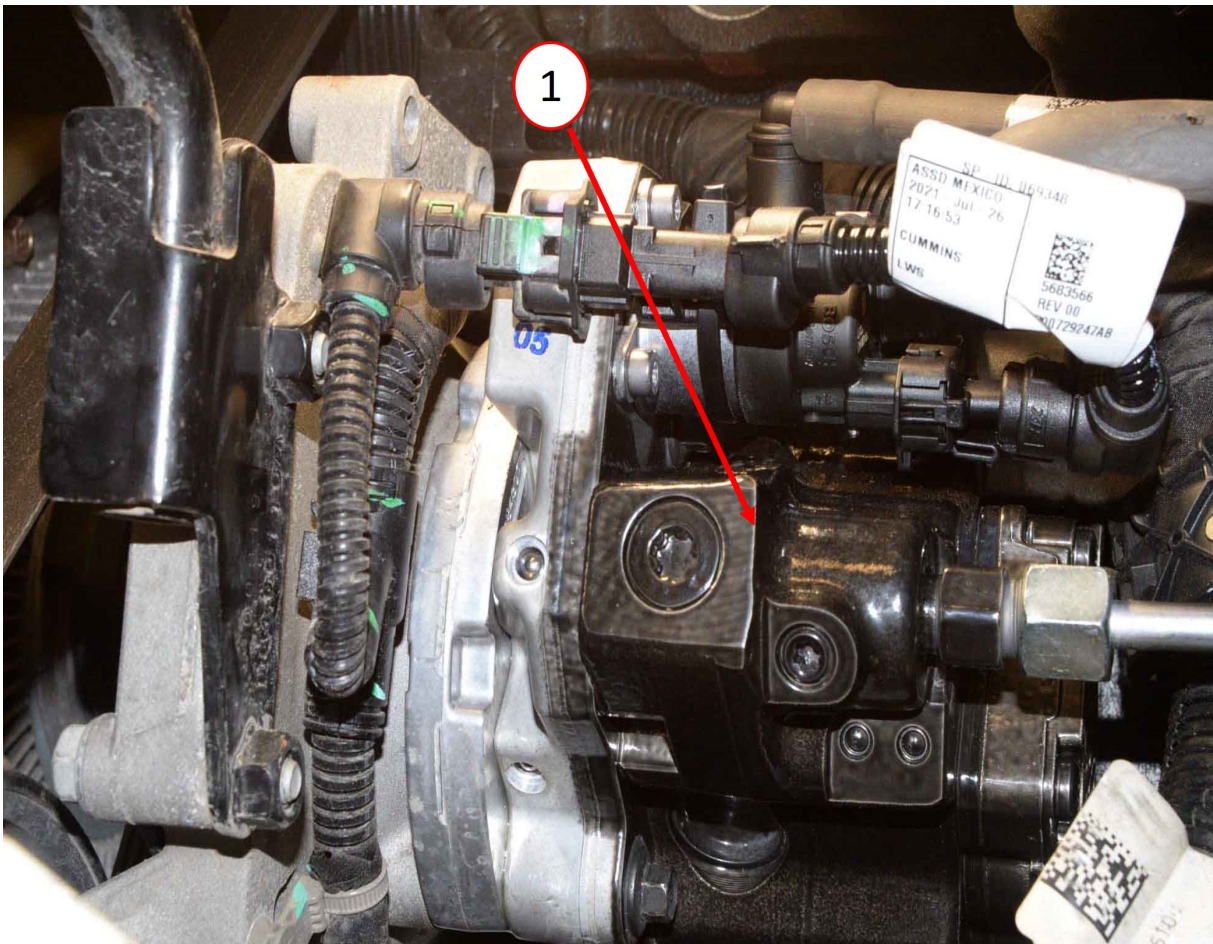
Fig. 1
CP3.3 Design Pump

NOTE: The only calibration available will be for the updated CP3.3 design High-Pressure Fuel Injection Pump (Fig. 1) . Please ensure that recall Y78 has been completed first before proceeding with this update.

1 - CP3.3 Design Pump From Top View.

1. Inspect the High-Pressure Fuel Injection Pump to see which pump is currently installed on the vehicle (Fig. 1) . Also review the vehicle VIP report to see if campaign Y78 has been performed.
