# TECHNICAL SERVICE BULLETIN

## Various Concerns With The Active Exhaust System

**22-2282**  
03 October 2022

<b>Ford</b> 2018-2022 Mustang	non-Shelby GT350
----------------------------------	------------------

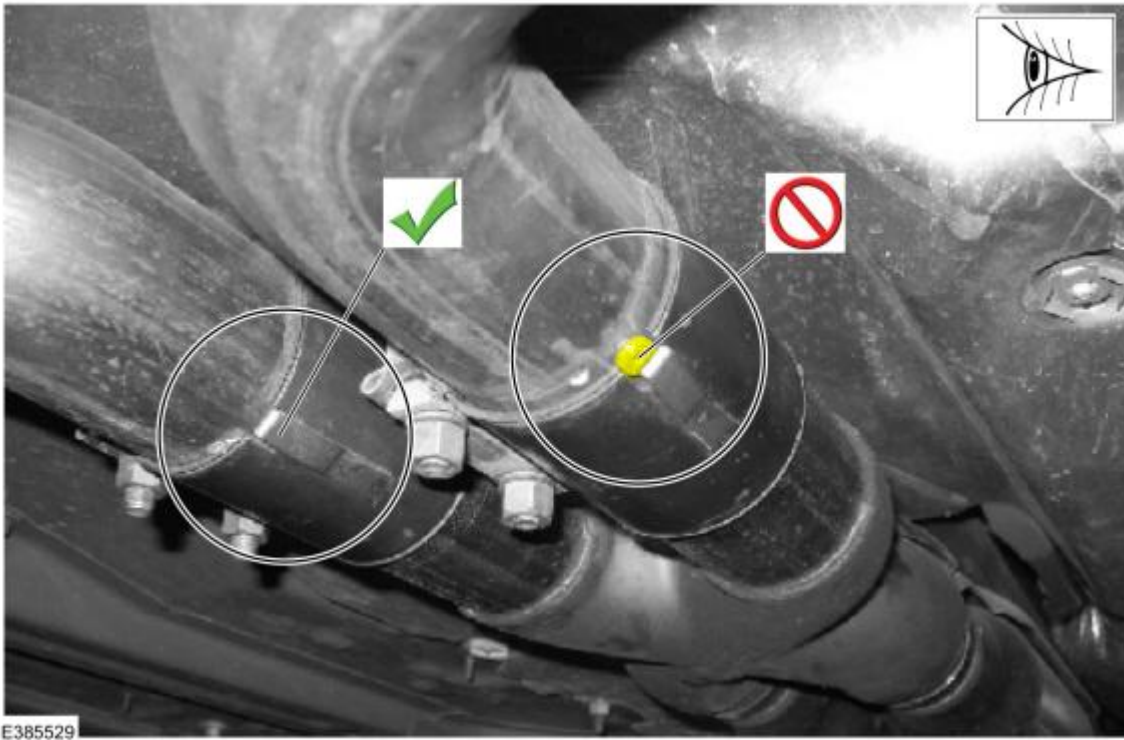
Figure 1 - Exhaust clamp locking tabs

- Is the concern still present?
  - Yes - proceed to Step 5.
  - No - repair is complete.
- Inspect the muffler and tailpipe assembly and both catalytic converters for proper positioning in the exhaust clamps which secure them together. Make sure the exhaust clamp locking tab is fully engaged to the catalytic converters (Refer to Figure 1). Make sure the knurled/ridge area of the muffler and tailpipe assembly are covered by the exhaust clamps (Refer to Figures 2-3). Adjustments can be made by loosening the exhaust clamps and repositioning the muffler and tailpipe assembly. (Figures 1-3)

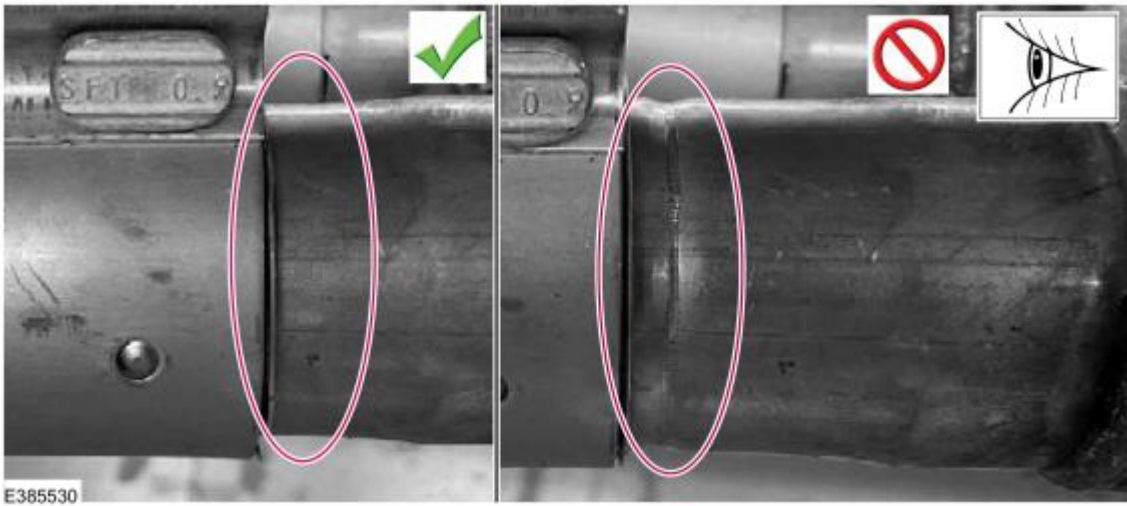
Figure 2 - Non-GT500 exhaust with ridge

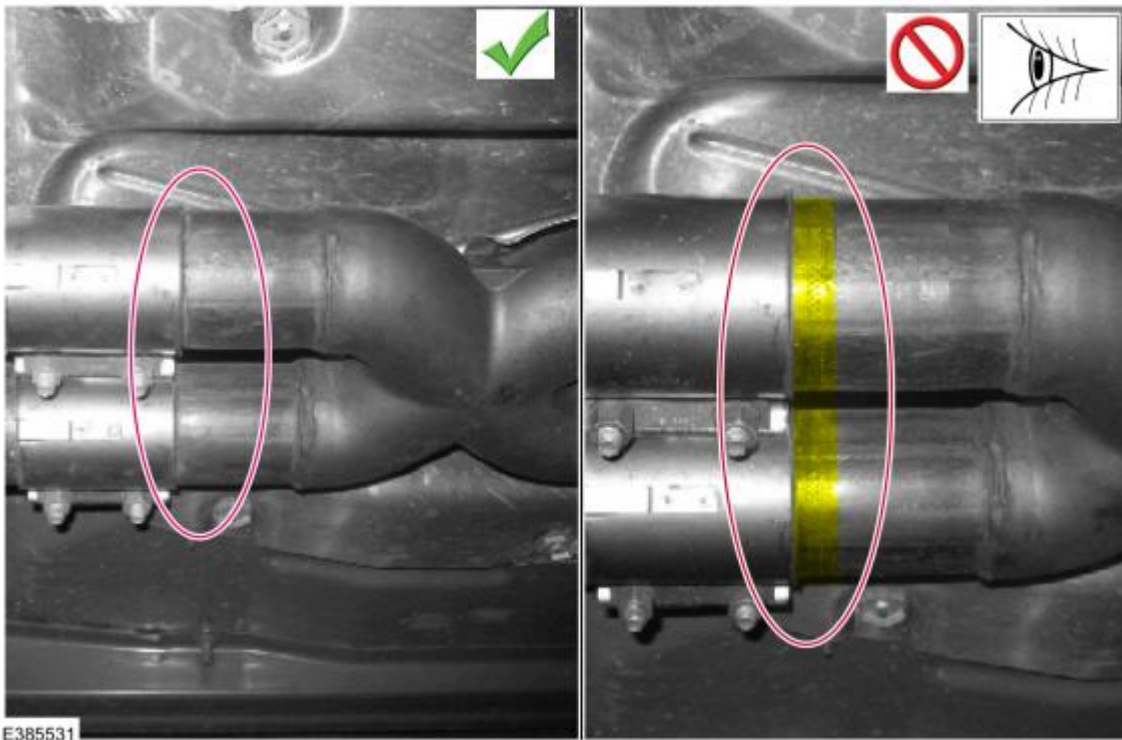
Figure 3 - GT500 exhaust with knurled area
