# TECHNICAL SERVICE BULLETIN

## 2.0L EcoBoost - Rattle Noise At The Transmission Bellhousing Area

**22-2381**

<b>Ford</b> 2015-2018 Fusion	Engine: 2.0L EcoBoost
<b>Lincoln</b> 2015-2018 MKZ	Engine: 2.0L EcoBoost

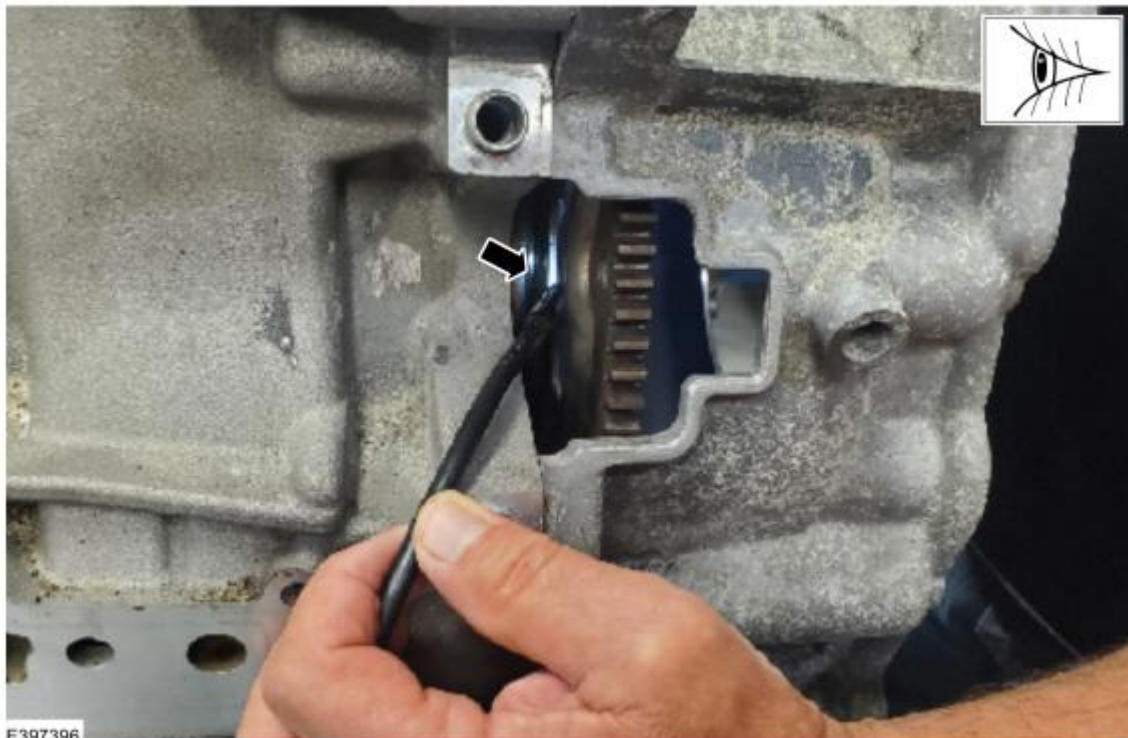
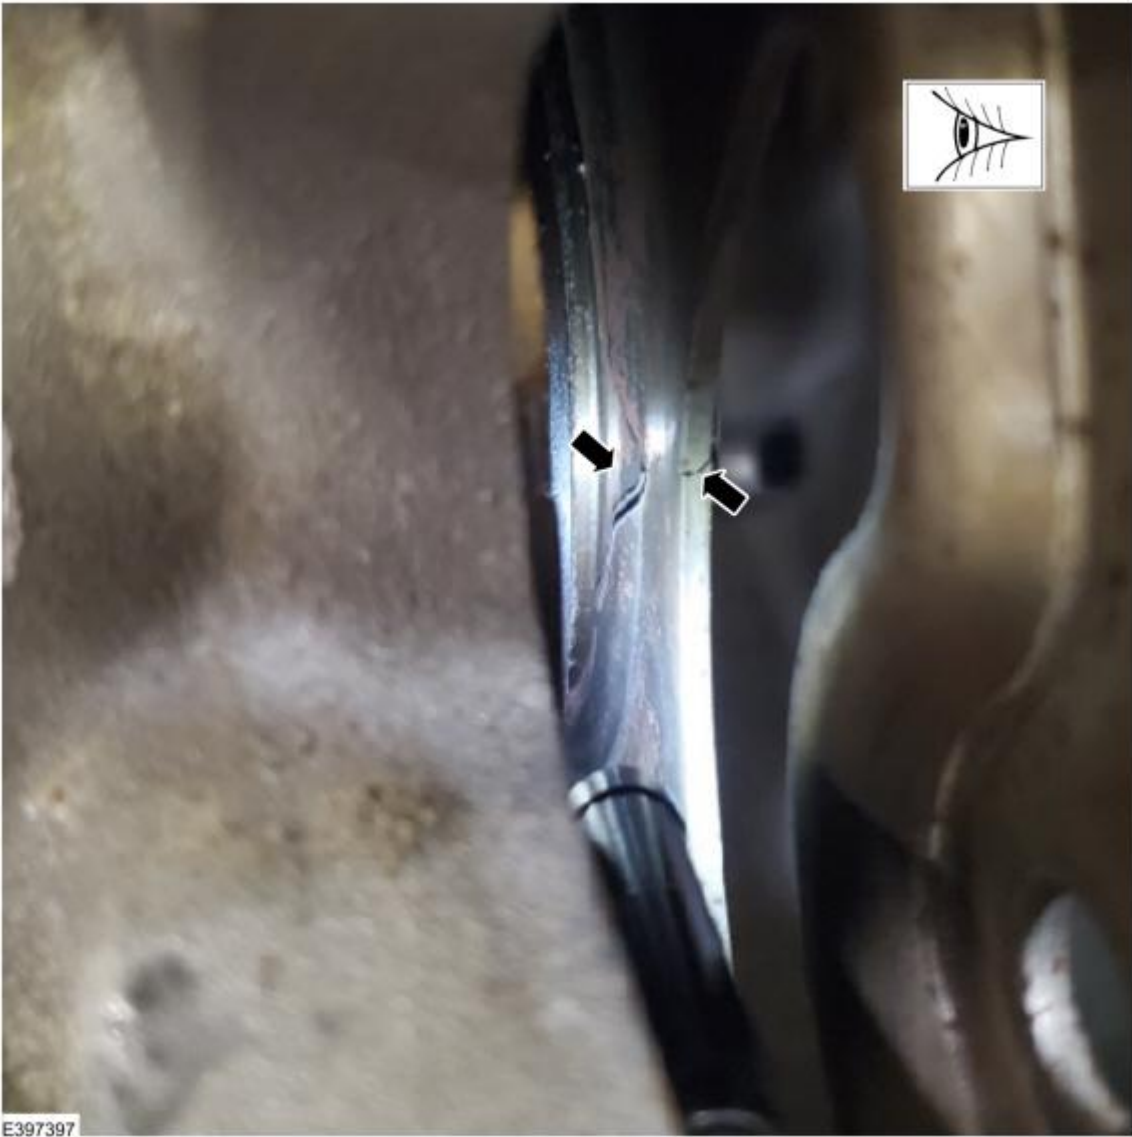
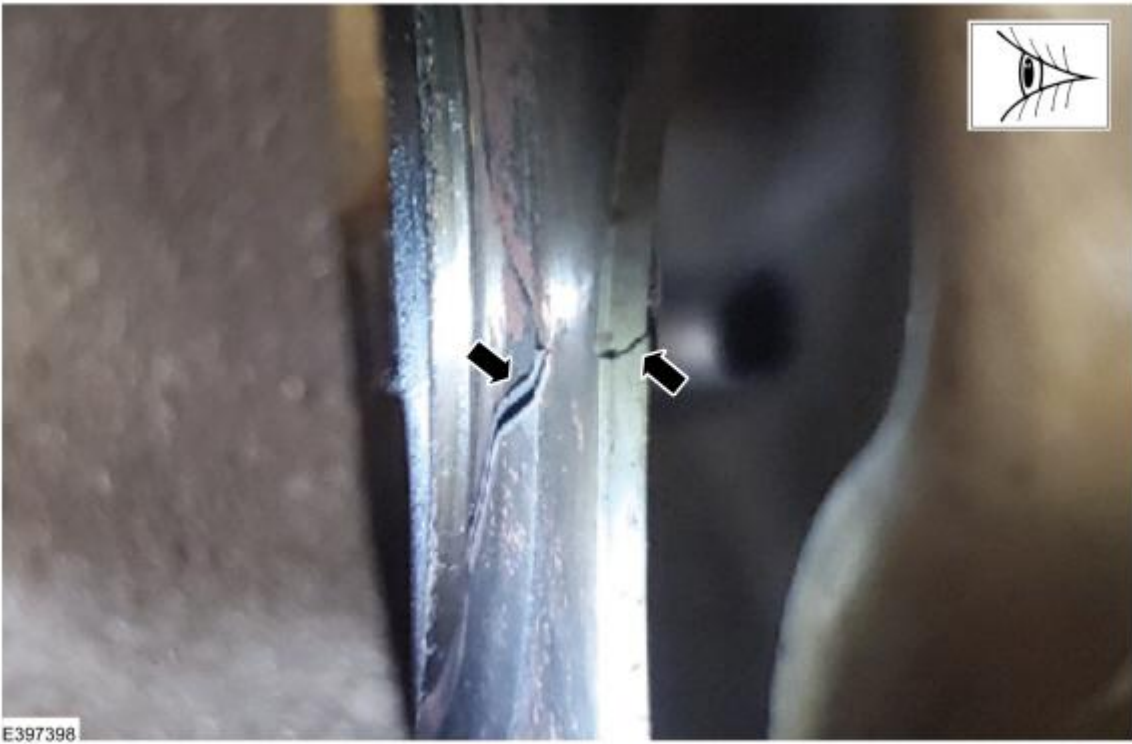
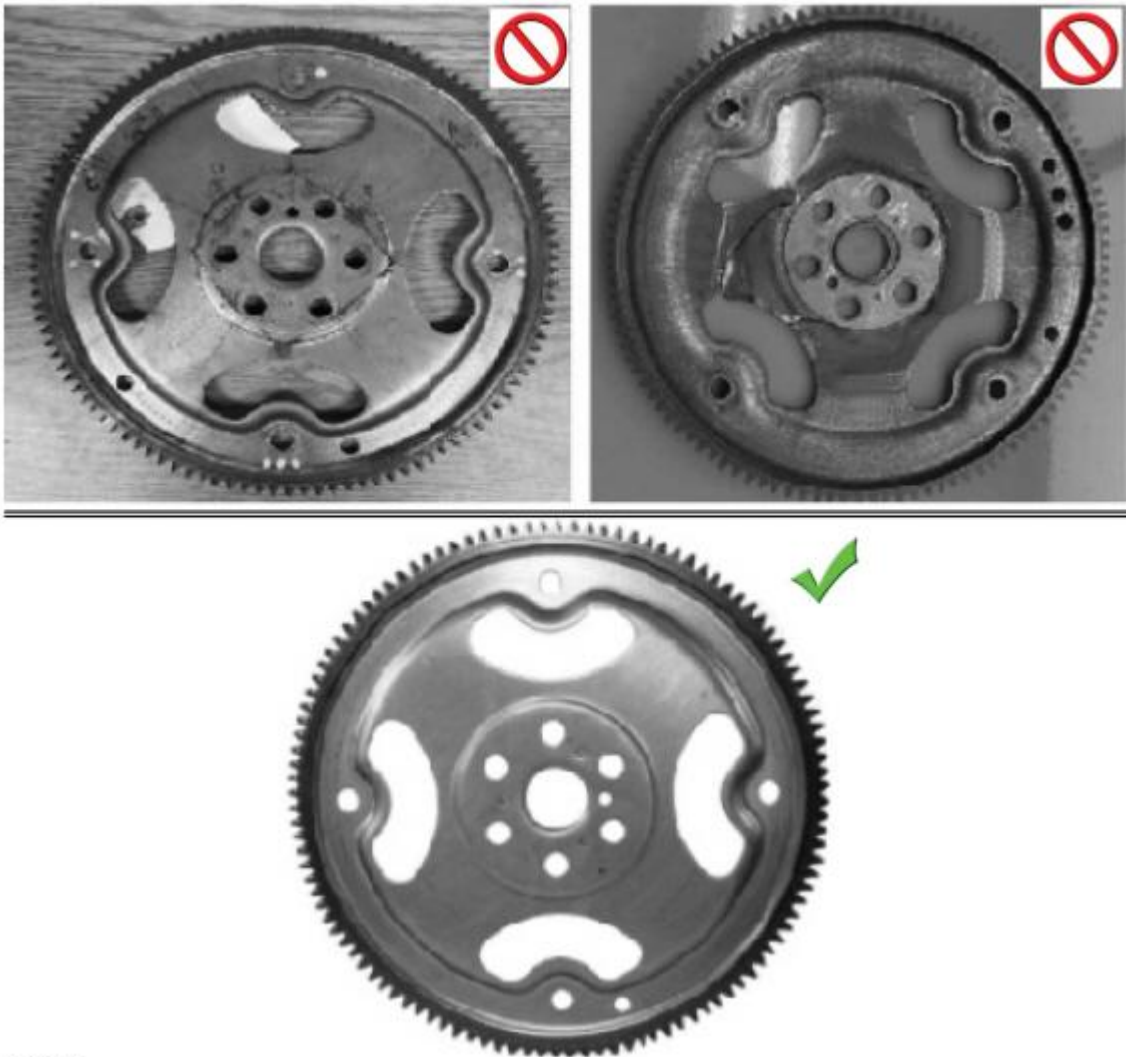
**Issue:** Some 2015-2018 Fusion/MKZ vehicles equipped with a 2.0L EcoBoost engine may exhibit a rattle noise from the transmission bellhousing area. This may be more noticeable at idle. This may be due to a flexplate crack around the mounting area. To correct the condition, follow the Service Procedure to replace the flexplate, transmission fluid pump, and torque converter.

- Placing a borescope between the engine block and flexplate, inspect the flexplate for cracks near the crankshaft. Are there any cracks present in the flexplate? (Figures 1-4)

- (1). Yes - proceed to Step 5.
- (2). No - reinstall the starter motor. Refer to WSM, Section 303-06. For further diagnostics outside this article, refer to WSM, Section 100-04. Repair is complete.

6. Remove and replace the flexplate. Refer to WSM, Section 303-01B.
7. Remove and discard the torque converter.
8. Remove the torque converter housing from the transmission case. Refer to WSM, Section 307-01A. Steps 6 through 40 are not required.

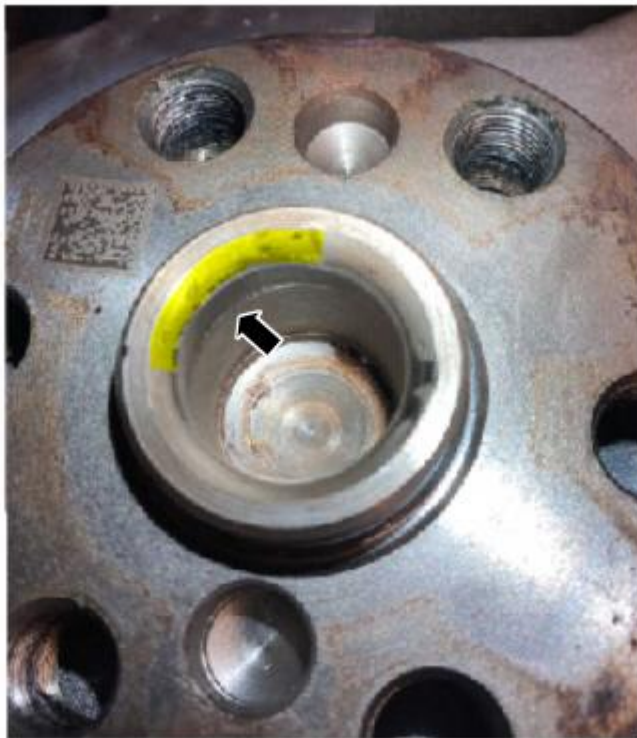
Figure 5

15. Inspect for damage on the crankshaft pilot bore. Is there damage? (Figure 5)

(1). Yes - rotate the stud hole nearest to the 12 O'clock upright position so that the damaged part of the crankshaft pilot bore is at the 12 O'clock position. This is important to endure minimal imbalance. Proceed to Step 16. (Figure 6)
