HYUNDAI Technical Service Bulletin

GROUP	NUMBER
BODY ELECTRICAL	22-BE-007H
DATE	MODEL(S)
OCTOBER, 2022	Accent (HC)

SUBJECT: HORN RELAY AND CLOCK SPRING REPLACEMENT

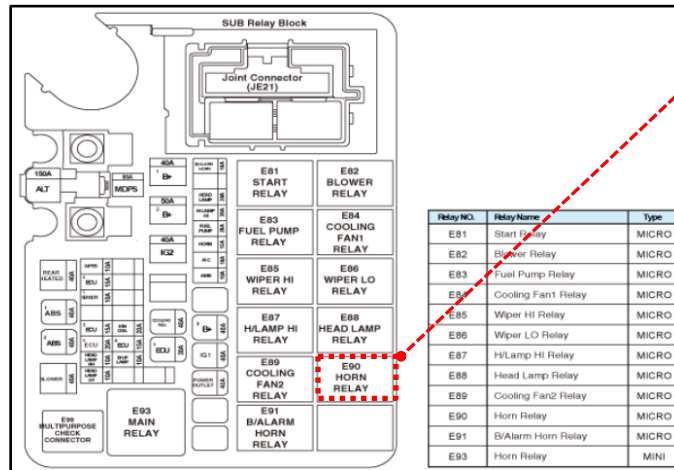
Relay Assy Micro/
Location diagram.

Description: Certain 2022MY Accent (HC) vehicles may experience an inoperative horn due to an open circuit inside the clock spring caused by a malfunctioning horn relay. This bulletin provides procedure to replace the horn relay and clock spring.
