# HYUNDAI

## Technical Service Bulletin

GROUP	NUMBER
CAMPAIGN	22-01-073H
DATE	MODEL(S)
OCTOBER 2022	SANTA FE SPORT (AN)

**SUBJECT:** JUNCTION BOX UPPER COVER LABEL REPLACEMENT (SERVICE CAMPAIGN 985)

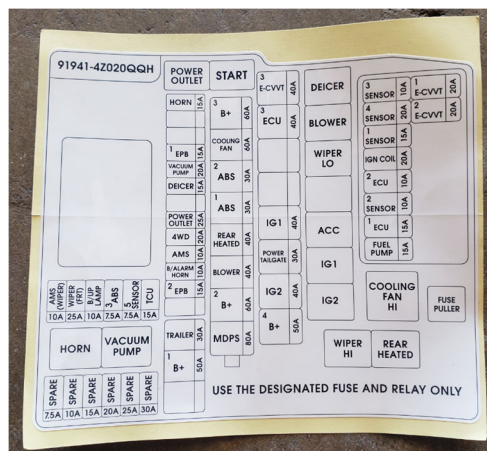
**Description:** Certain 2017-2018MY Santa Fe Sport (AN) vehicles received an incorrectly labeled fuse cover during Recall 218. This bulletin describes the procedure to replace the label with a corrected one.

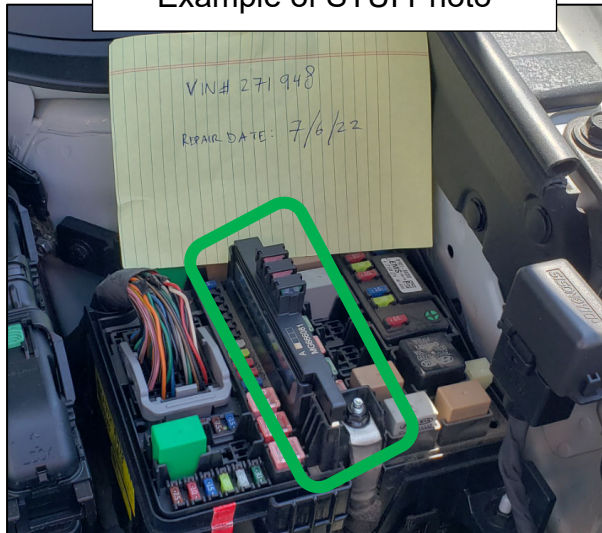
**Correct multi-fuse.** Fuse is taller, with protruding individual, replaceable fuses.

Using STUI, take a photo of the installed multi-fuse with the last 6 digits of the VIN and the date of repair on a piece of paper.

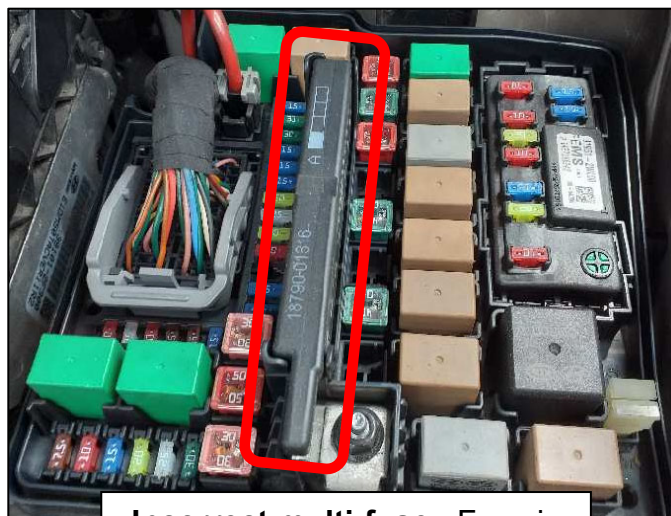
**Incorrect multi-fuse.** Fuse is shorter and flat across the top.
