SS 3112 FTL 2022 P4 Detroit Side Object Detection Harness Rub-Chafe on Bracket

This solution applies to P4 Models specifying Detroit Side Guard Assist.

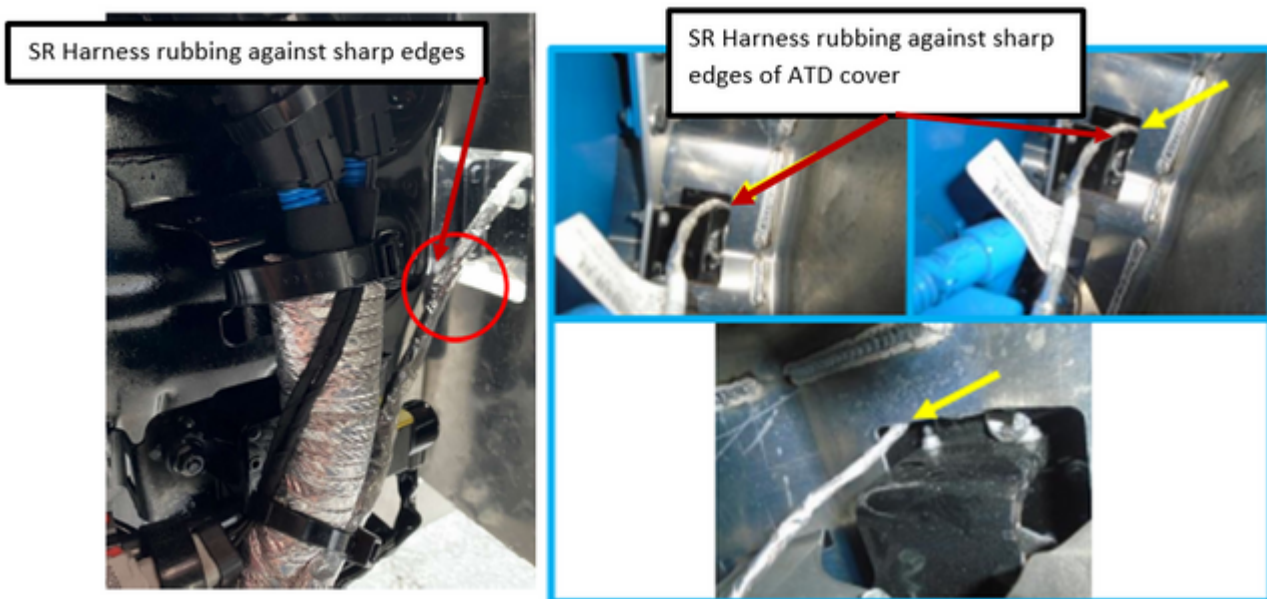
SOD harness may be rubbing the sharp edge of the ATD cover cutout and against the radar support-mounting bracket, causing harness to short out, which trigger several fault codes.

Figure 1: Side Object Detect (SOD) Harness rubbing points at SRR mounting bracket and ATD cover.

- Access SOD Harness and inspect to identify rubbing and chaffing spots. Remove existing clipping points and inspect and repair harness as needed. Refer to Figure 2 for SOD Harness installation.

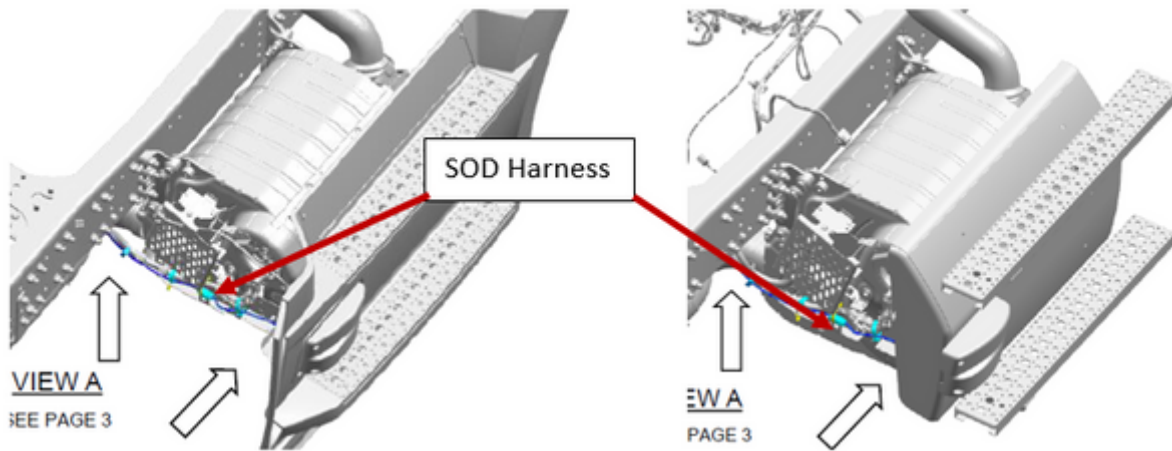
Figure 2: SOD harness installation (Reference: D66-13128-003/4/5)

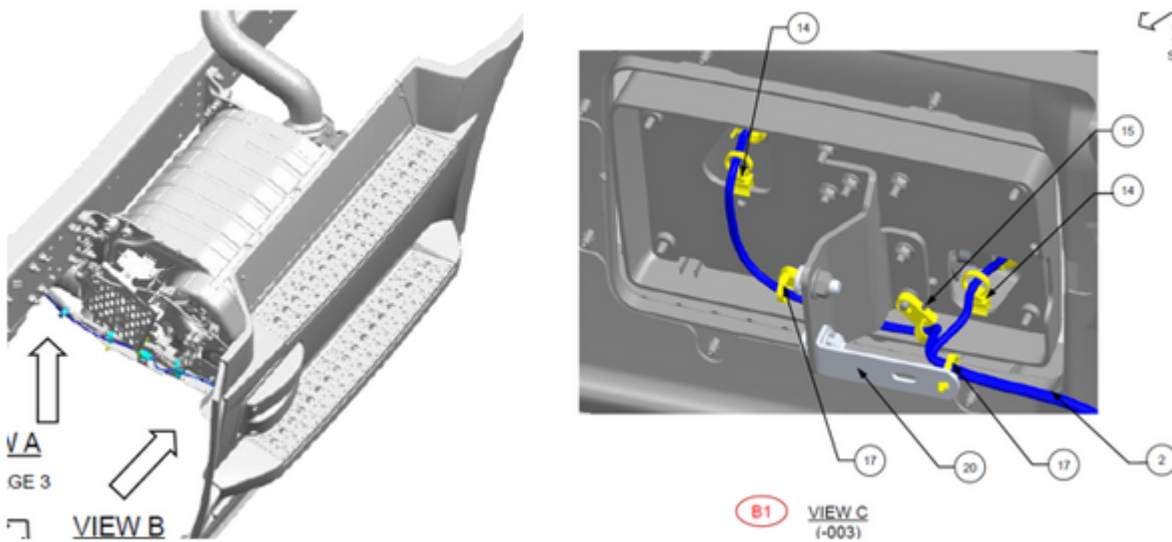
Figure 3: SOD Harness installation (-003) with additional clipping points (CAS 116 DC/SLP)

- Install and route Harness as per installation Diagram shown in Figure 3 for the specific models listed and refer to Table 2 for additional parts required:

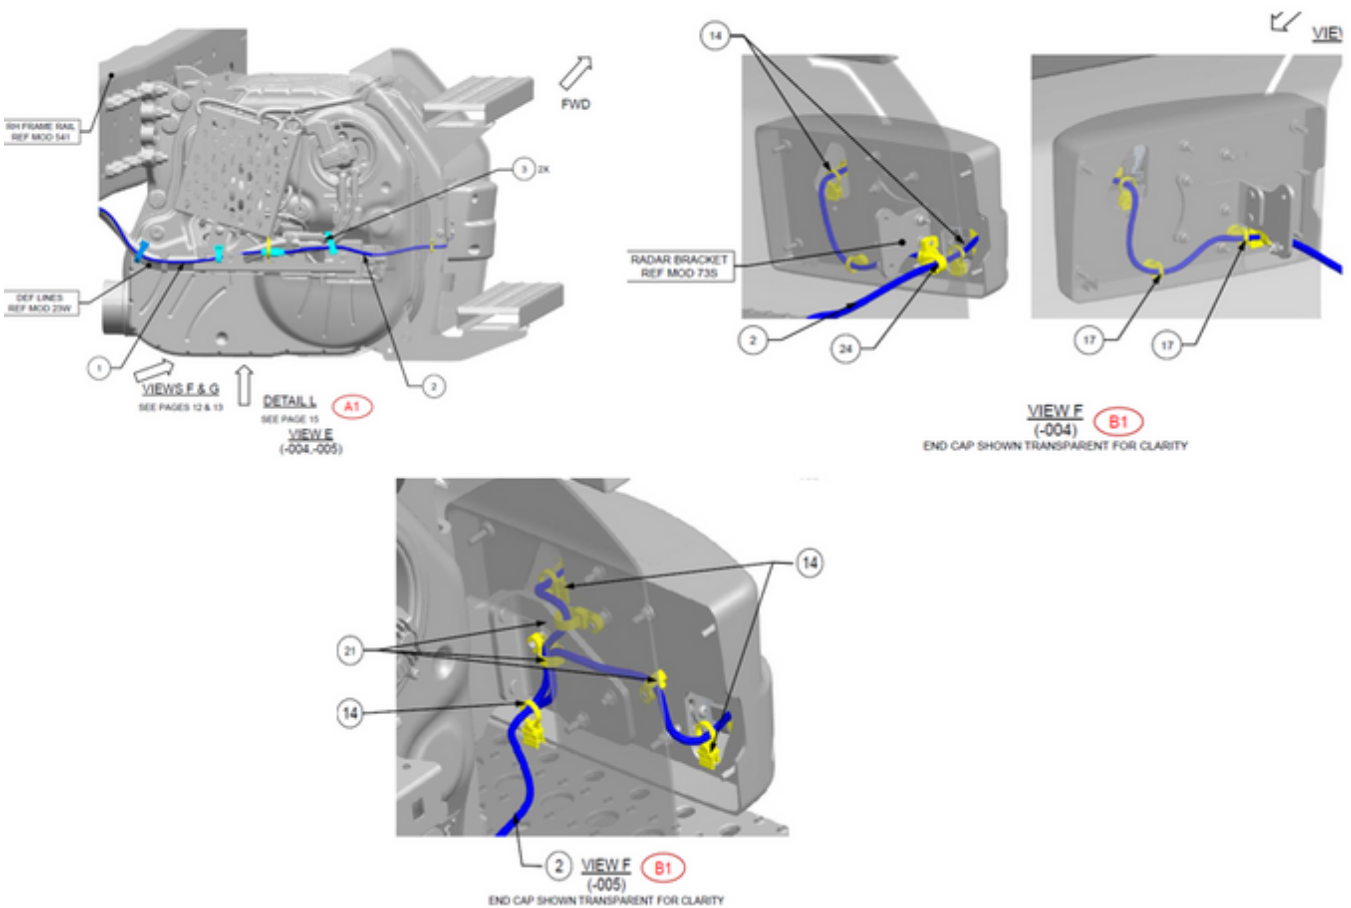
Figure 4: SOD Harness installation with additional clipping points (CAS 116 – 126 DC/SLP)

- Install and route Harness as per installation Diagram shown in Figure 4 for the specific models shown and refer to Table 3 for additional parts required:
