SS 3113 - FTL2022 - P4 DPF Harness Rub-Chafe on Trans-Wire Braided Air Hose

This solution applies to P4 Models specifying DT12 Transmissions built before 3/15/2021.

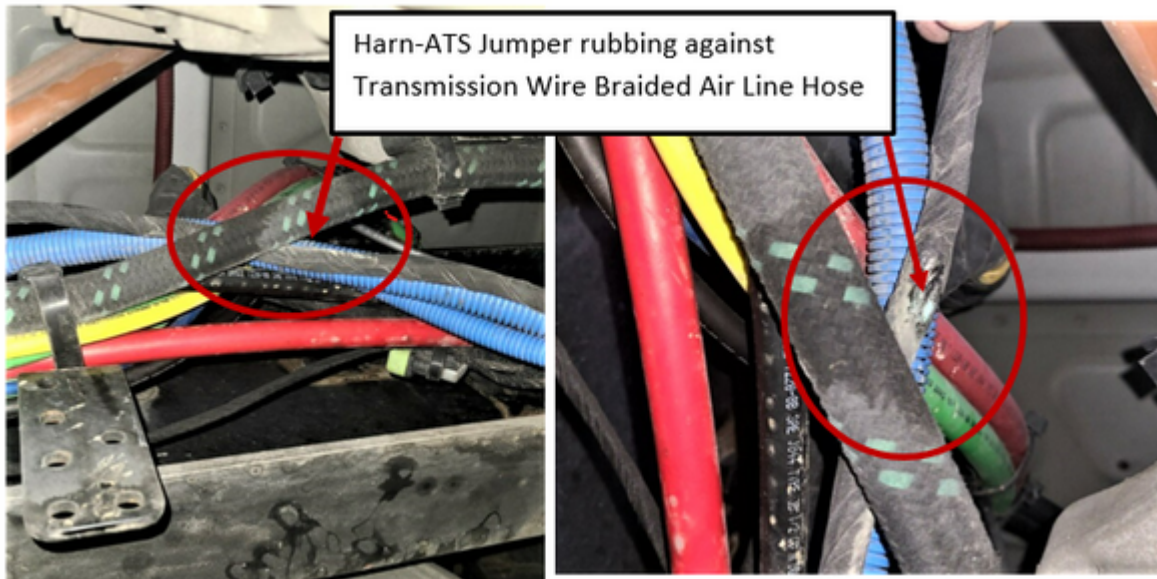
HARN-ATS, JMPR, DEF may be rubbing against the Transmission Wire Braided Air Hose causing harness to short out, which trigger several fault codes. Figures 1 and 2 show the rubbing area and location in the truck.

Figure 1: Harness -ATS Jumper rubbing points against Transmission Wire Braided Air Hose.

- Locate area of potential Harness rubbing and identify rubbing / chaffing spots. Remove existing clipping points and repair Harness as needed.
- Install Dual Tie Cable to separate Harness and Wire Braided Air Line as shown in Figure 3. Required part, TYC DCT110HIR (TIE-CABLE, DUAL, .375 TO 2.25) one piece and clip-route Harness as per installation diagram D66-12713-001.

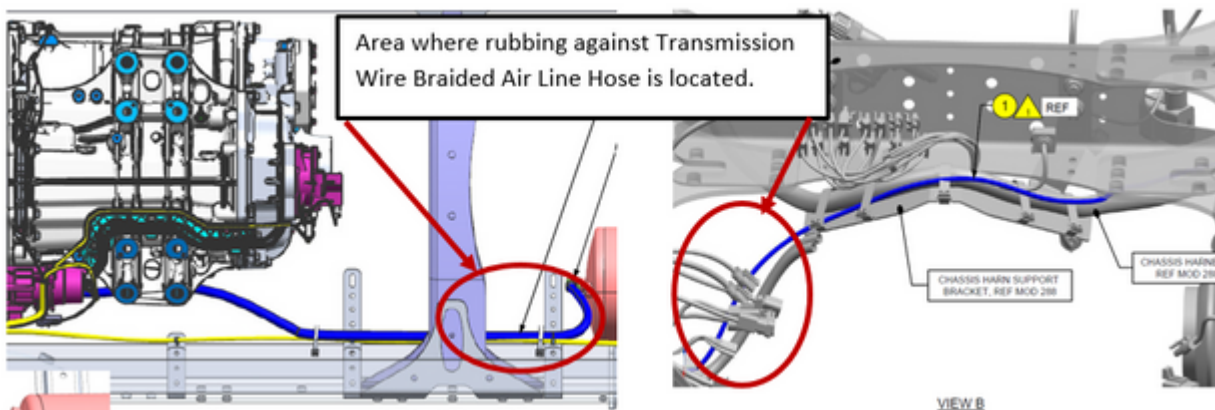
Figure 2: Location of Harness-ATS Jumper rubbing with Transmission Wire Braided Air Hose.

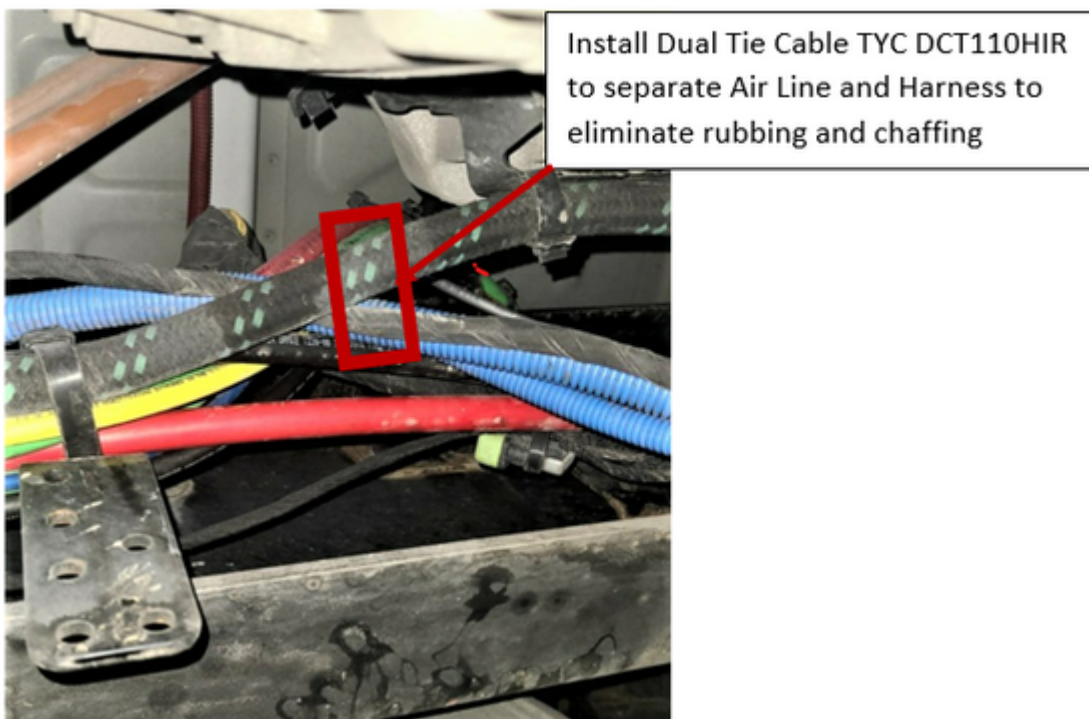
Figure 3: Installation of Dual Tie Cable to separate Harness and Air Line Hose.
