## SS 732-WST 2022 Low Power Complaint

### **Applicable Vehicles**

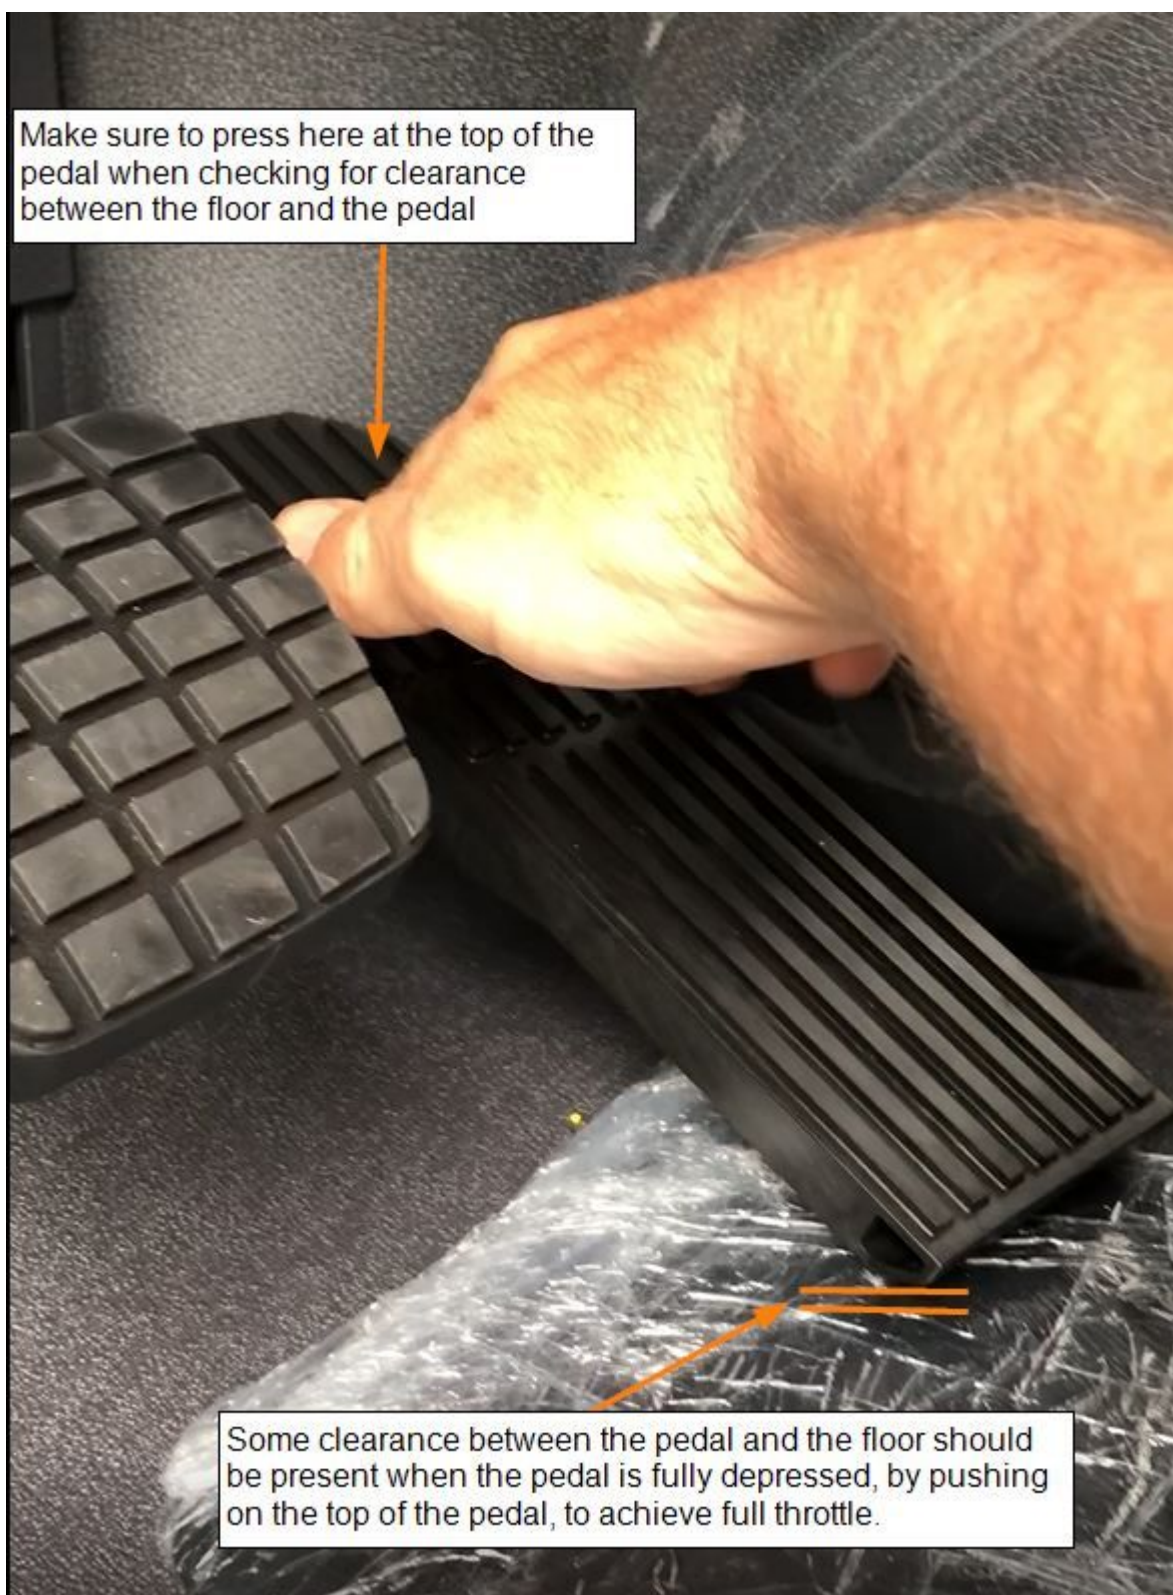
**Figure 1** Checking for clearance between the throttle pedal and the floor in the full throttle position.

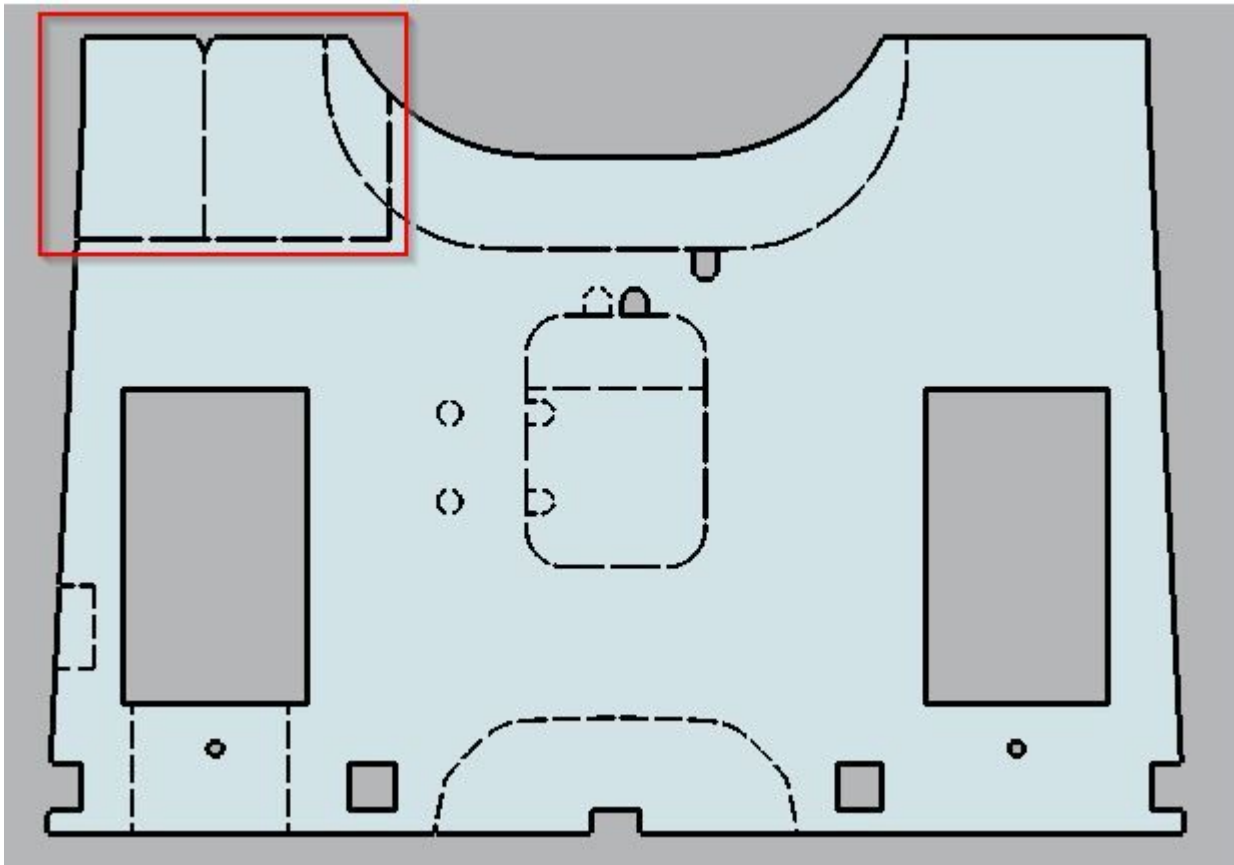
**Figure 2** For left hand drive vehicles, the added insulation marked in red box should be removed to provide additional floor clearance for the throttle pedal when needed.

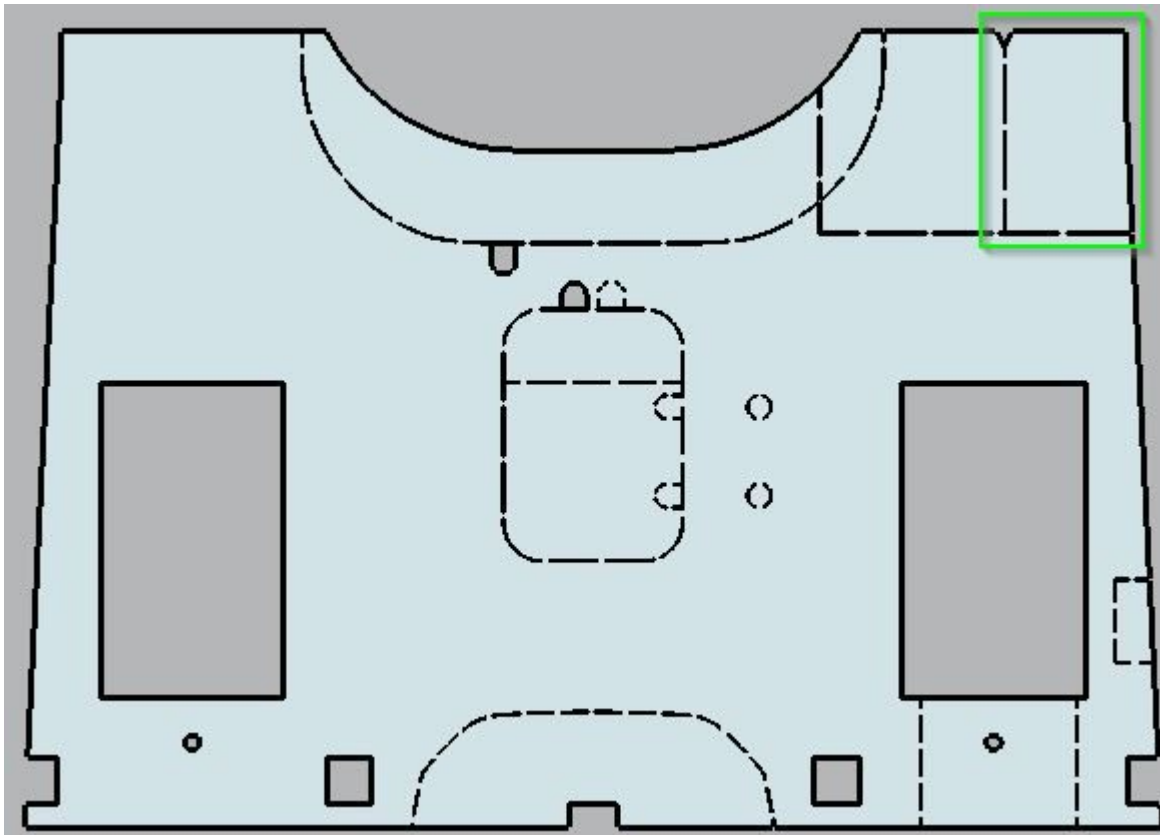
**Figure 3** For right hand drive vehicles, the added insulation marked in green box should be removed to provide addition floor clearance for the throttle pedal when needed.

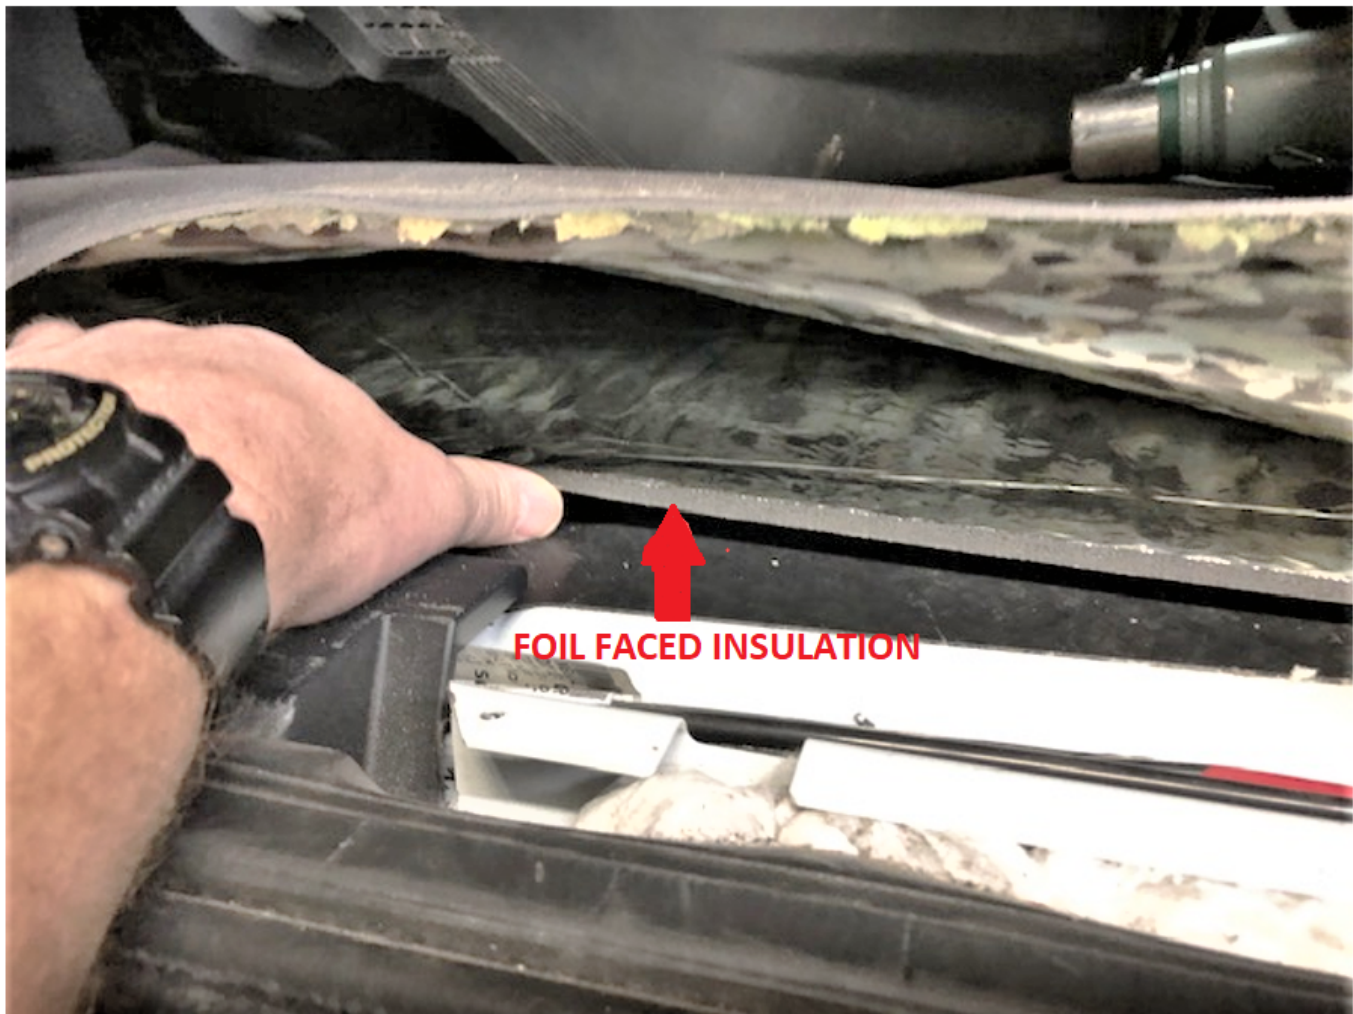
**Figure 4** Added insulation (foil faced) to be removed as documented in figure 2 or figure 3 depending on the drive position.
