01-22-05 - Update Programming Engine/Motor Control Module - J623- for Various Concerns

Release date: 10/26/2022

Technical Background

Customer states MIL-ON with various fault codes found in the ECM.

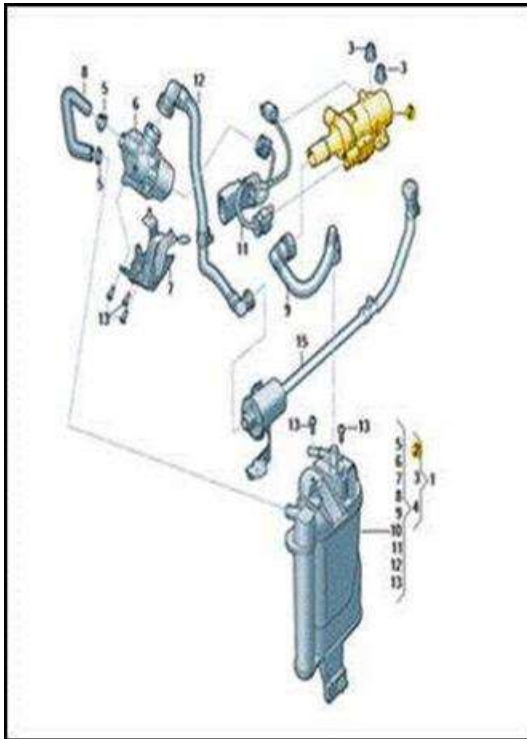
Figure 1.

In addition to the software improvement, there is also an improvement to the FTIV (fuel tank isolation valve/tank switch-off valve -**N288**-) (Figure 1.), which is necessary in preventing erroneous occurrences of the P2421 fault code.

The FTIV / Tank switch-off valve -**N288**- currently installed on the vehicle must be inspected, to verify whether an improved part has already been installed. The FTIV / Tank switch-off valve -N288- is mounted to the EVAP canister assembly, as shown below.

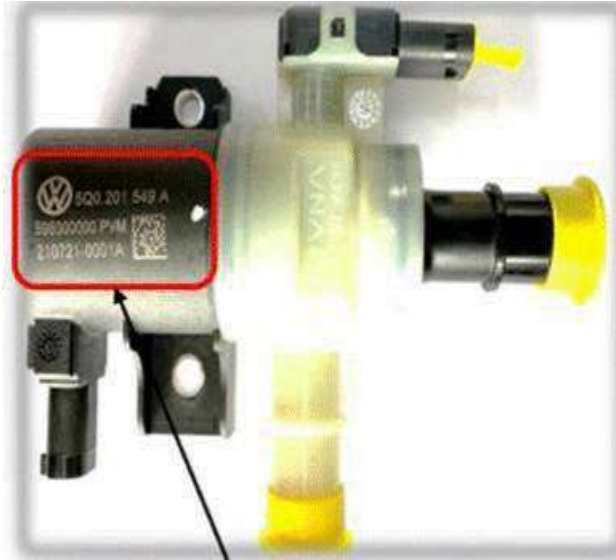
Figure 2.

Remove the EVAP canister assembly and inspect the face of the FTIV / Tank switch-off valve -**N288**-. If the part is already updated, it will have a white paint marking or "02S" printed after the part number, as shown in Figure 2 and Figure 3.

- If the part has a white paint mark or "02S", the FTIV / Tank switch-off valve -N288- is already the updated component. In this case DO NOT replace it, and instead reinstall the EVAP canister assembly. Only the software update will be required.
- If there is no white paint mark or "02S" visible on the FTIV / Tank switch-off valve -**N288**-, the component must be replaced in addition to the software update. Always refer to ETKA for the most up to date part number information.
