91 MIB ASI: Apple CarPlay screen is blank

91 22 40 2065728/3 October 20, 2022. Supersedes Technical Service Bulletin Group 91 number 22-92 dated March 29, 2022, for reasons listed below.

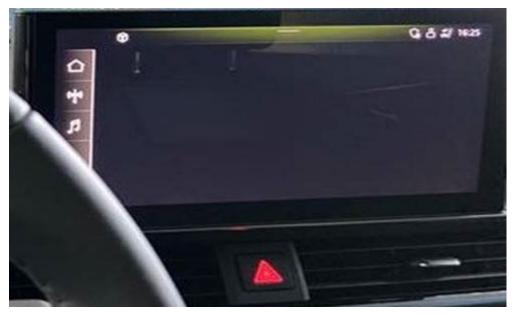
- An iPhone is connected via wireless Apple Carplay (wACP) to the vehicle's MMI system.
- The Audi Smartphone Integration (ASI) feature is selected in the vehicle.
- Audio dropouts can be heard.
- The ASI display goes blank. The shortcut bar on the left side of the screen, as well as the top dropdown menu anchor, can still be seen on the screen (see Figure 1).

Figure 1: ASI display blank when using wACP.

A non-standard behavior of the current Apple iOS versions (including all 14.x and 15.x versions) causes the phone to fail to send screen data to the vehicle. Additionally, a hardware issue in iPhone 8, iPhone X, and iPhone XR models can cause the display to blank out.

- 1. Do not perform any repairs. Any repairs for this concern may be denied.
- 2. For customers with iPhone 8, iPhone X, and iPhone XR:

The problem is due to a hardware issue in the WiFi chipset of the listed phone models. As those phone models are already out of production, no repair will be available. It is advisable to use a wired connection to use Apple CarPlay for those models.

Please inform the customer that this behavior is due to a bug in the phone's operating system (iOS). Apple is currently analyzing the root cause of this behavior and is working on a solution that will be distributed with a future iOS update.

In some cases, going to the home menu by clicking the home shortcut on the left of the screen and then reentering ASI resolves the concern. In other cases, the phone might need to be disconnected and then reconnected.
