# TECHNICAL SERVICE BULLETIN

Technical Service Bulletin: 20-1565

# TECHNICAL SERVICE BULLETIN 20-1565 REMEDY INSTRUCTIONS

Make(s): CEDAR CREEK Model(s): MANY, SEE BELOW Model Year(s): 2022 - 2023	Repair Code: SB-041-03-00-004254 Allotted Time: .50 HRS. Inspection Code: SB-041-05-00-004253 Allotted Time: .10 HRS.
	Concern: Moisture may wick into the ends of the slideroom floors, causing layer delamination of the floor.	Photo(s) Required: YES Prior Authorization Required: YES Part(s) Number: 20-1565 Part(s) Return: N/A

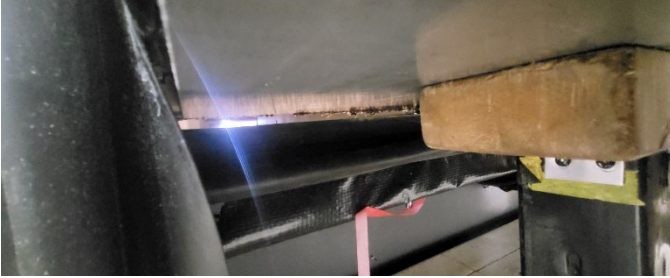
FIG. 1

- THE WEAR BAR SHOULD BE VISIBLE ON FLUSH FLOOR ROOMS;
- IN THE BED SLIDE, THE FLOOR HAS BEEN RAISED ENOUGH TO WHERE THERE IS APPROXIMATELY A 3/4" GAP BETWEEN THE FLOOR AND THE BOTTOM SWEEP (FIG. 1)

STEP 1: USE A FLOOR JACK, JACK SLIDE OUT UP ENOUGH TO WHERE THERE IS GAP BETWEEN THE BOTTOM SWEEP AND FLOOR.
