GROUP	MODEL
Service Campaign	2015MY Cadenza (VG)
NUMBER	DATE
SC240	October 2022

VOLUNTARY SERVICE CAMPAIGN

FRONT COIL SPRING REPLACEMENT (SC240)

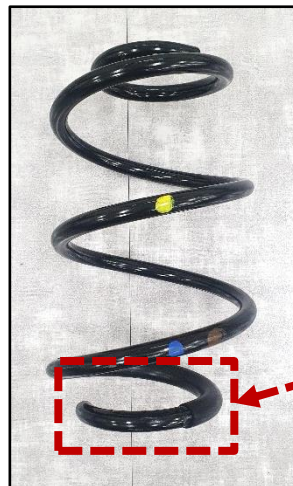
Front Coil Spring

A sleeve has been added to the bottom of the coil spring to prevent corrosion.

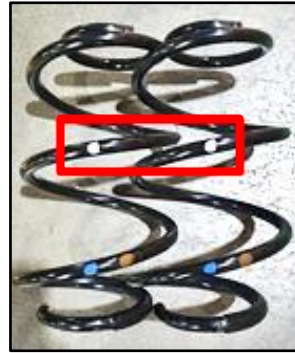
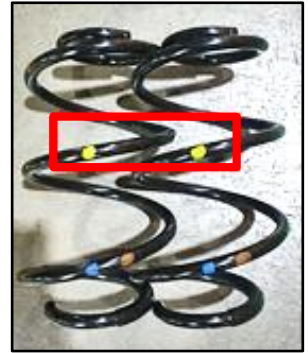
**ⓘ IMPORTANT**

Confirm that the (yellow or white) marking of two (2) 'new' front coil springs match each other in the location shown. If they don't, there is a possibility of a slight height difference. If so, return them to MPA and order a new kit.
