Special Bulletin

SP22-303

ALTERNATOR LOOSE CONNECTORS

Prevost vehicles

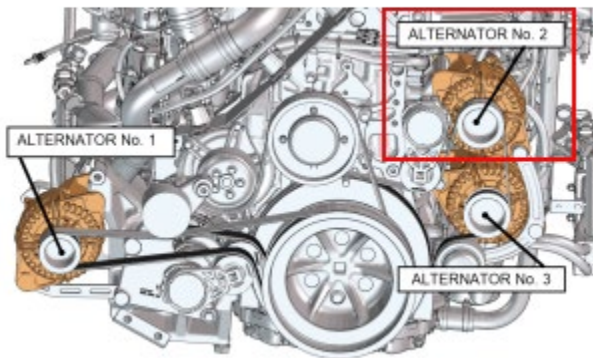
Figure 1: First alternator to be checked

1. Locate the positive alternator cable at the back of the upper RH alternator (alternator #2 Figure 1 & 2).

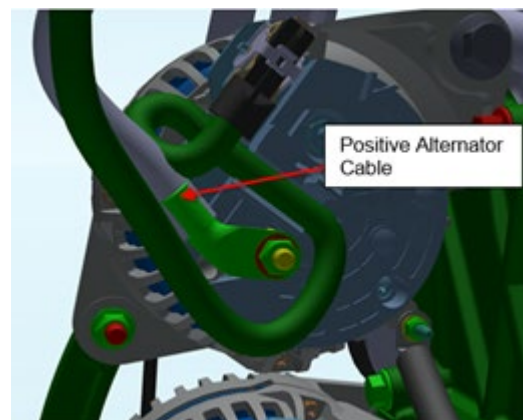
On the vehicles affected by this bulletin, the positive terminal (main power cable) may not be fully tightened at the back some the alternators.

Figure 2: Problematic cable & terminal upper RH

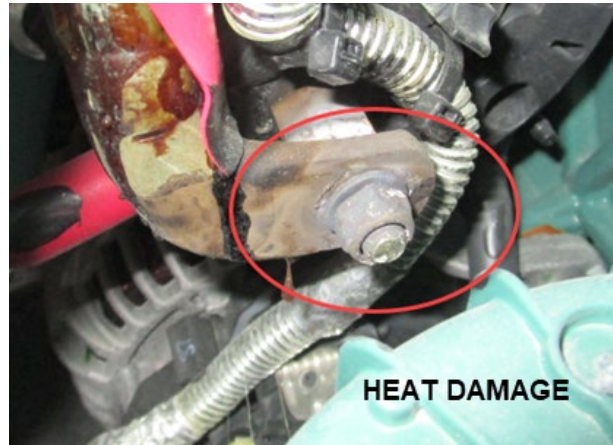
3. Inspect the terminal and the alternator stud.
Look for any color change or heat damage (see example Figure 4).

Figure 4: Example of discoloration caused by heat damage

IMPORTANT: If heat damage is present, STOP AT THIS STEP and contact the Prevost field service manager and NYCT representative to further inspect the damage, parts may need to be replaced.

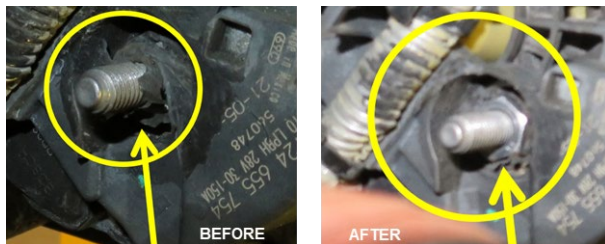
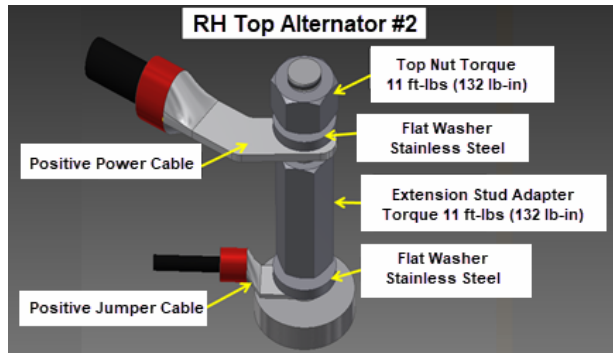
Figure 5: Torque adaptor stud + Top nut to 132 lb-in

- Jumper cable terminal to alternator stud
- Flat Washer
- Stud extension **torque the stud extension to 132 lb-in** (Figure 5)
- Power cable terminal to stud extension.
- Flat Washer
- Top nut **torque the top nut to 132 lb-in** (Figure 5 & 6)

HOLD THE CABLE WHILE TIGHTENING TO AVOID ROTATION

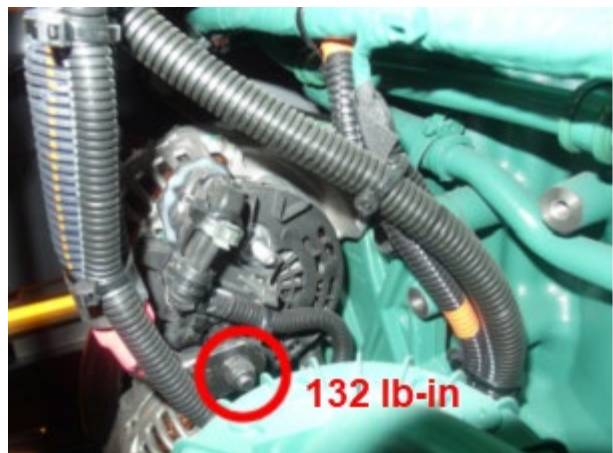
Figure 6: Torque top nut to 132 lb-in

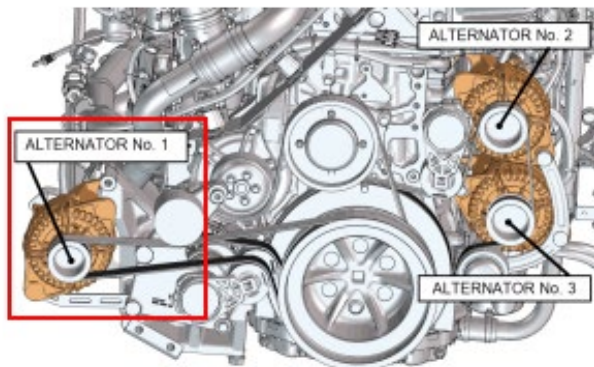
Figure 8: Second alternator to be checked

7. Repeat this procedure for the LH alternator (alternator # 1, Figure 8 & 9).

IMPORTANT: If heat damage is present, STOP AT THIS STEP and contact the Prevost field service manager and NYCT representative to further inspect the damage, parts may need to be replaced.

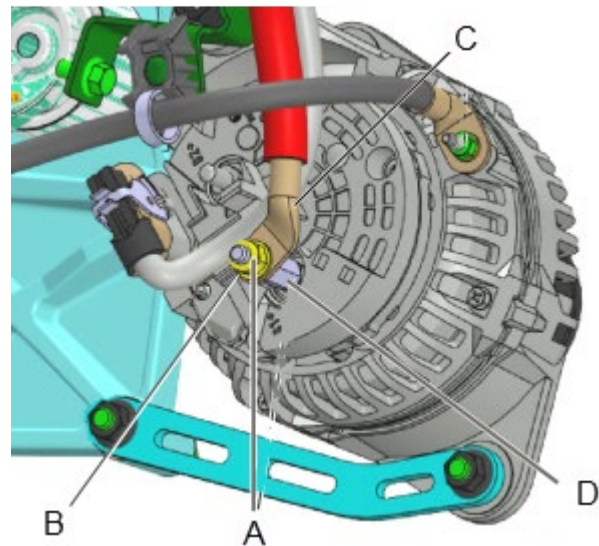
Figure 9: Problematic cable & terminal LH alternator

- A. Top Nut
- B. Flat Washer
- C. Power (positive) Cable
- D. Extension Stud (adapter)

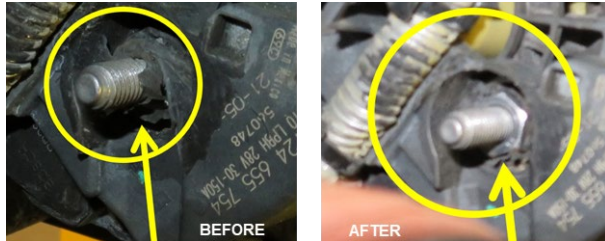
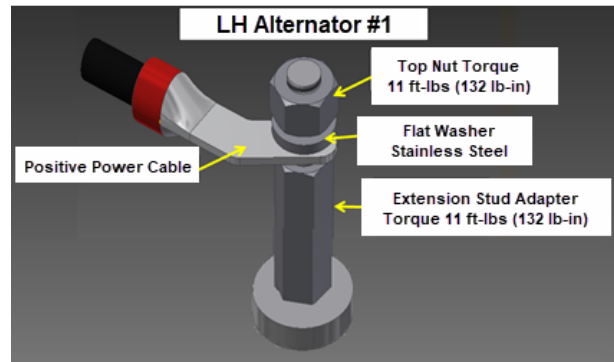
Figure 10: Torque adaptor stud & top nut to 132 lb-in

- Stud extension **torque the stud extension to 132 lb-in** (figure 10)
- Power cable terminal to stud extension.
- Flat Washer
- Top nut **torque the top nut to 132 lb-in** (Figure 10 & 11)

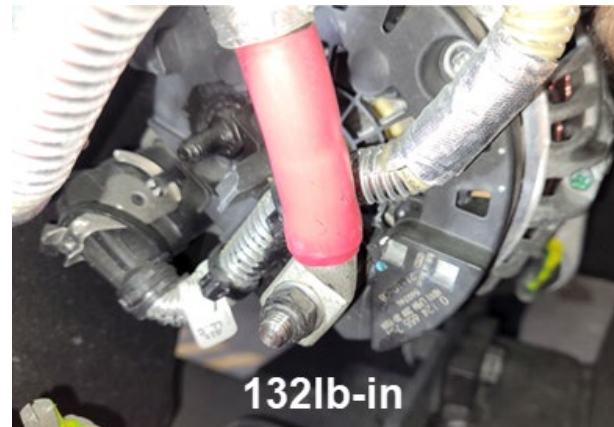
Figure 11: Torque top nut to 132 lb-in

HOLD THE CABLE WHILE TIGHTENING TO AVOID ROTATION

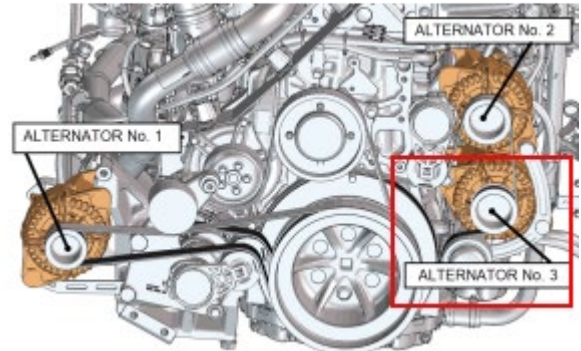
Figure 13: Lower RH alternator VISUAL INSPECTION ONLY

12. **Do not** repeat this procedure for the lower RH alternator (Figure 13).

Proceed to a visual inspection and report anything suspicious and contact the Prevost field service manager and NYCT representative to further inspect the problem.
