GROUP	MODEL
ELE	2022MY Sorento (MQ4a)
NUMBER	DATE
269	October 2022

TECHNICAL SERVICE BULLETIN

SERVICE ACTION: MULTIFUNCTION CAMERA REPLACEMENT (SA511)

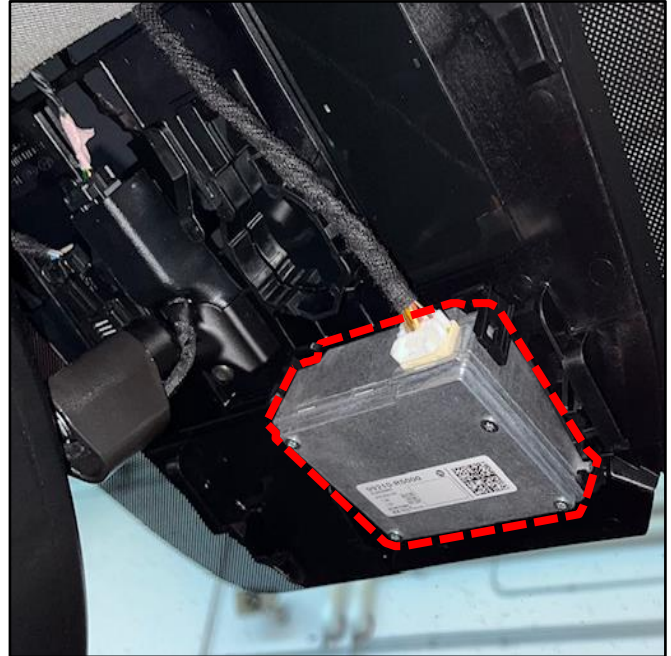
This bulletin provides information to replace the Multifunction Camera (MFC) assembly on some 2022MY Sorento vehicles produced by Kia Georgia (MQ4a) from October 10, 2022 through October 12, 2022. Some MFC assemblies contain software that may not activate haptic feedback or audibly alert the driver when lane departure is detected, although visual lane departure alerts on the instrument cluster continue to function if the Lane Departure Warning (LDW) is enabled by the driver. This issue does not affect other driver assistance features, such as Lane Keeping Assist (LKA), Smart Cruise Control (SCC), Highway Driving Assist (HDA), or Forward Collision Avoidance Assist (FCA), if equipped on the vehicle and enabled by the driver. Before conducting the MFC replacement, verify that the vehicle is included in the list of affected VINs.

1. Replace the front view camera unit (A) by referring to "Advance Driver Assistance System (ADAS) → Front View Camera System → Repair procedures" in the applicable Shop Manual on KGIS.

After installation, be sure to perform the 'Variant Coding' and Adjustment procedure on the new MFC unit on the vehicle which also includes the 'SPTAC Calibration' using KDS.

Ensure the front camera windshield area is clean from debris or contaminants prior to installing new camera.
