Service Bulletin

Bulletin No.: 22-NA-085

Subject: Radio Software Version 135120 (IOR) – Multiple Updates

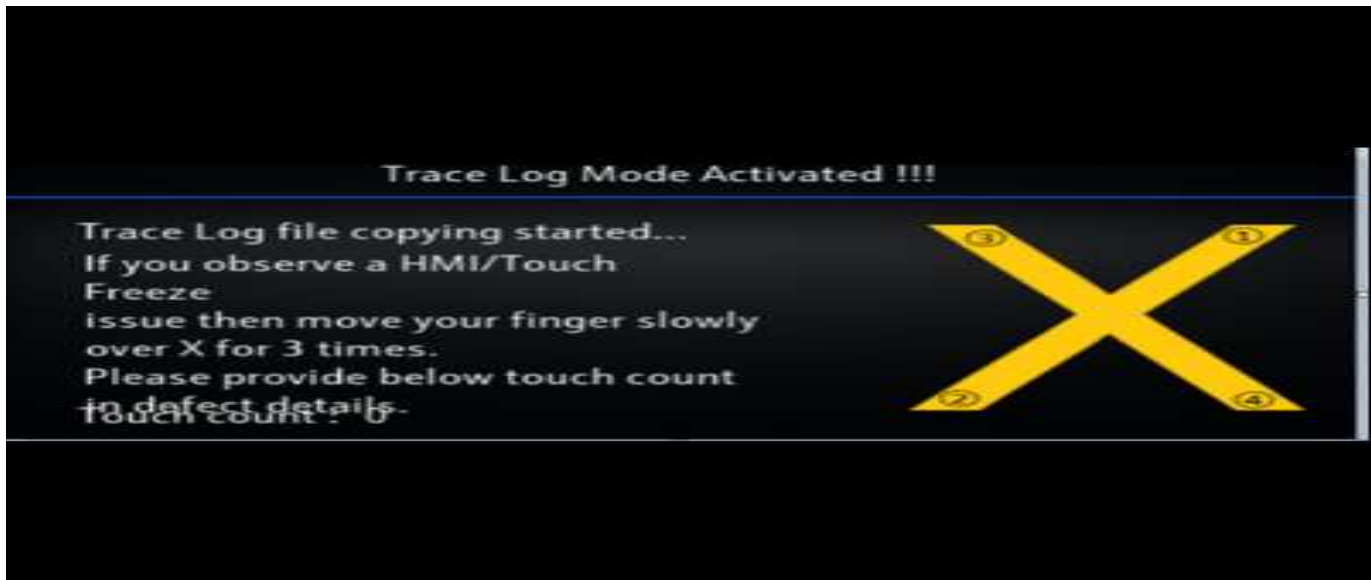
6049197

135120 Most Notable Improvements

- Improvements to Rearview Camera (RVC) performance
- Improvements made to preventing radio resets after USB communication failures
- Removing the RVC guideline button on the box delete trucks
- Fixing the issue where the logging screen is randomly displayed

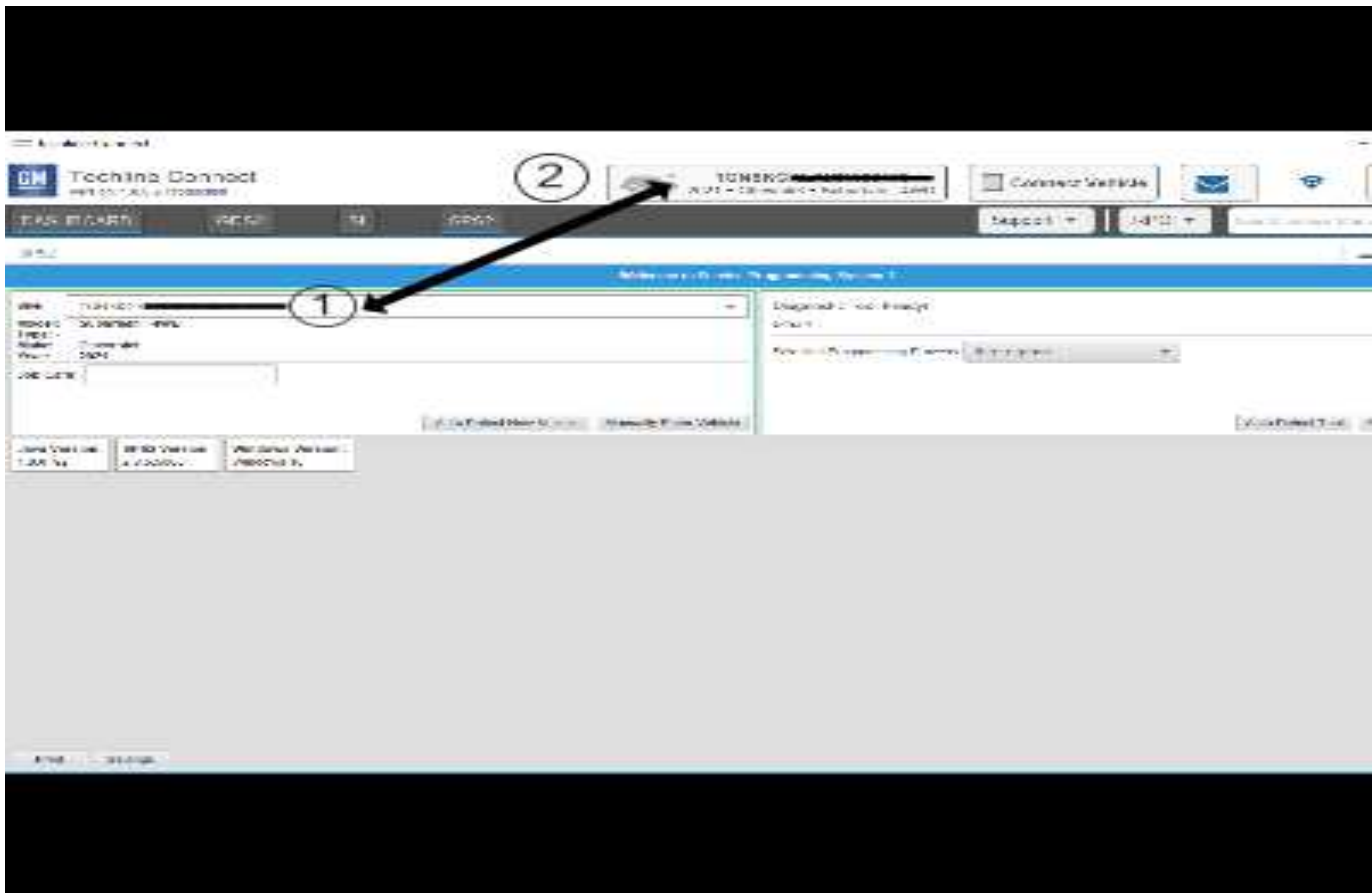
Caution: Be sure the VIN selected in the drop down menu (1) is the same as the vehicle connected (2) before beginning programming.
