**FIELD SERVICE CAMPAIGN – 22119**

26 October 2022

Reprogram radio software

IC Bus® CE Series buses

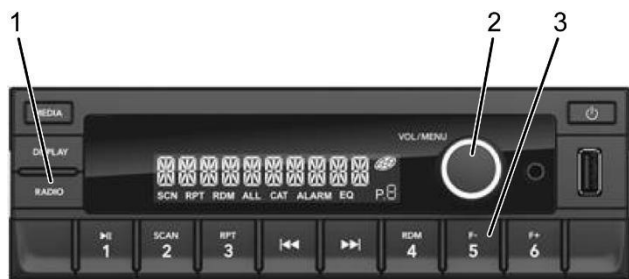
**Figure 1. Radio**

Certain IC Bus® CE Series buses may have outdated radio software that could interfere with the operation of the Public Address (PA) external speakers.

1. RADIO button
  2. VOL / MENU knob
  3. 5 button
8. Simultaneously press **RADIO** button (Figure 1, Item 1) and **5** button (Figure 1, item 3) to open hidden menu.
  9. Turn **VOL / MENU** knob (Figure 1, Item 2) and scroll through options in hidden menu until **UPDATE MCU** is displayed
- NOTE: After selecting UPDATE MCU, a LOAD FILE prompt will display in the radio.**
10. Press the **VOL / MENU** knob (Figure 1, Item 2) to select **UPDATE MCU** setting.

11. Once the radio has auto restarted, simultaneously press **RADIO** button (Figure 1, Item 1) and **5** button (Figure 1, Item 3).
  - a. If radio displays software version MCU-02042D or software version MCU02042E, proceed to Step 12.
  - b. If versions MCU-02042D or MCU02042E are not displayed, open a case file.
