Service Bulletin

Bulletin No.: 22-NA-205

Subject: Information on Module Harvesting

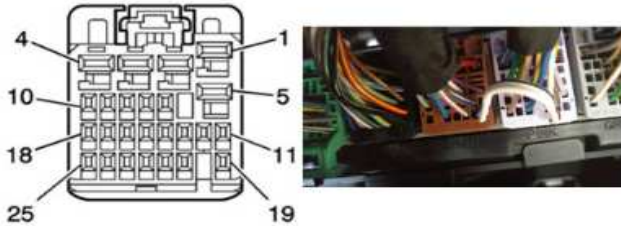
6175304

- Use Service Information Schematics connector end view to find the components pinout to identify the (-) Ground and (+) 12V power supply terminals.

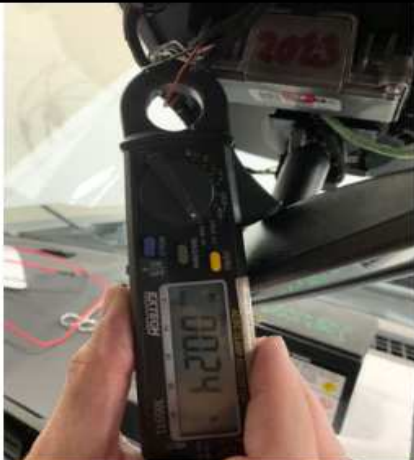
6175306

5. Carefully expose wiring leading to the module and verify drain is present.

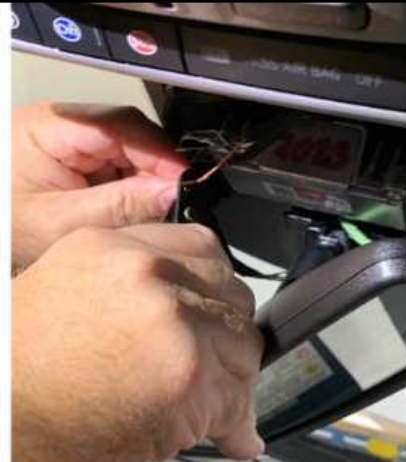
6175307

6. Identify the (+) 12V power supply on the vehicle harness and remove insulation off the wire to splice. Careful not to cause an accidental short.

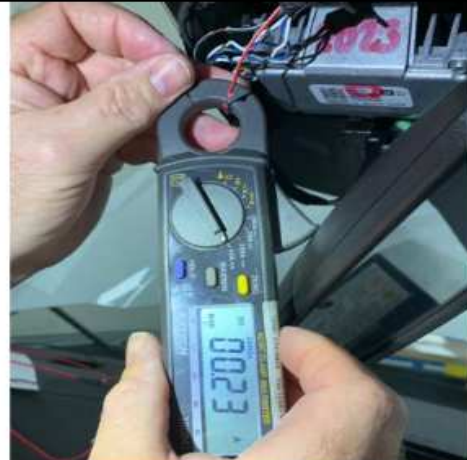
6175309

7. Verify drain is still present after carefully exposing the wire.

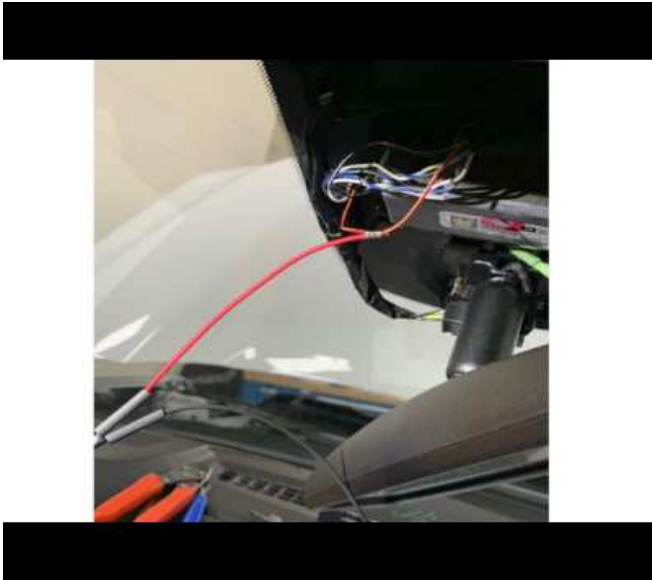
6175310

8. A secure connection is important. The wires should be twisted together to form a good mechanical bond before soldering.

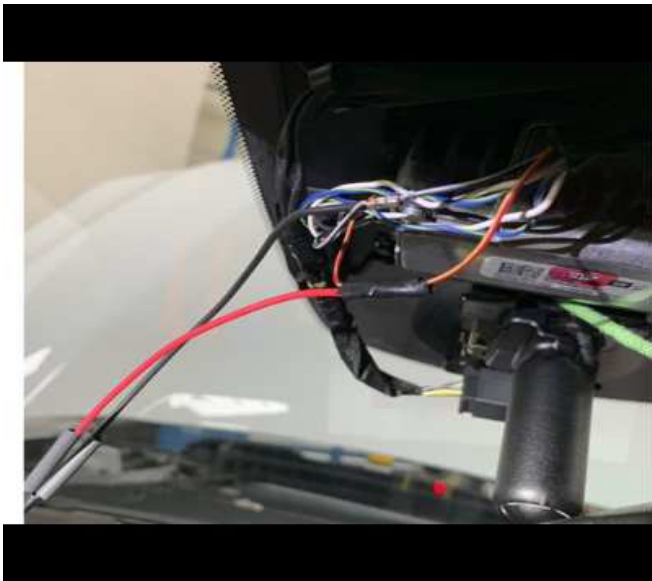
6175312

9. Tape and/or heat shrink to protect the spliced connection.

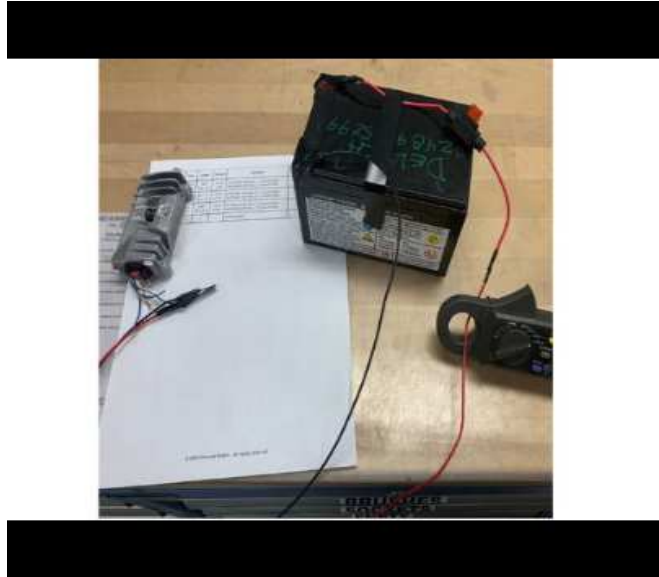
6175313

10. Repeat from step 7 for the (-) Ground wire.
11. Connect the (-) Ground and (+) 12V wires to the battery.
12. Cut the wires on the connector one at a time to remove the battery and component out of the vehicle.
