Service Bulletin

Bulletin No.: 22-NA-206

Subject: Service Engine Soon (SES) Light/Message with DTCs P16F3 and/or P060C in Engine Control Module (ECM)

Brand:	Model:	Model Year:		VIN:		Engine:	Transmission:
		from	to	from	to		
Chevrolet	Corvette	2020	2023	—	—	6.2L (RPO LT2)	—

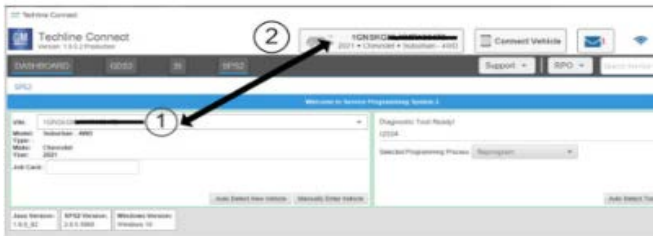
6175813

Caution: Be sure the VIN selected in the drop down menu (1) is the same as the vehicle connected (2) before beginning programming.

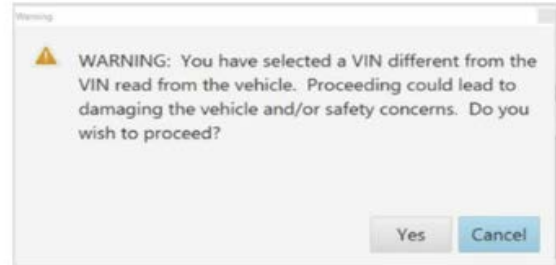
6175816

Important: If the vehicle VIN DOES NOT match, the message below will be shown.

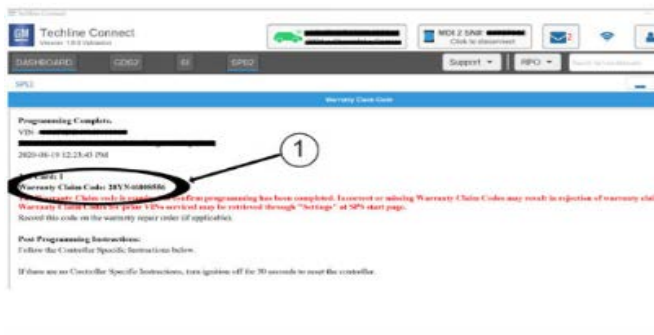
6175820

Note: The screenshot above is an example of module programming and may not be indicative of the specific module that is being programmed. Module selection and VIN information have been blacked out.

Important: To avoid warranty transaction rejections, you **MUST** record the warranty claim code provided on the Warranty Claim Code (WCC) screen shown above on the job card. Refer to callout 1 above for the location of the WCC on the screen.

2. Record the Warranty Claim Code on the job card for warranty transaction submission.

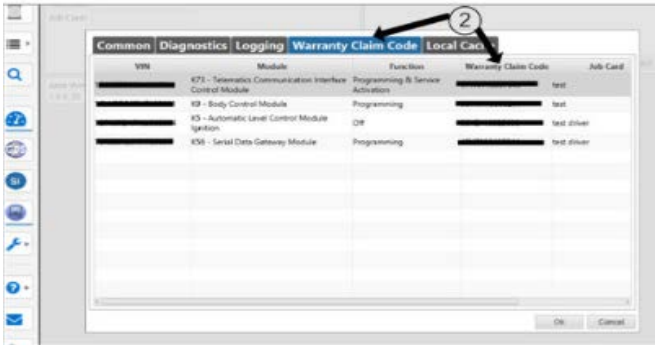
6175823

If the SPS Warranty Claim Code was not recorded on the Job Card, the code can be retrieved in the SPS system as follows:

1. Open TLC/TIS on the computer used to program the vehicle.
2. Select and start SPS/SPS2.
3. Select Settings.
4. Select the Warranty Claim Code tab.

The VIN, Warranty Claim Code and Date/Time will be listed on a roster of recent programming events. If the code is retrievable, dealers should resubmit the transaction making sure to include the code in the SPS Warranty Claim Code field.
