# Revised Fan Ring Bracket Mounting Screws

M-263-006

(July 2008)

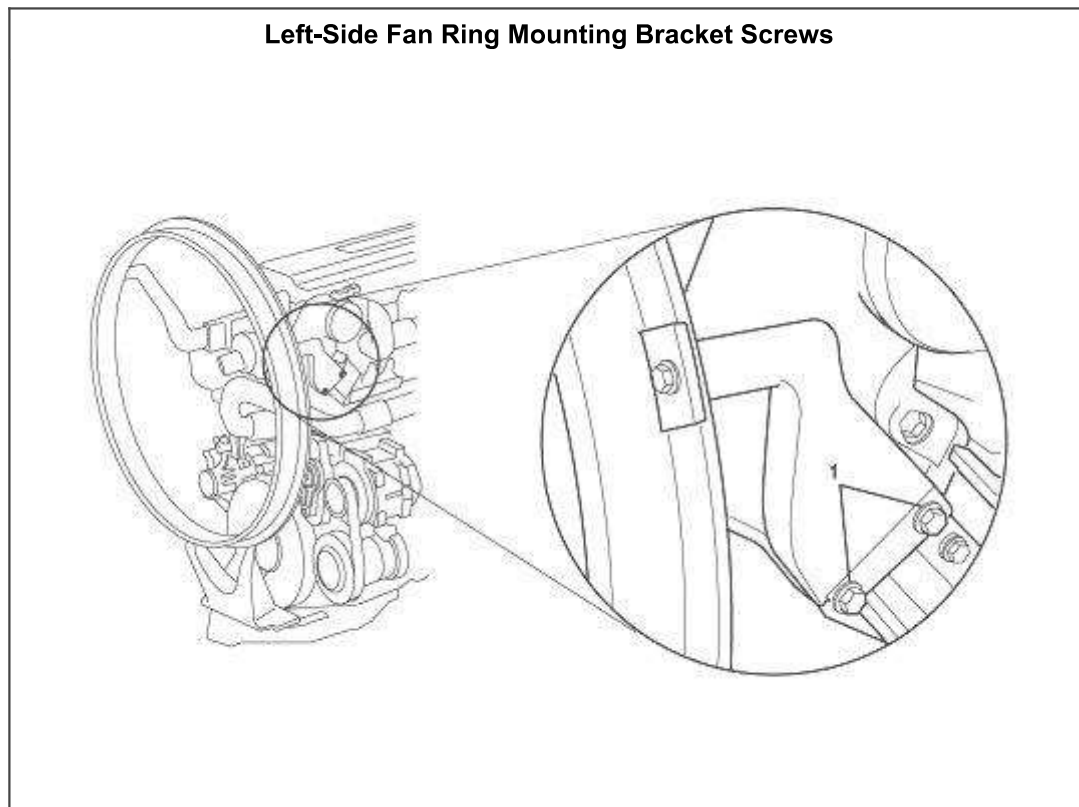
The revised screw is 25 mm long, 5 mm longer than the previous screw. Should broken left-side fan ring bracket mounting screws be encountered on a CXU, CHU or GU model chassis manufactured prior to the above mentioned dates, replacement with the revised screw is recommended.

Key	Qty.	Part number	Description	Replaces
1	2	945444	Flange	64AM12

Torque specification for the revised bolt is 24 N•m (18 lb-ft).
