# Rocker Arm Upgrade to Current Configuration

M-214-001

(November 2008)

CXU,CHU,GU,MRU built with an MP8 and before October 2008

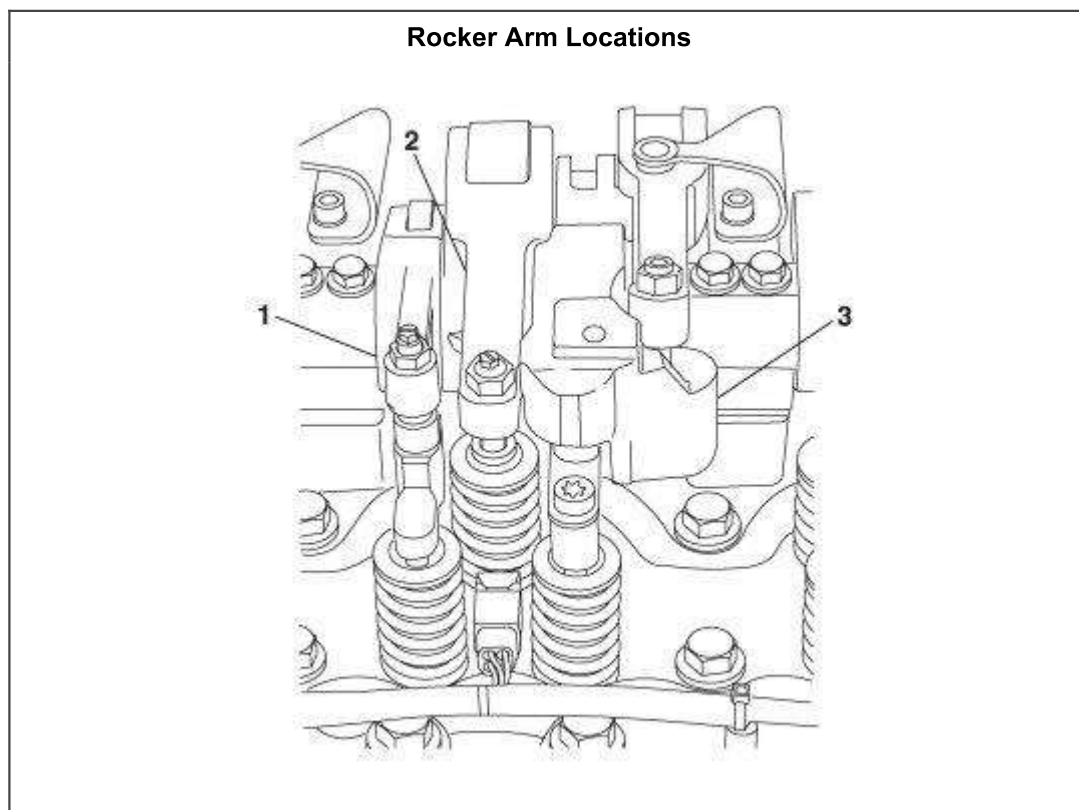
During 3rd and 4th Qtr 2008, revised rocker arms were implemented into production on MACK MP8 engines for the Inlet, Unit Injector and Exhaust locations. These revised rocker arms must be used for any repairs involving camshaft replacement due to damaged rocker arms and cam lobes. Additionally, if a rocker arm failure has resulted in camshaft lobe damage requiring camshaft replacement, ALL inlet, unit injector and exhaust rocker arms must be replaced except those which may already be current part numbers. Current rockers have the part numbers on them. If any are the part numbers below, do not replace them unless they are damaged. Those which have a part number other than given below, or no part number, are to be replaced with these current part numbers.

Key	Part number	Description
1	21260905	Inlet Rocker Arm (Production implementation, 10/13/2008)
2	21266310	Unit Injector Rocker Arm (Production

implementation, 10/27/2008)
3	21228650	Exhaust Rocker Arm (Production implementation, 07/07/2008)
