Service Bulletin

Bulletin No.: 21-NA-054

Subject: Various Instrument Cluster Functional Concerns or DTC U0155 Set

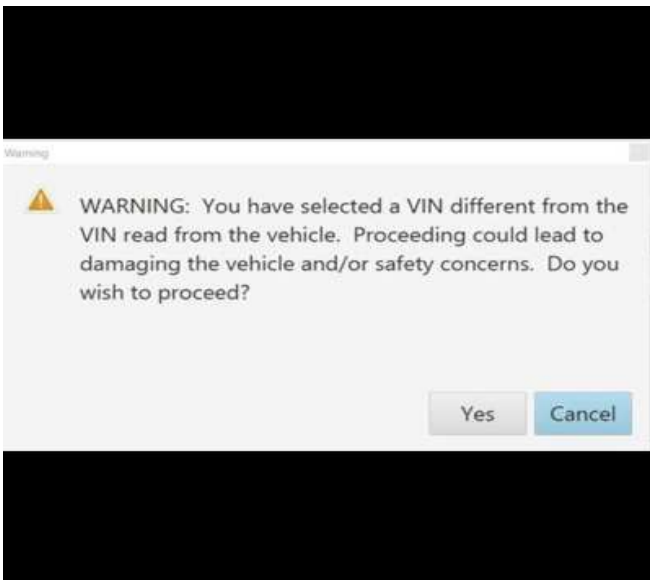
5877000

Important: If the vehicle VIN DOES NOT match, the message below will be shown.
