# Service Bulletin

Bulletin No.: 21-NA-138

**Subject:** Squeak, Grind or Clunking Noise from Rear Leaf Springs

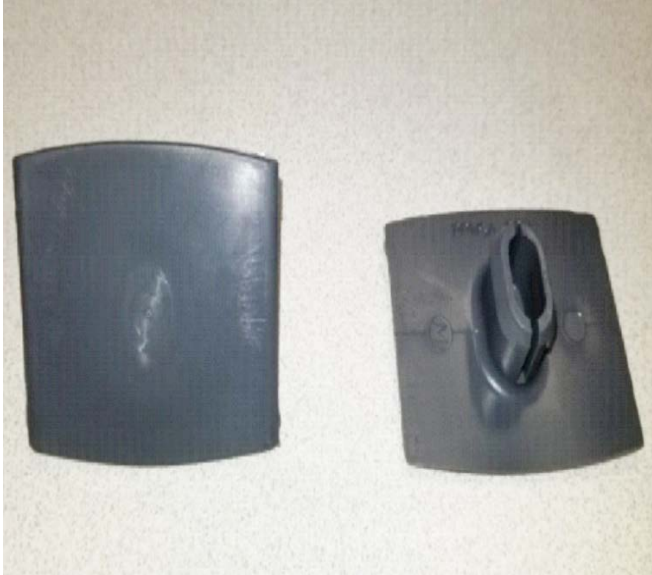
<b>Involved Region or Country</b>	North America, Middle East, Israel, Australia and New Zealand
<b>Condition</b>	Some customers may comment that a squeak, grind or clunking noise can be heard from the rear leaf springs.
<b>Cause</b>	This condition may be caused by the spring insert interacting with the leaf spring. <b>Note:</b> Some noise is characteristic with leaf spring suspensions when going over bumps.
<b>Correction</b>	<div style="text-align: center;">
