Windshield Washer Reservoir Leak

V-363-001

(September 2022)

Volvo VN model trucks built between July 1, 2017, and September 16, 2022

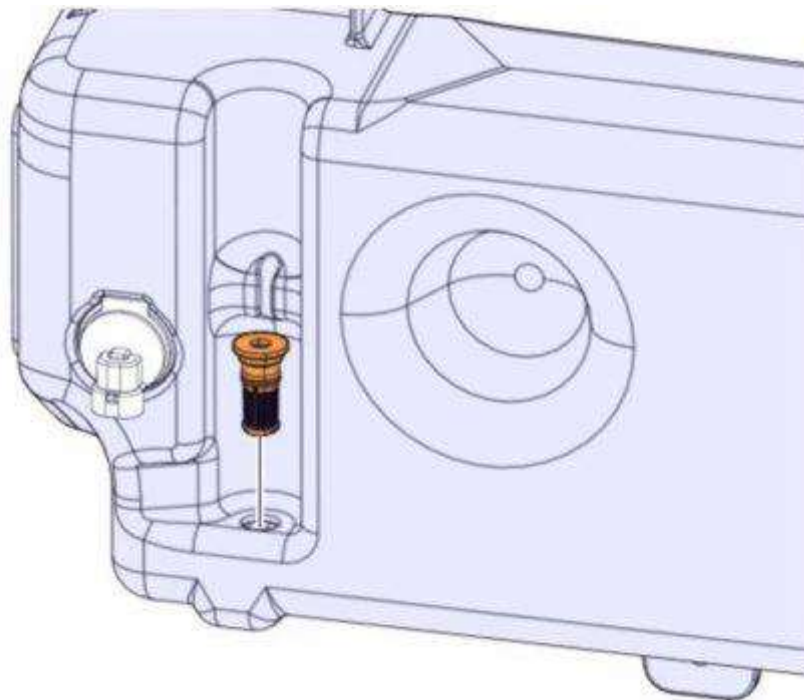
Some Volvo Trucks may experience a leak at the windshield washer reservoir pump mounting grommet/filter. A revised pump grommet/filter has been developed to improve sealing and can be replaced separately from the pump. If the above condition is found replace the grommet/filter with the updated one following the instructions below.

1. Follow [Windshield Washer Fluid Filter, Replacement](#) in impact.
