# Service Bulletin

Bulletin No.: 17-NA-404

**Subject: Radio Control Display Makes Random Selections with No User Input and/or Places Unwanted Phone Calls**

Brand:	Model:	Model Year:		VIN:		Engine:	Transmission:
		from	to	from	to		
Chevrolet	Traverse	2018	2018	SOP	November 19, 2017	All	All

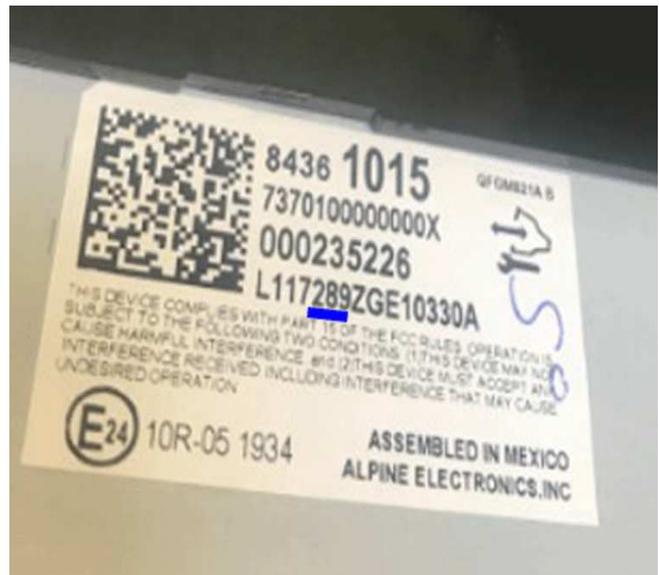
5069189

If you encounter a vehicle with the above concern, inspect the build date code of the radio control (ICS) assembly (characters 5-7) shown below. If it is 245-306, replace the radio control (ICS) assembly. Refer to Radio Control Assembly Replacement with IO5, IO6 in Service Information for detailed instructions.

**Important:** After replacing the Radio Control Assembly, programming of the Radio Control Assembly may be required depending on the part number of the service replacement part. After installing the replacement assembly, use TIS2web to determine if the latest TIS2web files are already installed by selecting A22 Radio Control in TIS2web and comparing the “current” vs “selected” calibration numbers. If no updates are present, no further action is required. If updates are present, use TIS2web to program the replacement radio control assembly by following the Reprogram Control Module section of the A22 Radio Controls: Programming and Setup procedure found in Service Information.
