Service Bulletin

Bulletin No.: 16-NA-292

Subject: Phone Icon on Radio Display Intermittently Will Not Respond or Spins When Pressed

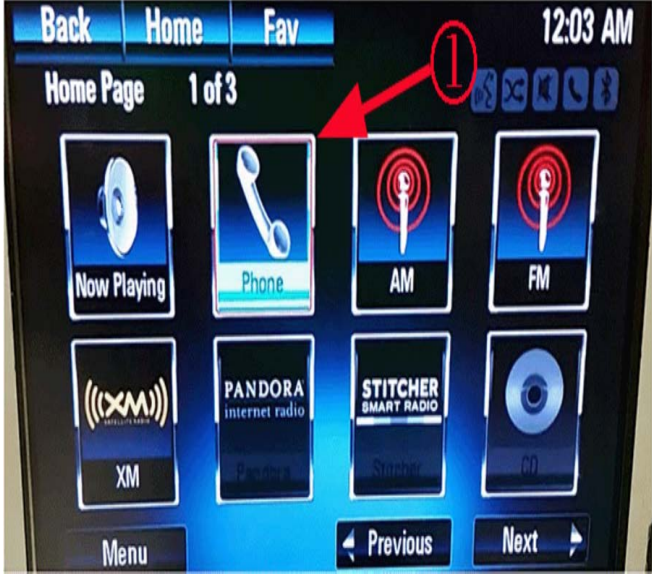
<p>4519340</p> <p>On rare occasions, a customer may comment that the phone icon on the radio display (1) will intermittently highlight (or highlight and spin) when pressed but the radio will not respond to the request/command. Also, the Pair Device icon under the Phone Settings Menu will not function and the user will be presented with an error message if they attempt to use it.</p>
<p>Cause</p>	<p>This is the result of an internal radio concern.</p>

If you encounter a vehicle with the above concern, replace the radio. Refer to *Radio Replacement* in SI.

The replacement radio includes improvements to repair this concern and prevent it from reoccurring.
