Service Alert

MELTED OR WARPED MIRROR COVER OR OUTSIDE TRIM

Service Alert No.: SA-008/22 Last Issued : 10/17/2022

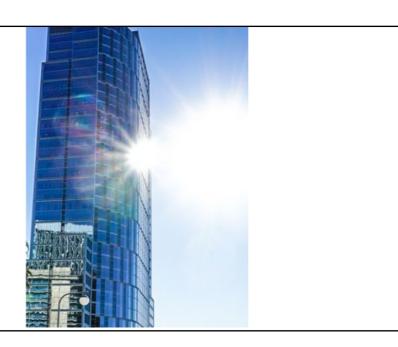
Some vehicles may experience exterior trim heat damage when parked near a glass building or Low-E windows. This may be caused by the sun's reflection.

If a structure's windows create enough of a curve, the concave glass can focus the sun's rays onto a small area and acting like magnifying glass direct the sunbeams into a hot pinpoint of light. This magnification of the sun's rays can cause damge to vehicle trim (see examples). Additional information and exemplar images regarding this phenomenon can be found by performing a google search.

Repair or replace the affected part(s) as needed.

If the customer regularly parks the vehicle where there is exposure to such conditions as described in the description above, explain to the customer that parking location may need to be reconsidered.
